**FIRNTEC**  
BUILDING COMPLIANCE

VISUAL STRUCTURAL APPRAISAL

Holly Court  
Acacia Avenue  
West Brom  
WS5 4HB

24<sup>th</sup> June 2025

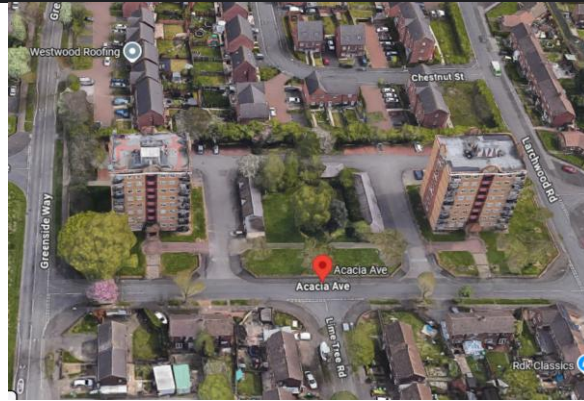
Figure 5. Holly Court to the Left

The elevations are cavity walls with external leaf of stretcher bond masonry supported off the exposed slab edge.

Each floor has 4 cantilevering balconies in opposing corners of the block. These were not accessible however from inspection they have been cast as part of the main concrete slab.

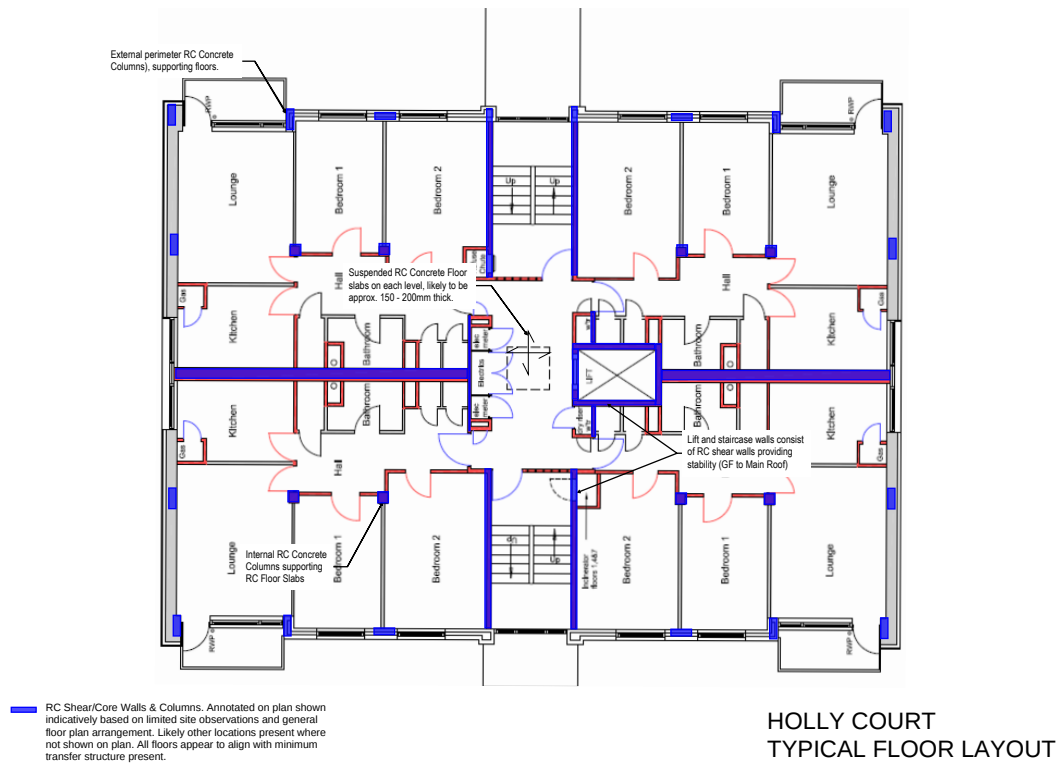
Figure 6: Diagram of typical floor plan

Figure 6 indicates the assumed structural layout for a typical upper floor level.

There were vertical concrete walls supporting the floor plates at every level. The elements visible matched the floor layout in Figure 6. The walls appear continuous from ground to roof with no transfer structure. The overall condition of the structure observed is good.
