**FIRNTEC**  
BUILDING COMPLIANCE

VISUAL STRUCTURAL APPRAISAL

1-32 Horton Street

27<sup>th</sup> May 2025

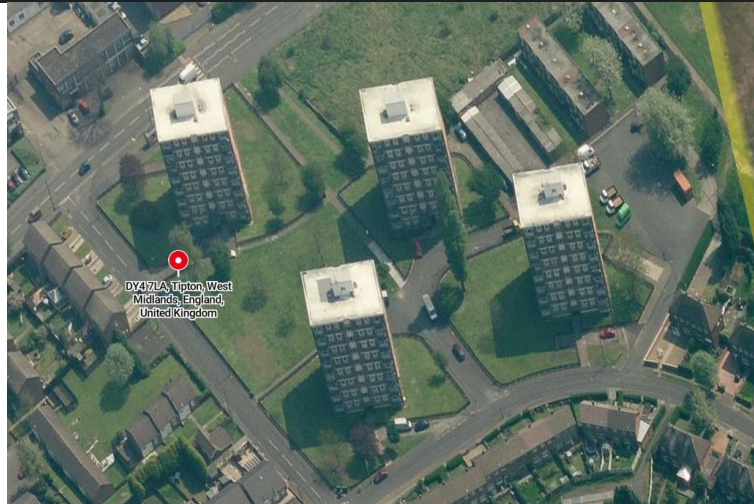
Figure 5. Aerial photograph of the estate before the buildings underwent the refurbishment

The gable end elevations were originally cavity walls with external leaf of stretcher bond masonry. The building was re-clad in 2009 and now the gable ends are finished in Wetherby render system.

Each floor has 4 cantilevering balconies in opposing corners of the block. These were not accessible however from inspection they have been cast as part of the main concrete slab.

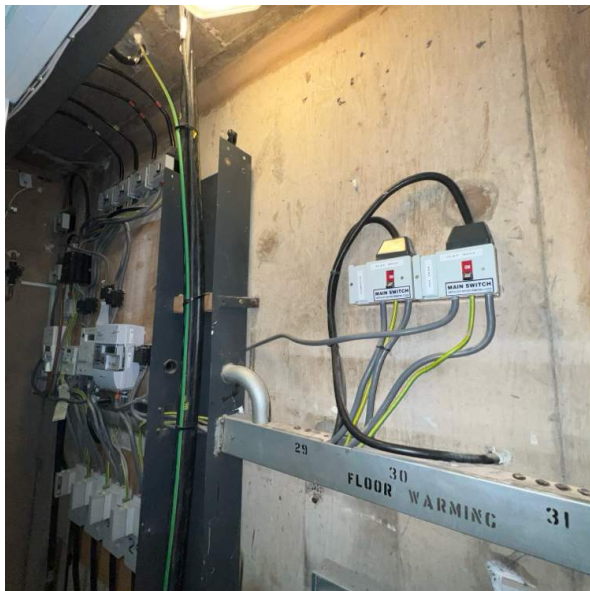
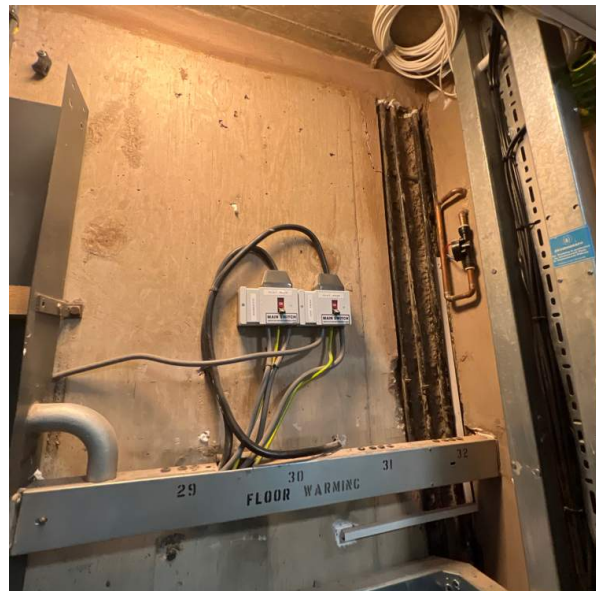
## 7th Floor Hallway

Comments: No jams or distortions noted to hallway doors to indicate any serviceability issues. Generally walls covered with finishes in hallway, likely to consist a mixture of concrete shear walls, embedded columns and masonry infill walls. Limited structure exposed. Concrete walls and infill masonry (non-load bearing) walls noted in riser cupboards.

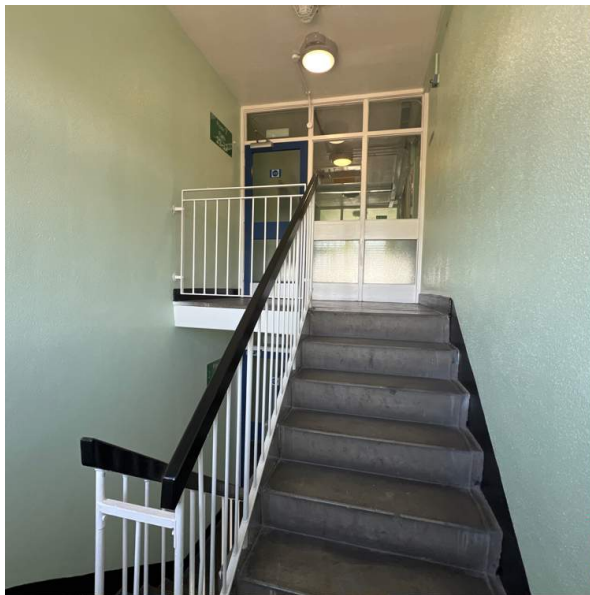
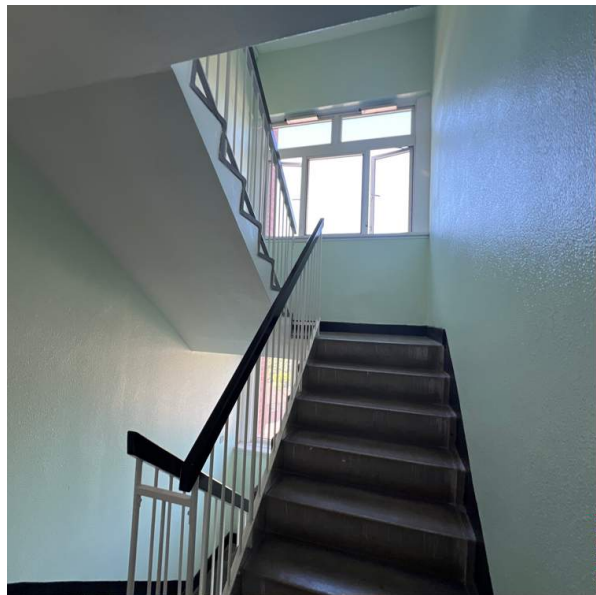
## 7th Floor Staircases

Comments: Insitu concrete stairs with steel hand railing fixed to stairs. Walls and floors appear to be fairly level.  
Stair walls covered with finishes however these would likely form the main concrete shear core walls.

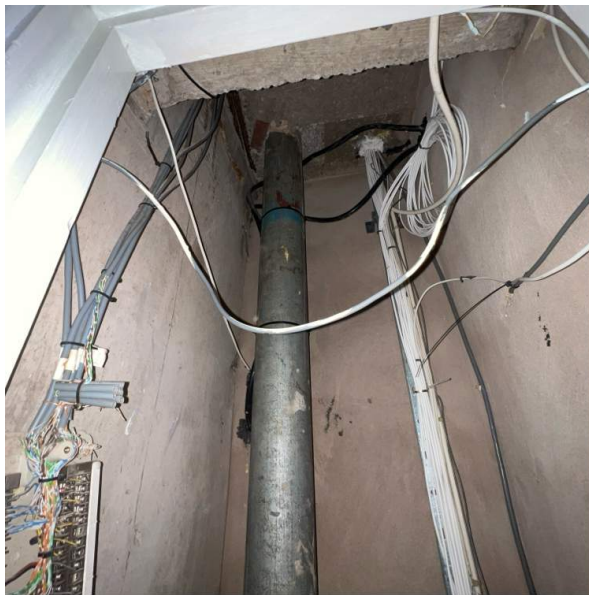
## 4th Floor Hallway

Comments: No jams or distortions noted to hallway doors to indicate any serviceability issues. Generally walls covered with finishes in hallway, likely to consist a mixture of concrete shear walls, embedded columns and masonry infill walls. Limited structure exposed. Concrete walls and infill masonry (non-load bearing) walls noted in riser cupboards.

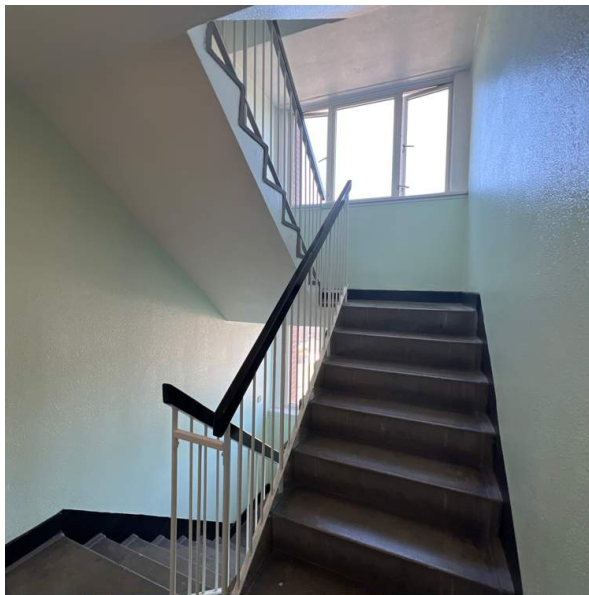
## 4th Floor Staircases

Comments: Insitu concrete stairs with steel hand railing fixed to stairs. Walls and floors appear to be fairly level.  
Stair walls covered with finishes however these would likely form the main concrete shear core walls.

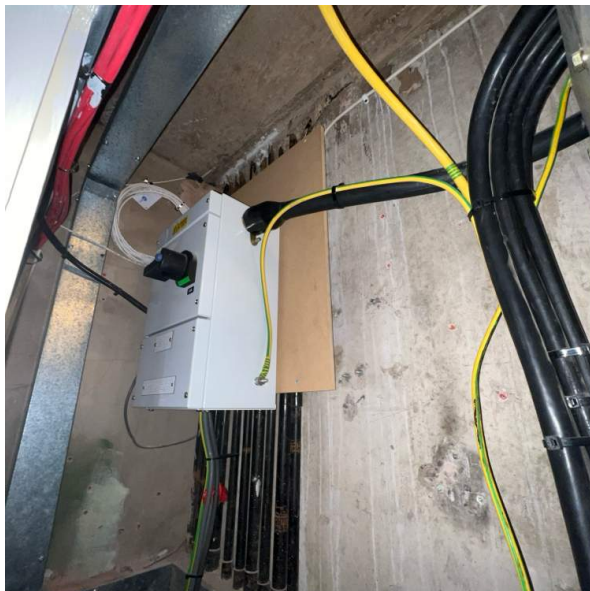
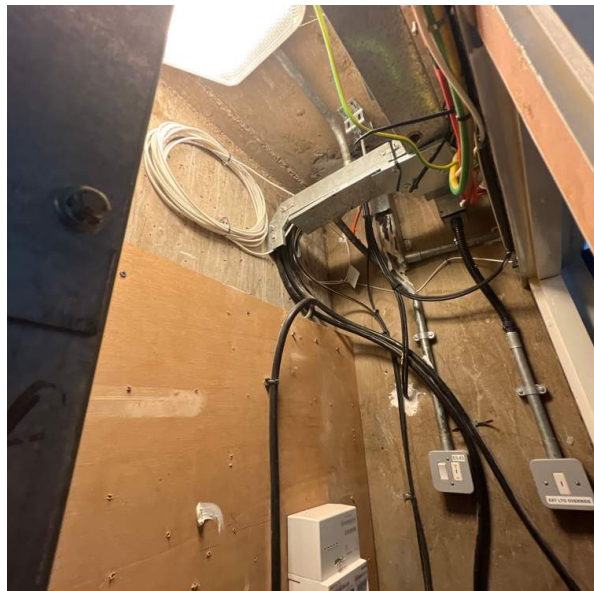
## Ground Floor Hallway

Comments: No jams or distortions noted to hallway doors to indicate any serviceability issues. Generally walls covered with finishes in hallway, likely to consist a mixture of concrete shear walls, embedded columns and masonry infill walls. Limited structure exposed. Concrete walls and infill masonry (non-load bearing) walls noted in riser cupboards.

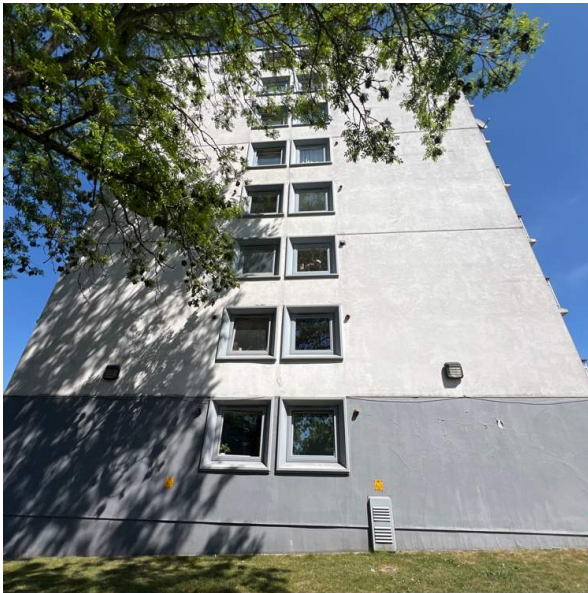
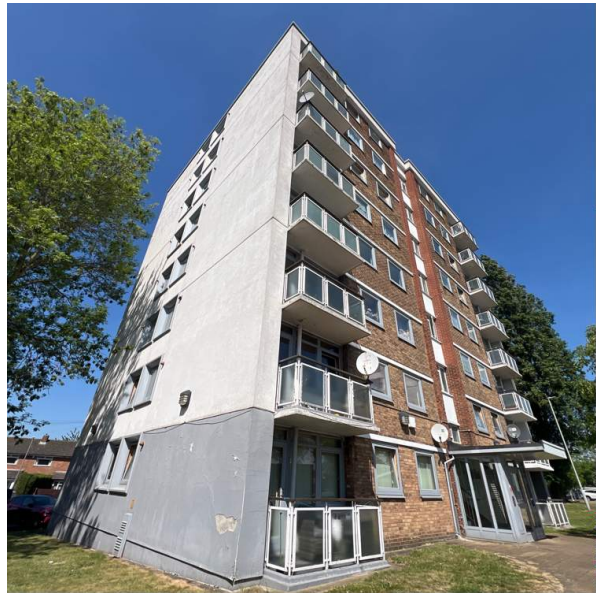
Comments: External facade consists of brick work on all levels to front and rear elevations with cantilevered balconies situated on corners. Side elevations consist of render to full height of walls.
