**FIRNTEC**  
BUILDING COMPLIANCE

VISUAL STRUCTURAL APPRAISAL

65-96 Horton Street

27<sup>th</sup> May 2025

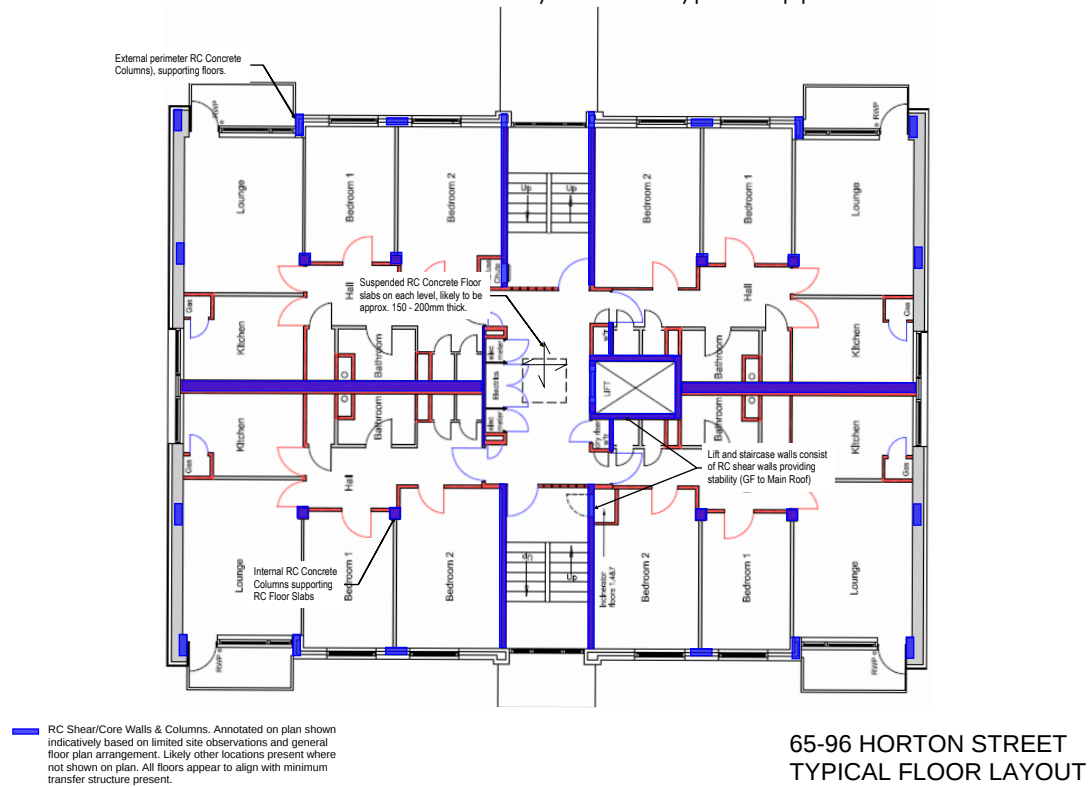
Figure 6: Diagram of typical floor plan

There were vertical concrete walls supporting the floor plates at every level. The elements visible matched the floor layout in Figure 6. The walls appear continuous from ground to roof with no transfer structure. The overall condition of the structure observed is good.
