VISUAL STRUCTURAL APPRAISAL

Kenrick House

Green Street  
West Bromwich  
B70 6DW

29<sup>th</sup> November 2024

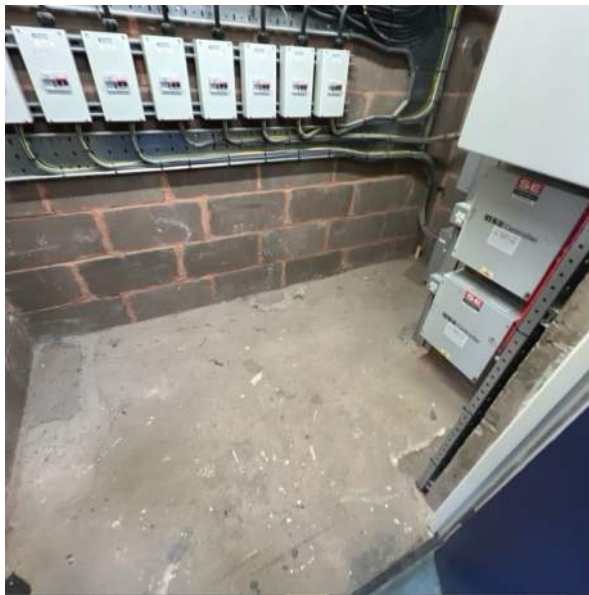
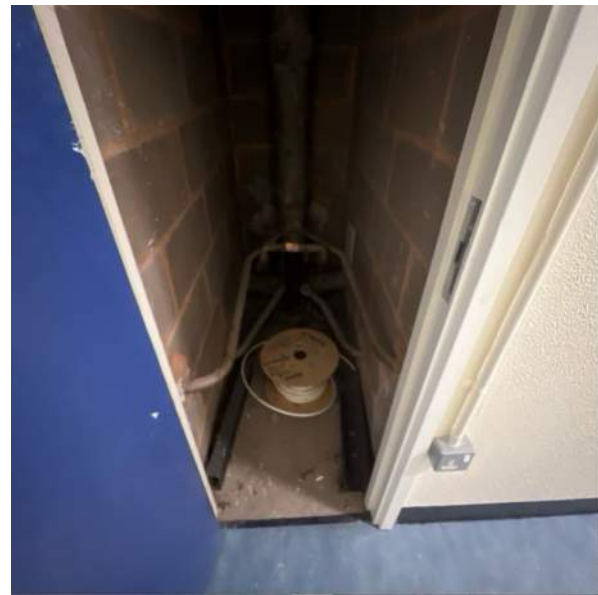
The lift and stair core located to two sides of the hallway. No jams or distortions noted to hallway doors to indicate any serviceability issues.  
Generally walls covered with finishes in hallway, likely to consist a mixture of concrete shear walls, embedded columns and block infill walls.  
Concrete walls forming part of the primary structure noted in the electric room. Walls noted to be approx. 150mm thick.

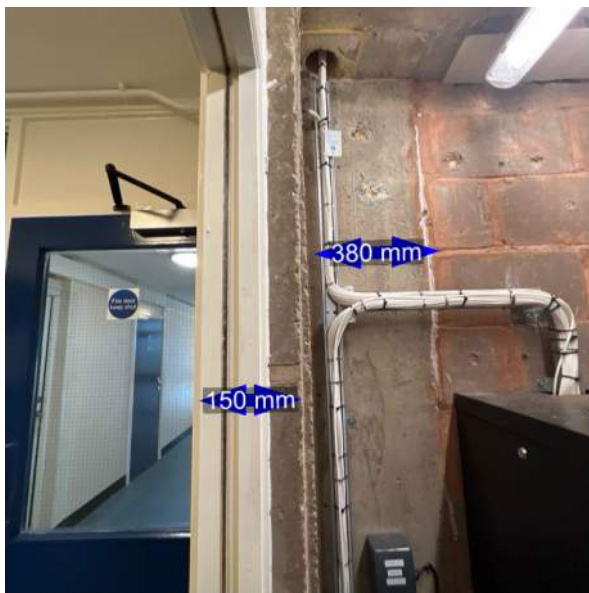
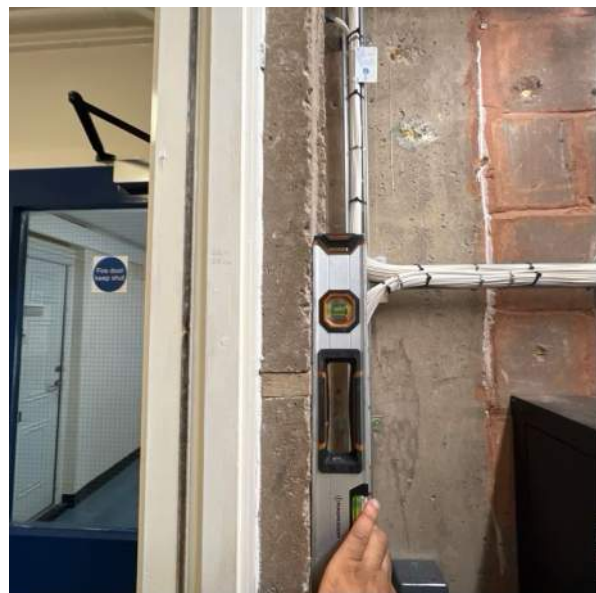
The lift and stair core located to two sides of the hallway. No jams or distortions noted to hallway doors to indicate any serviceability issues.  
Generally walls covered with finishes in hallway, likely to consist a mixture of concrete shear walls, embedded columns and block infill walls.  
Concrete walls forming part of the primary structure noted in the electric room. Walls noted to be approx. 150mm thick.  
Insitu concrete floor slabs noted in electric room.

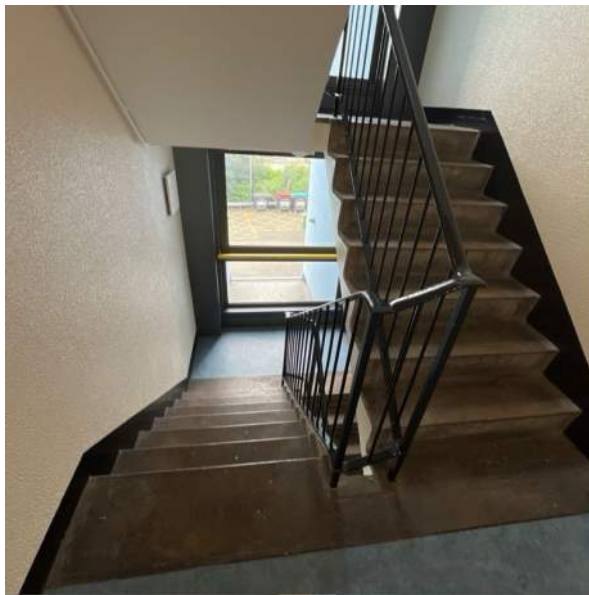
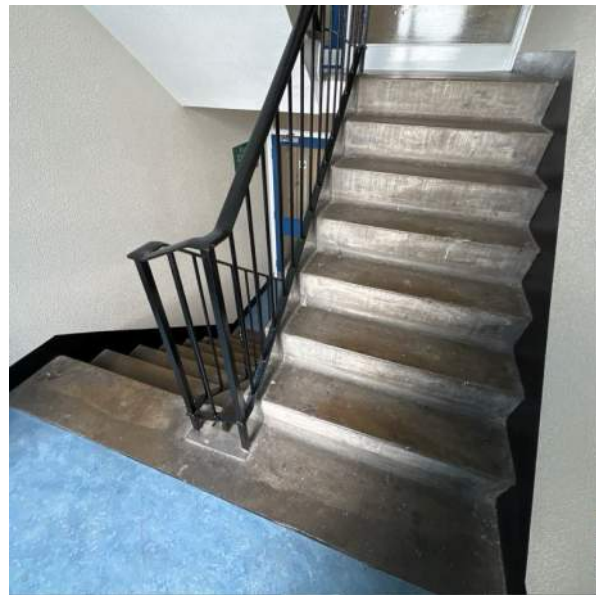
## 8th Floor Staircases (Both Sides) - Copy

Insitu concrete stairs with steel hand railing fixed to stairs. Walls and floors appear to be fairly level but some areas noted to be uneven likely due to finishes.  
Stair walls covered with finishes however these would likely form the main concrete shear core walls.  
Floor slab measures from stair platform appears to be approx. 180mm thick.

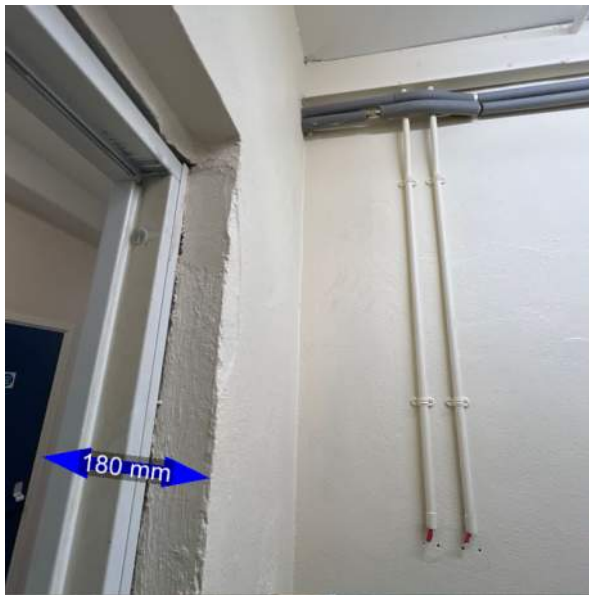
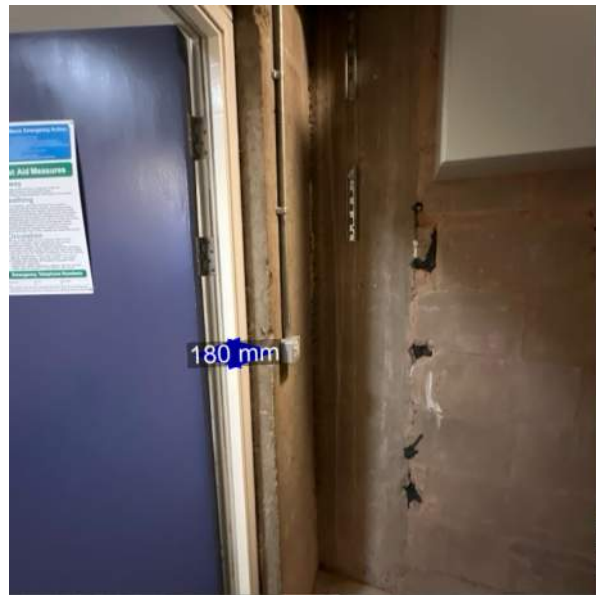
## Ground Floor Hallway

RC Concrete walls and columns noted in communal areas and accessible rooms on ground floor. The columns form part of the main primary structure of the building and were measured to be 380x380mm. Ground floor concrete walls measured to be approx. 180mm.

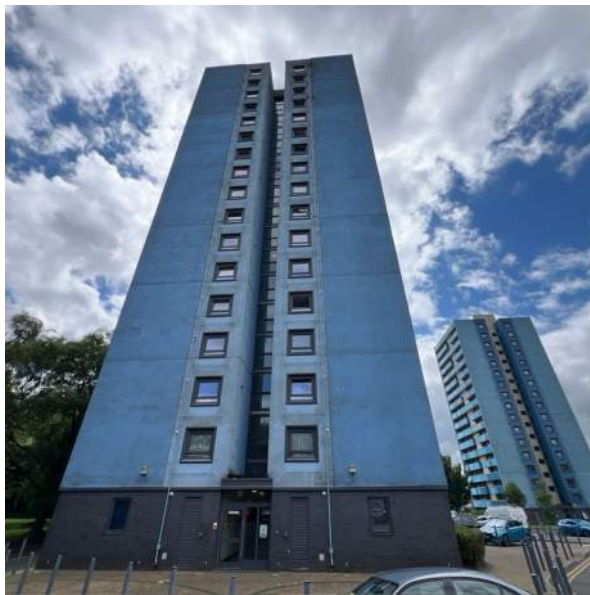
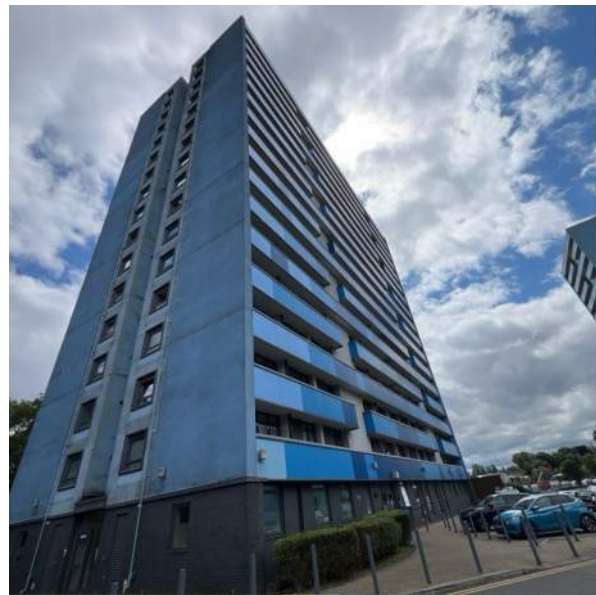
External ground floor level consists of brick work.  
Upper floors noted to have a rendered facade and cladding to balconies.  
Concrete columns noted to perimeter which form part of  
the primary structural elements of the building.
