VISUAL STRUCTURAL APPRAISAL

Kynaston House

Rydding Lane  
West Bromwich  
B71 2HD

3<sup>rd</sup> September 2025

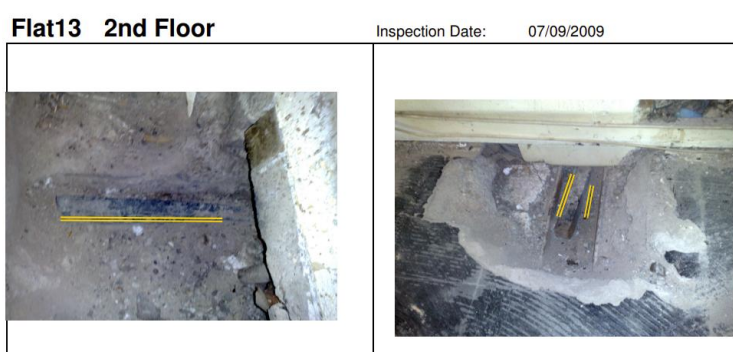
These should include opening up works to assess the form and presence of the remedial ties. Once their presence and form is confirmed it is possible to use a GPR to check the remaining joints. We are expecting ties similar to the ones installed to Russell House, shown below.

The findings of this report revealed that the building is built using the Large Panel System (LPS) form of construction, a method which involved assembling precast concrete panels on site to form the structure of the building. Due to LPS buildings susceptibility to disproportionate collapse, as discussed in detail in section 4.4, it is essential to perform intrusive investigations into the remedial ties installed between the wall and floor panels, as there is a **risk** the building does not satisfy the requirements and could therefore pose a risk to the residents and users of the block. We have been provided with archive correspondence which states that the tying requirements are met and that the remedial ties have been installed however no evidence is supplied to support their presence. Therefore we suggest completing spot checks to the ties in at least 25% flats of the property.
