**FIRNTEC**  
BUILDING COMPLIANCE

VISUAL STRUCTURAL APPRAISAL

Lancaster House

Oldbury Road  
Oldbury  
B65 0QE

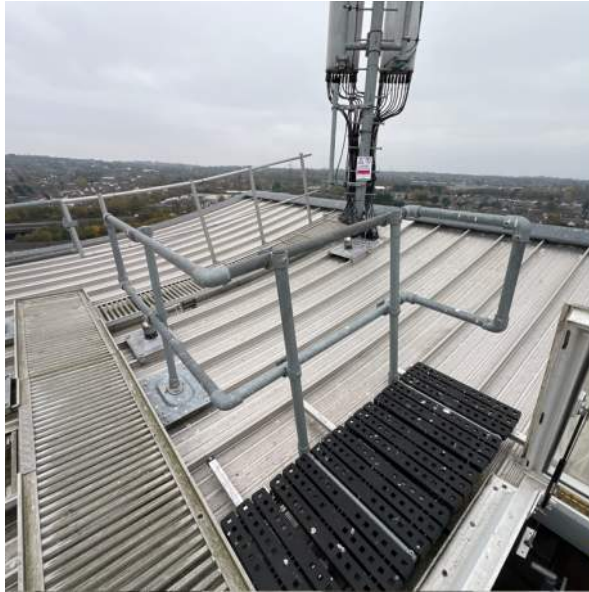
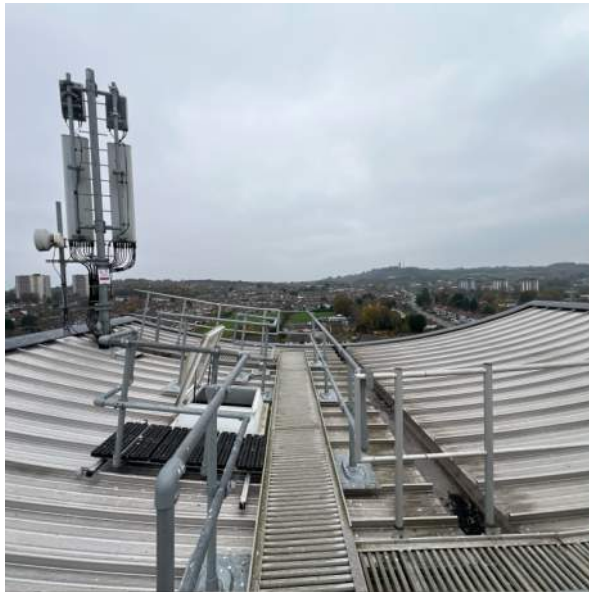
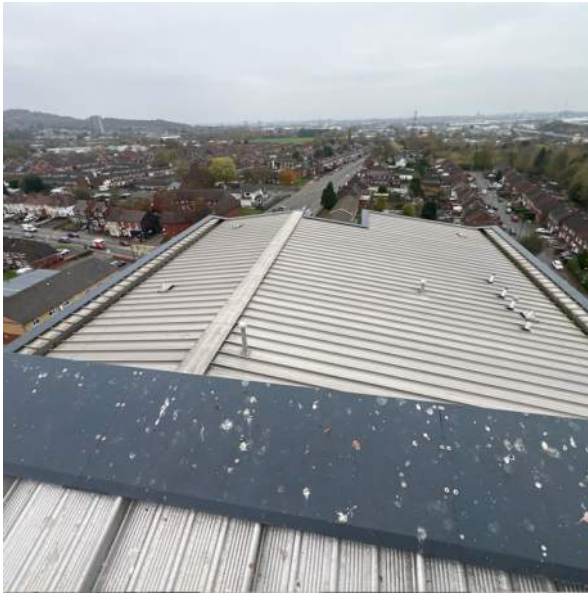
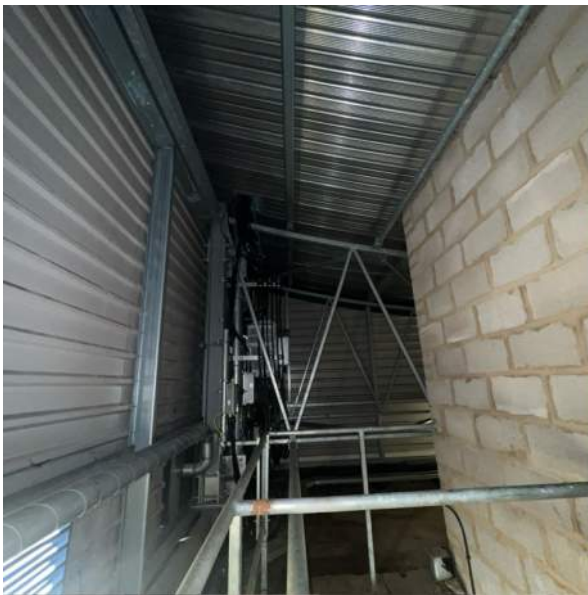
## Main Roof

Pitched Roof with profile metal sheet covering. Pitched roof/aluminium frame appears to have been added to the original building which consists of a flat roof.

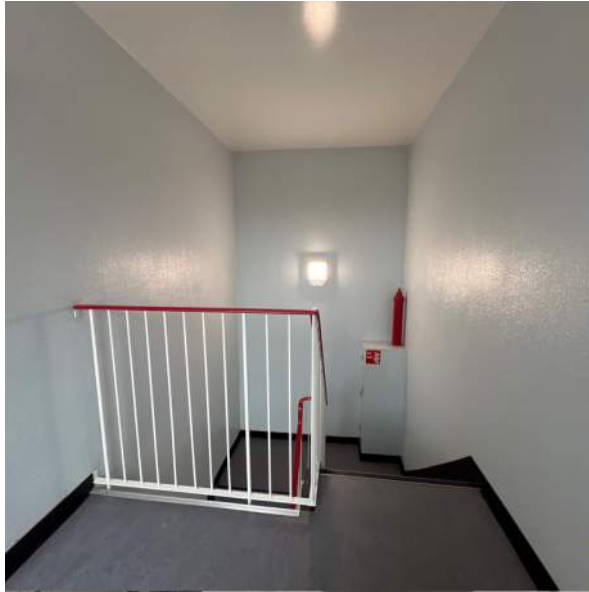
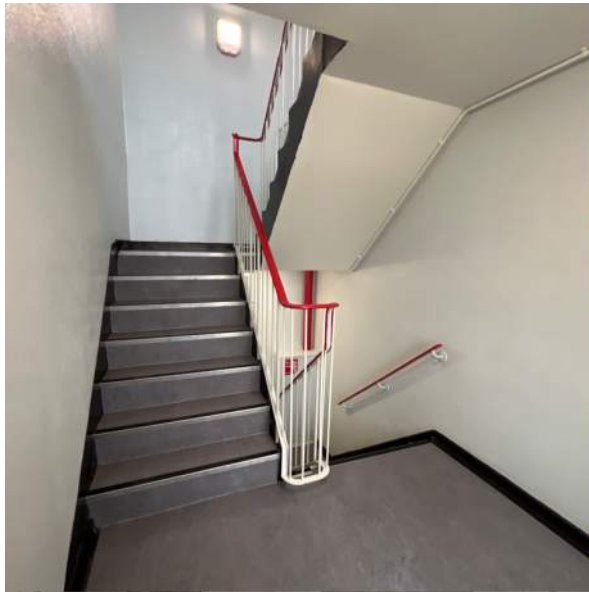
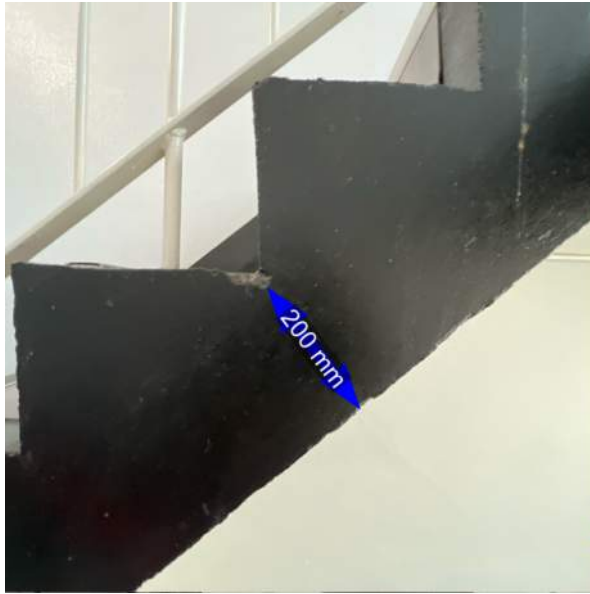
## 10th Floor Staircases

A set of staircases is located on both ends of the building. Insitu concrete stairs with steel hand railing fixed to stairs. Walls and floors appear to be fairly level. Stair walls covered with finishes however these would likely form the main concrete shear core walls.

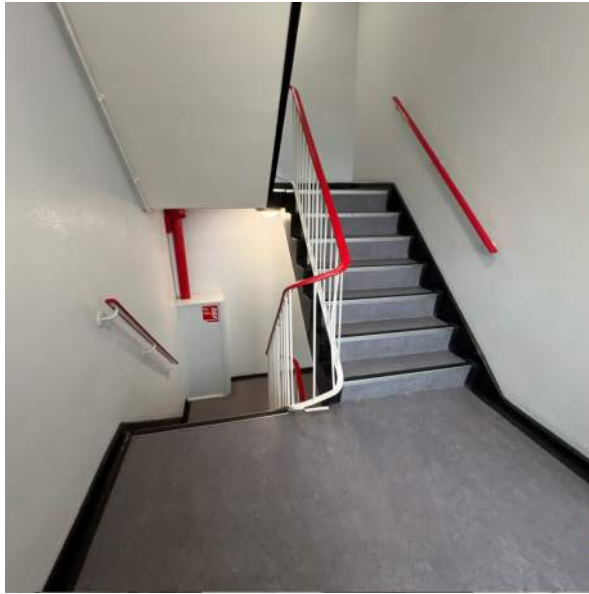
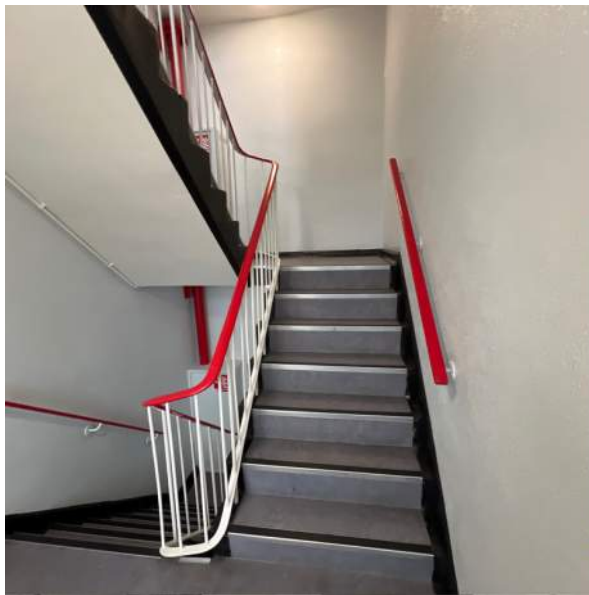
## 6th Floor Staircases

Comments: A set of staircases is located on both ends of the building. Insitu concrete stairs with steel hand railing fixed to stairs. Walls and floors appear to be fairly level. Stair walls covered with finishes however these would likely form the main concrete shear core walls.

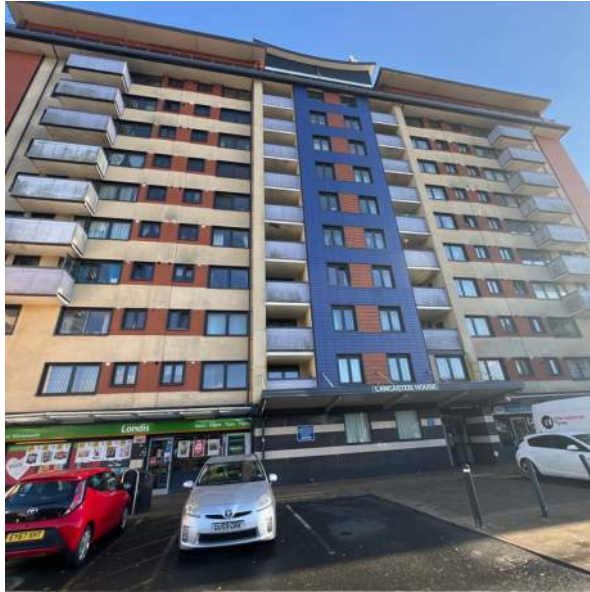
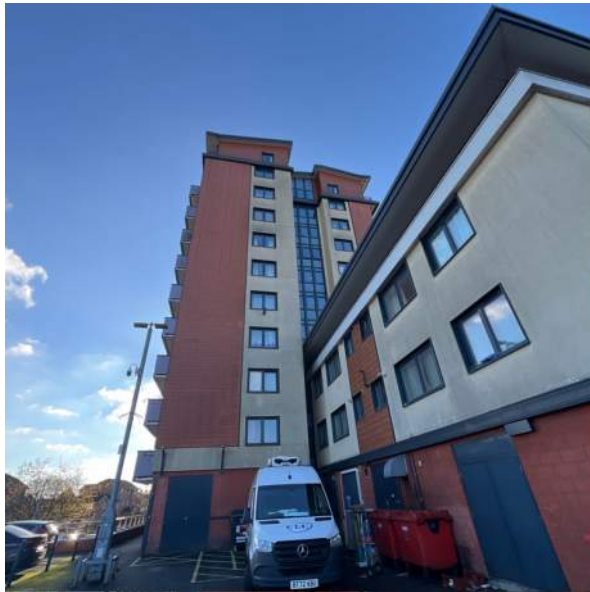
## Elevations

External facade consists of partial cladding and render. Elevations appear to be in fair condition.

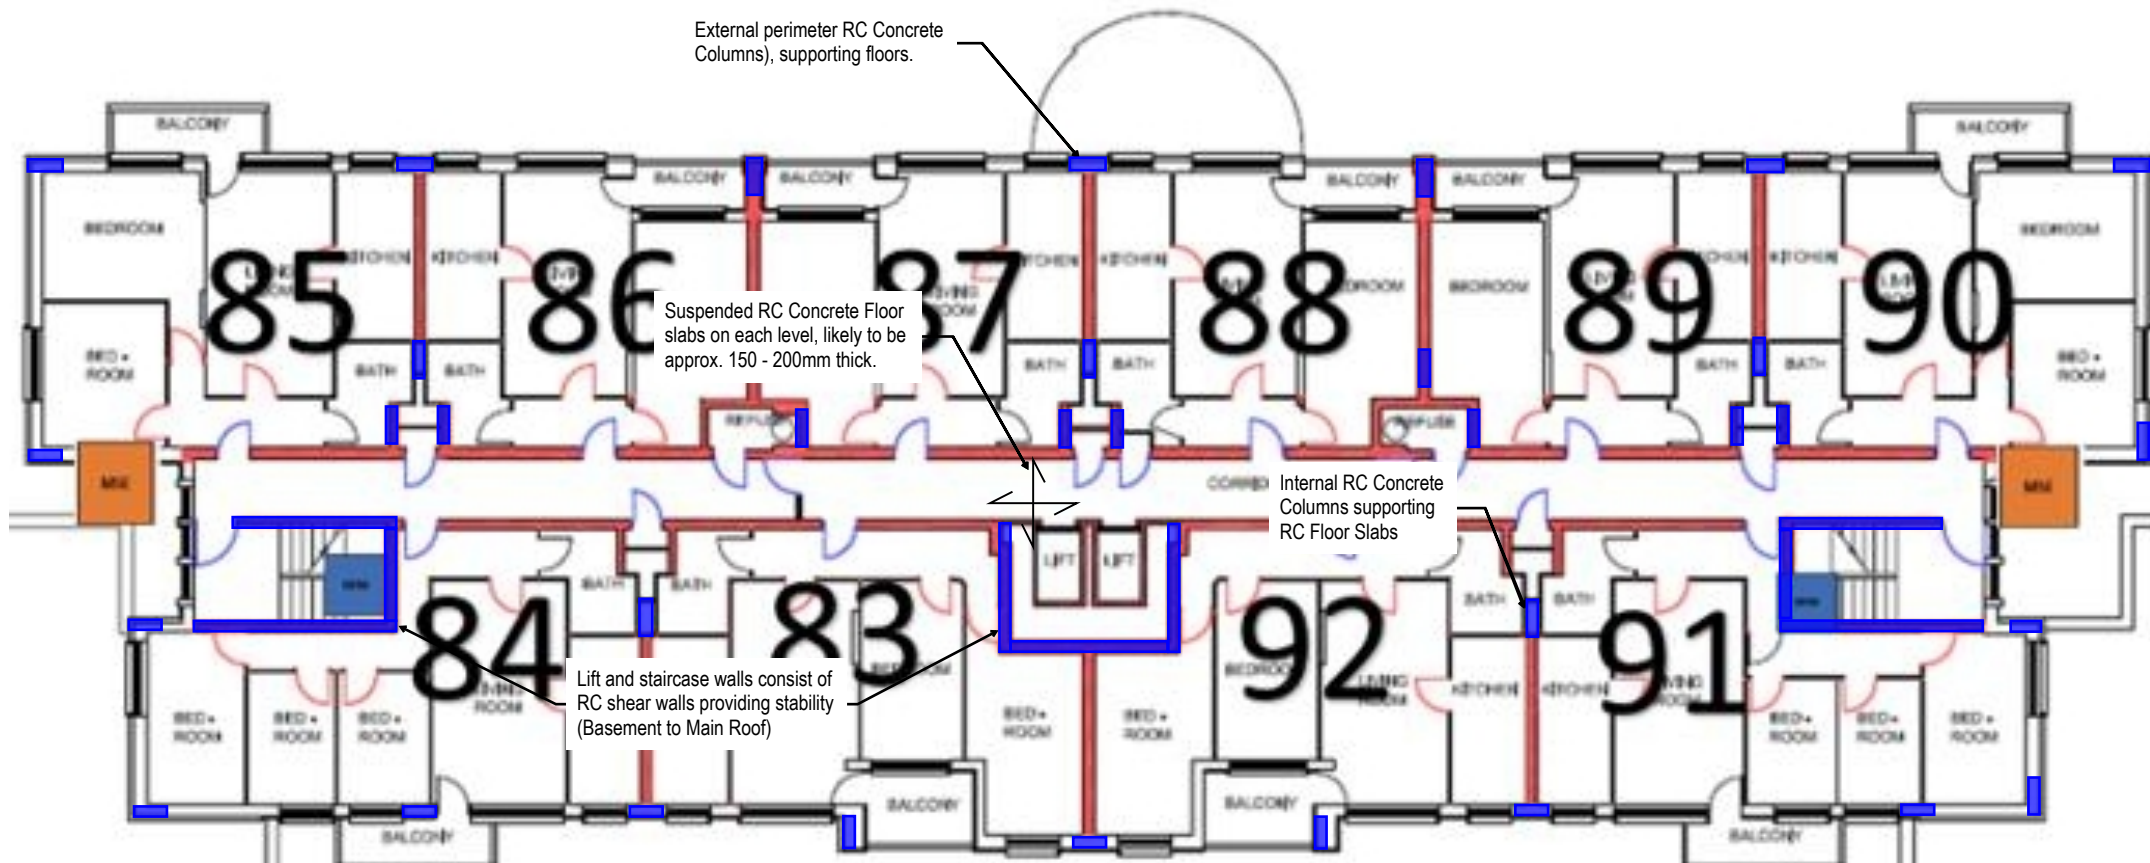
## LANCASTER HOUSE TYPICAL FLOOR LAYOUT

RC Shear/Core Walls & Columns. Annotated on plan shown indicatively based on limited site observations and general floor plan arrangement. Likely other locations present where not shown on plan. All upper floors appear to align, transfer structure likely present at Basement/Ground Floor levels.
