VISUAL STRUCTURAL APPRAISAL

Lawrence Court

Kingsway  
Brandhall  
B68 0HB

29<sup>th</sup> April 2025

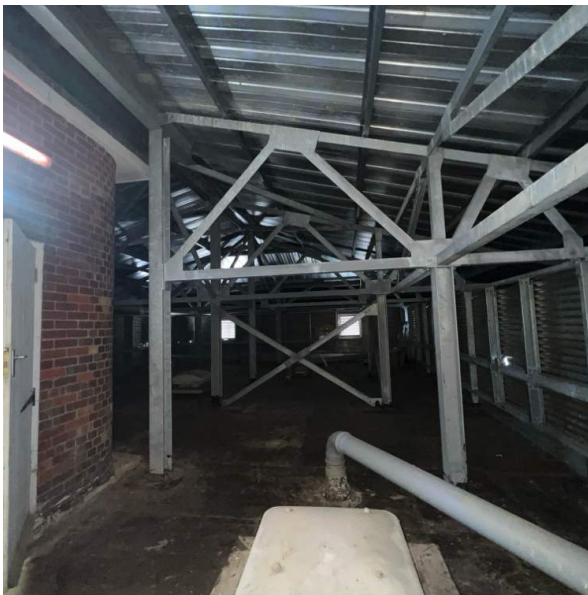
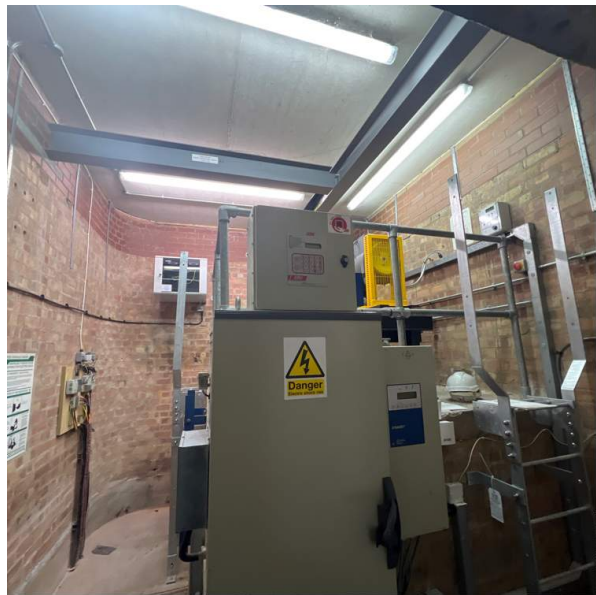
## Main Roof

Comments: A pitched roof constructed above existing original flat roof slab. Steel frame supporting purlins with aluminium standing / mineral wool core profiled panels. Masonry walls noted for motor room.

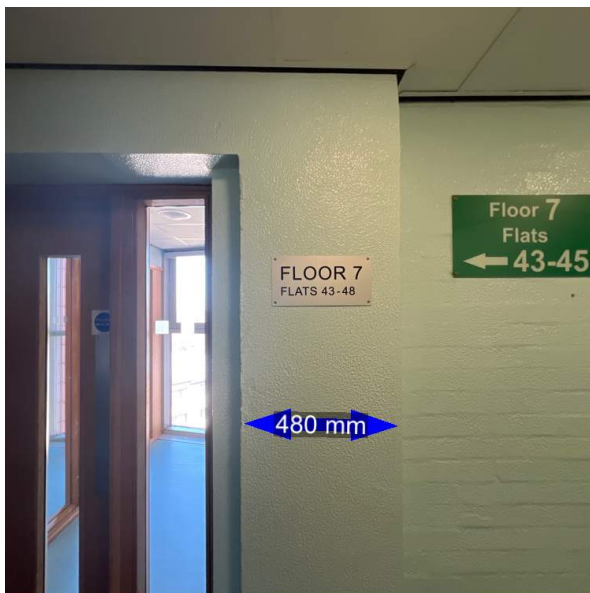
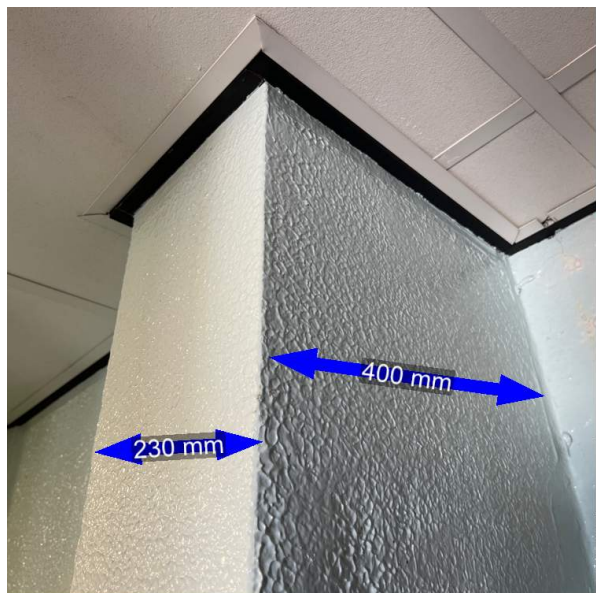
## 7th Floor Hallway

Comments: Hallway walls noted to comprise of a mixture of RC walls/columns and infill (non-load bearing) masonry walls. Concrete walls/columns noted via riser cupboards.

No jams or distortions noted to hallway doors to indicate any serviceability issues.

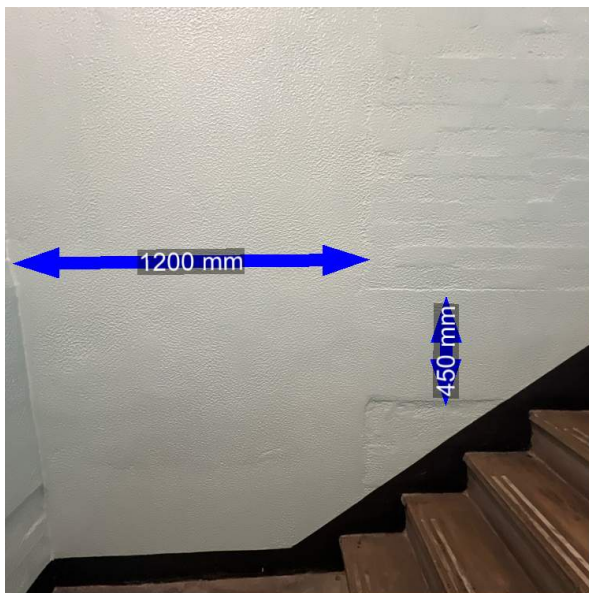
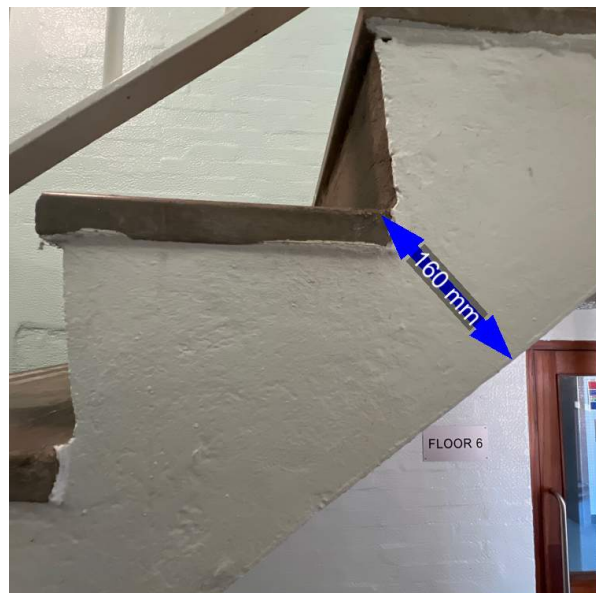
Comments: Insitu concrete stairs with steel hand railing fixed to stairs. Walls and floors appear to be fairly level.  
One side stair walls consist of a RC shear core wall. Other sides embedded with RC wall/column and beam with infill (non-load bearing) masonry.

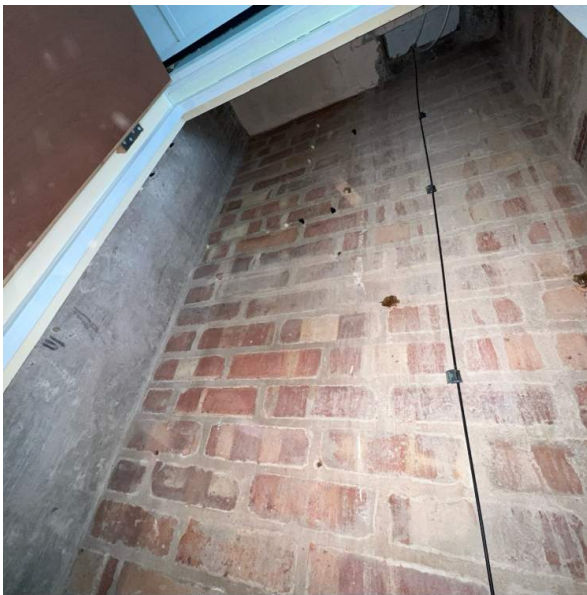
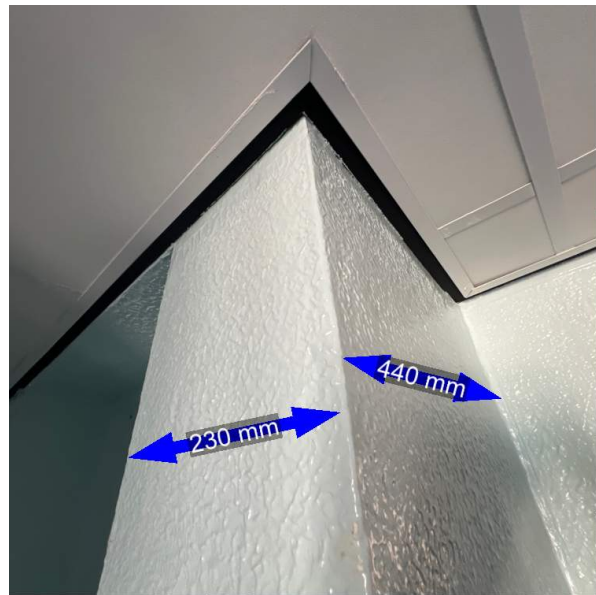
## 4th Floor Hallway

Comments: Hallway walls noted to comprise of a mixture of RC walls/columns and infill (non-load bearing) masonry walls. Concrete walls/columns noted via riser cupboards.

No jams or distortions noted to hallway doors to indicate any serviceability issues.

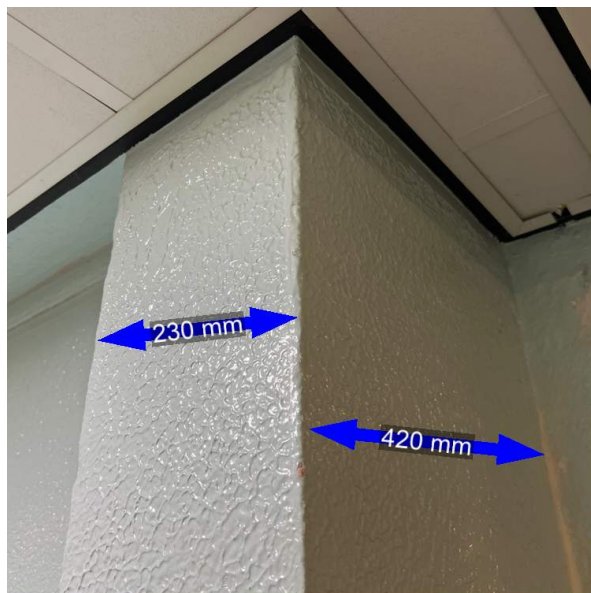
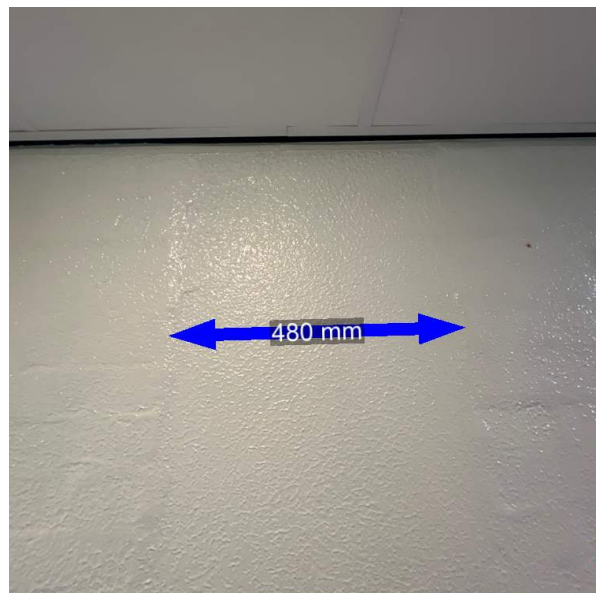
Comments: Hallway walls noted to comprise of a mixture of RC walls/columns and infill (non-load bearing) masonry walls. Concrete walls/columns noted via riser cupboards.

No jams or distortions noted to hallway doors to indicate any serviceability issues.

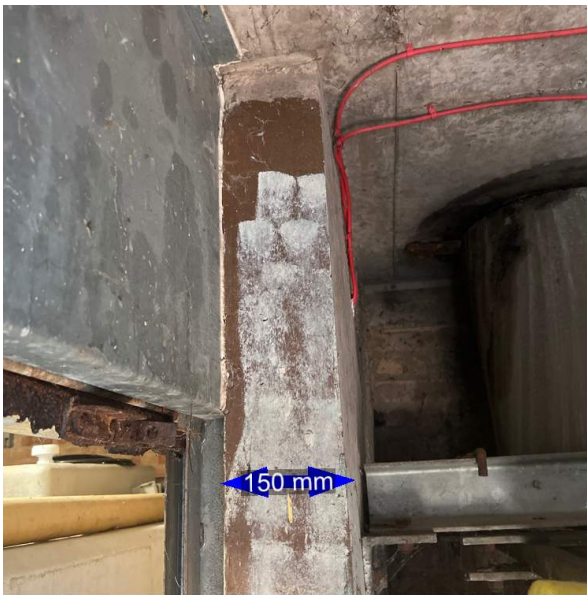
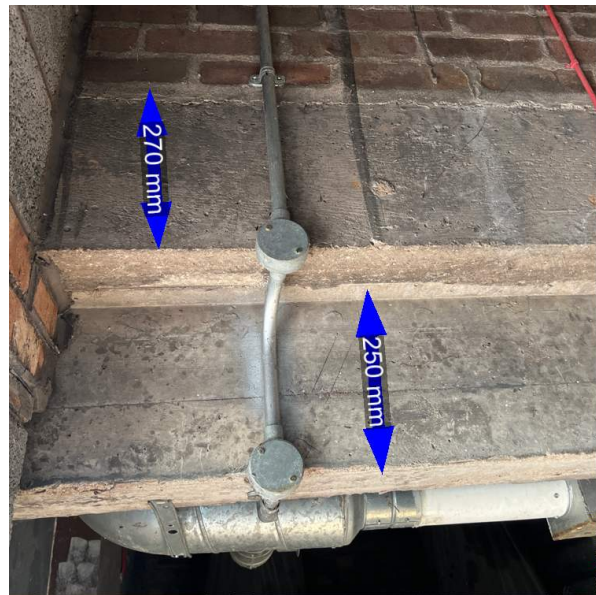
## Binstore

Comments: Mixture of RC shear walls, columns and beams with infill (non-load bearing) masonry noted in binstore.

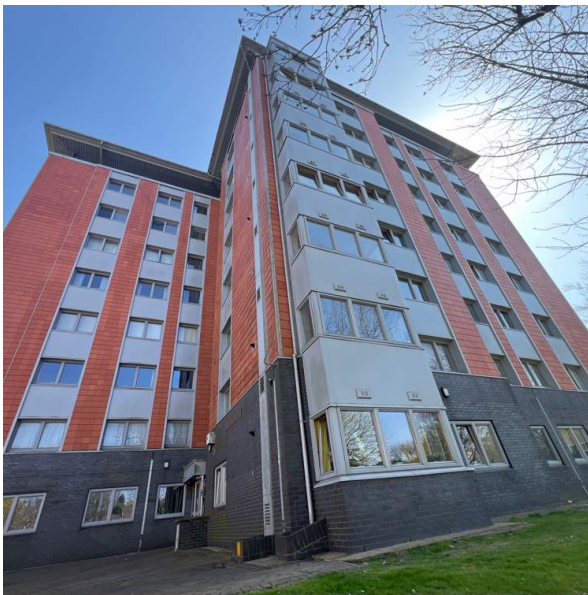
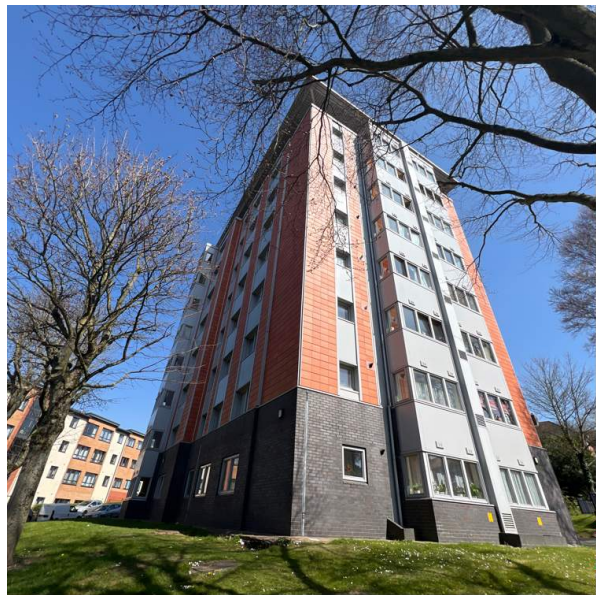
## Elevations

Ground floor level consists of brickwork. Remaining upper floors consist of cladded facade. Balconies have been encased in.
