VISUAL STRUCTURAL APPRAISAL

Lissimore House

Maria Street  
West Bromwich  
B70 6DR

29<sup>th</sup> November 2024

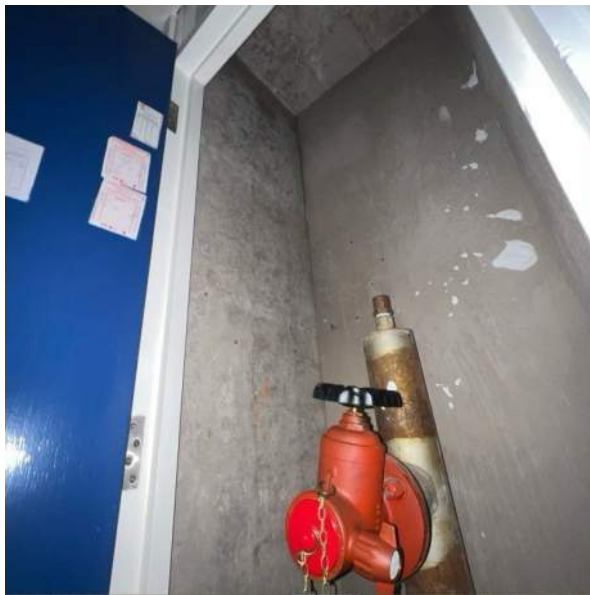
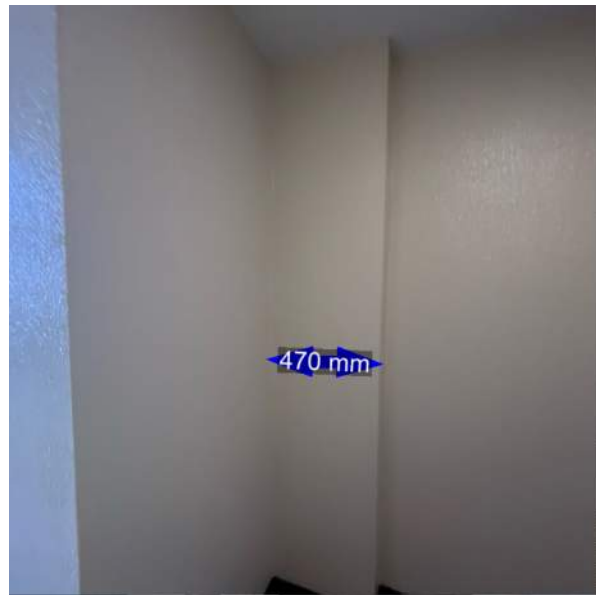
The lift and stair core are located in the hallway. No jams or distortions noted to hallway doors to indicate any serviceability issues.  
Generally walls covered with finishes in hallway, likely to consist a mixture of concrete shear walls, embedded columns and block infill walls.  
Concrete walls forming part of the primary structure noted in the dry riser. Electrical cabinet shows infill block walls.

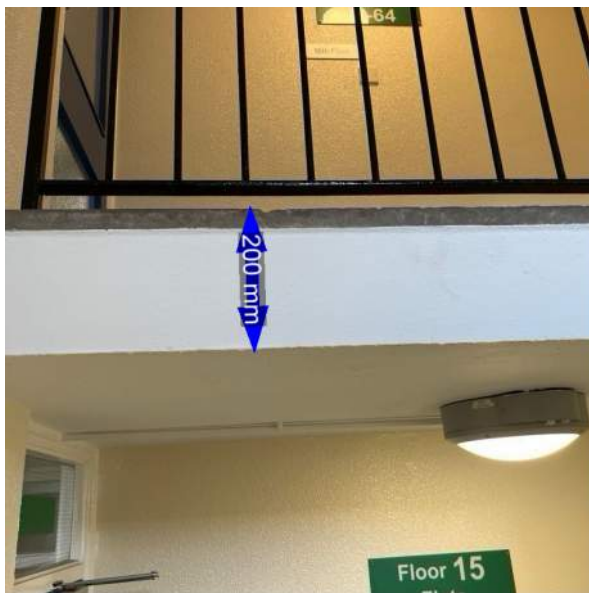
In situ concrete stairs with steel hand railing fixed to stairs. Walls and floors appear to be fairly level.

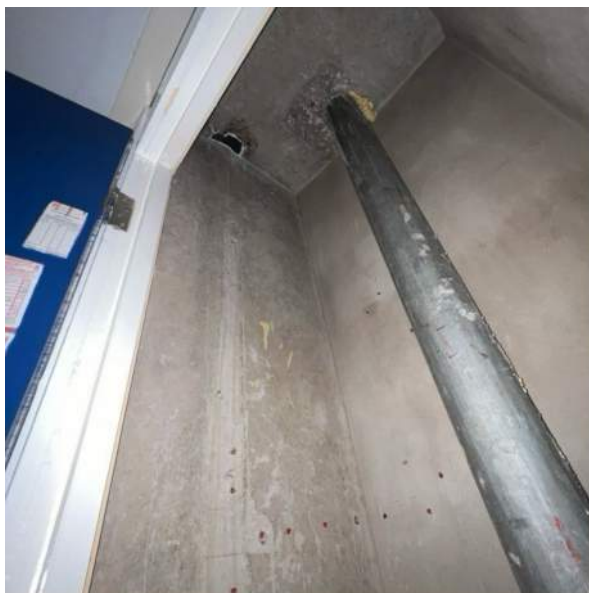
The lift and stair core are located in the hallway. No jams or distortions noted to hallway doors to indicate any serviceability issues.  
Generally walls covered with finishes in hallway, likely to consist a mixture of concrete shear walls, embedded columns and block infill walls.  
Concrete walls forming part of the primary structure noted in the dry riser. Electrical cabinet shows infill block walls.

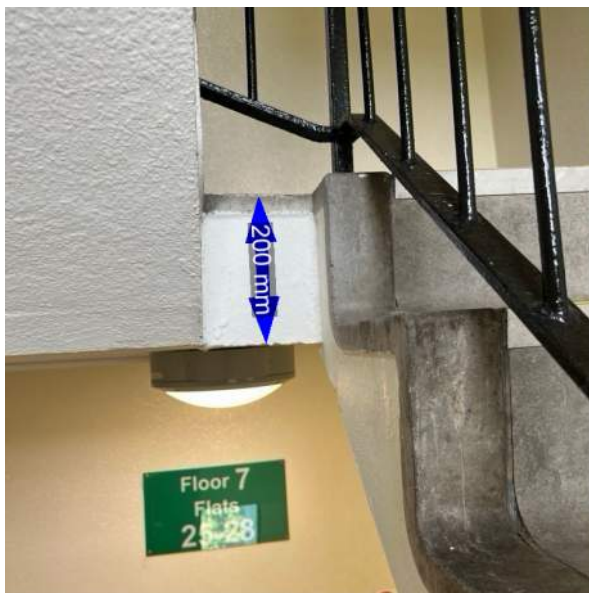
In situ concrete stairs with steel hand railing fixed to stairs. Walls and floors appear to be fairly level.

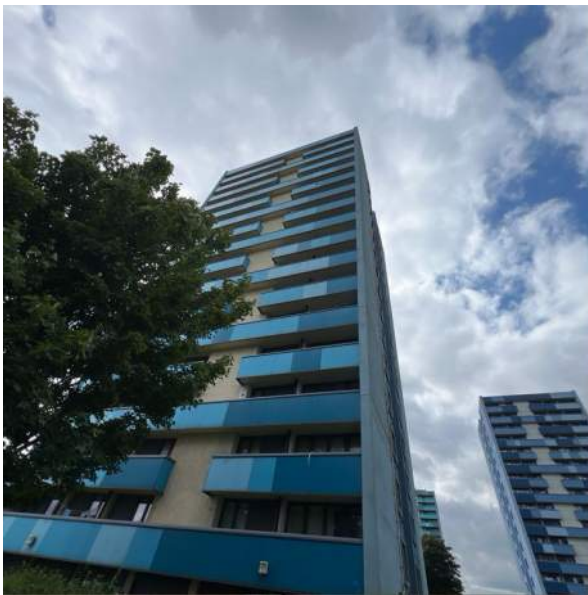
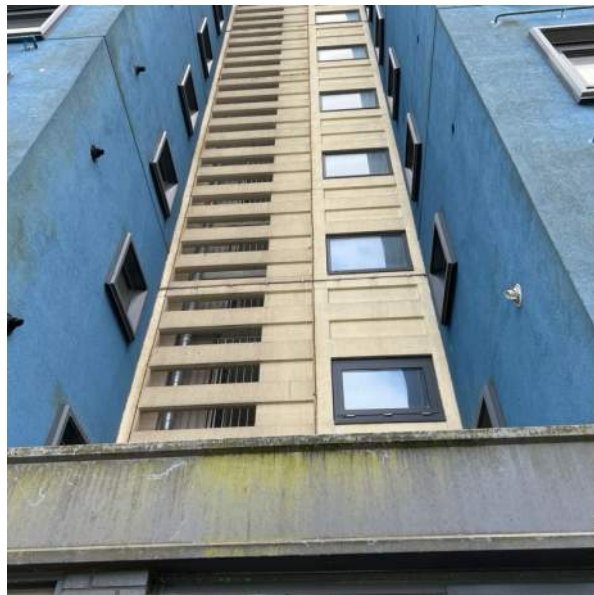
External ground floor level consists of brick work.  
Upper floors noted to have a rendered facade and cladding to balconies.  
Concrete columns (300mm wide) noted to perimeter which form part of the primary structural elements of the building.  
Staircase exterior appears to have a concrete panel facade feature.

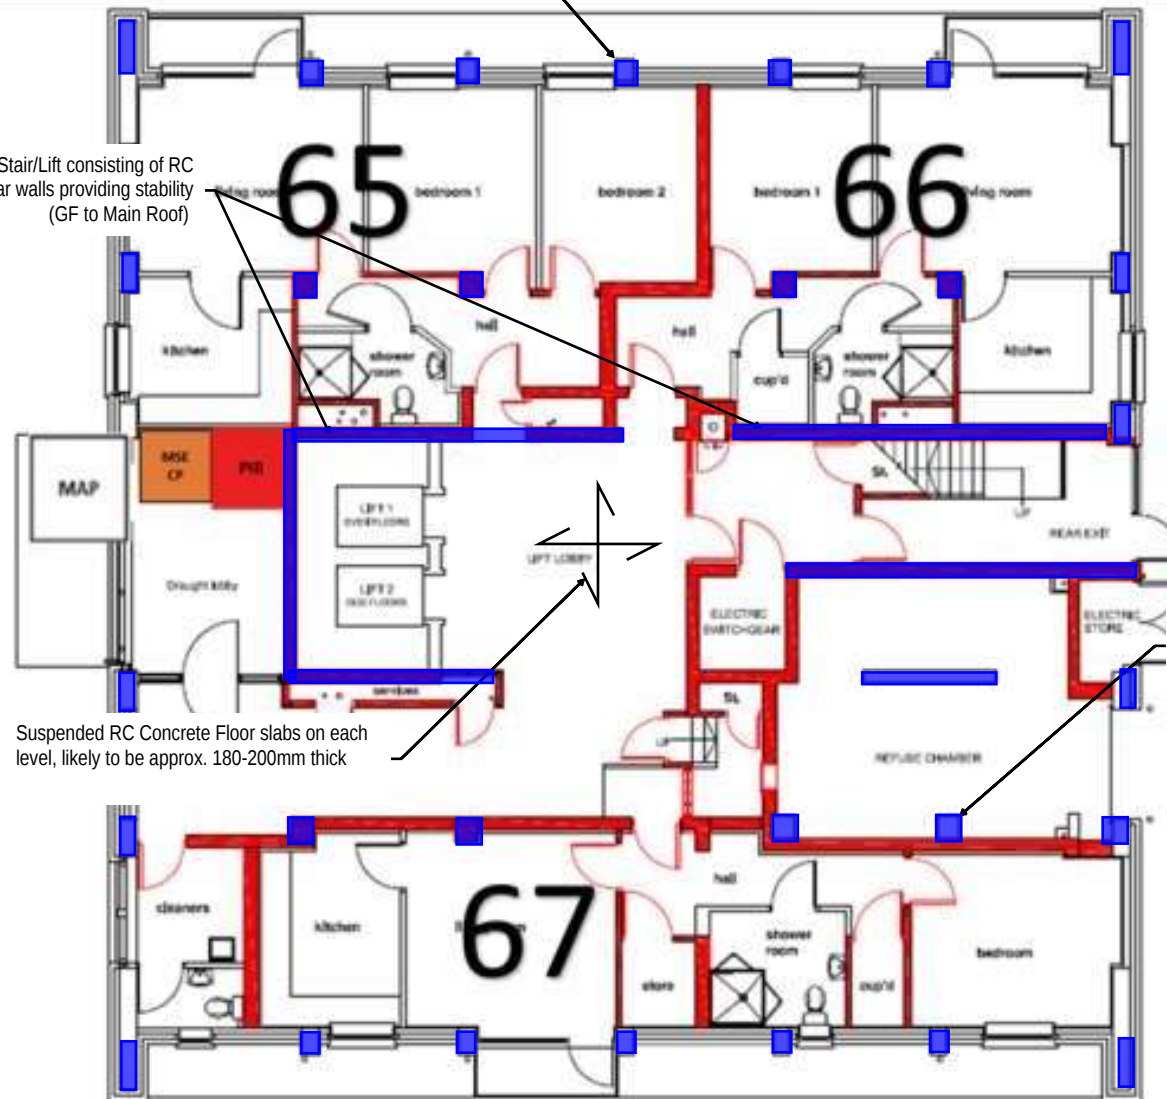
RC Shear/Core Walls & Columns. Annotated on plan shown indicatively based on limited site observations and general floor plan. Likely other locations present where not shown on plan.

Stair/Lift consisting of RC shear walls providing stability (GF to Main Roof)

Suspended RC Concrete Floor slabs on each level, likely to be approx. 180-200mm thick

Internal RC Concrete Columns. Noted to be approx. 380x380mm (measured in communal areas).
