VISUAL STRUCTURAL APPRAISAL

Macaulay House

Glover St  
West Bromwich  
B70 6DY

31<sup>st</sup> January 2025

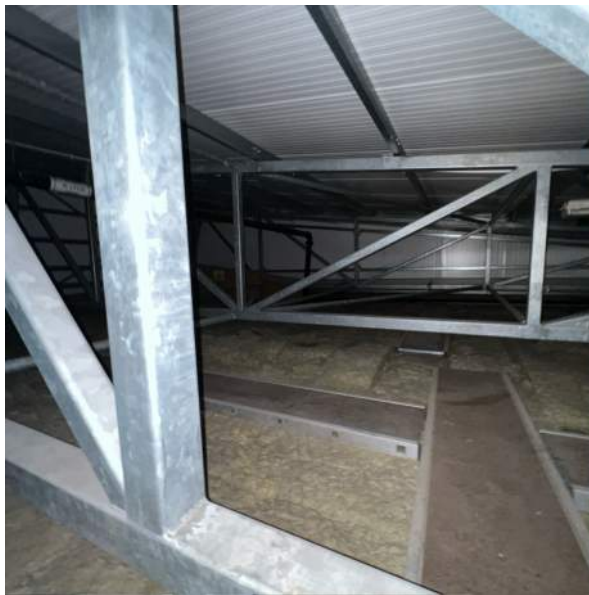
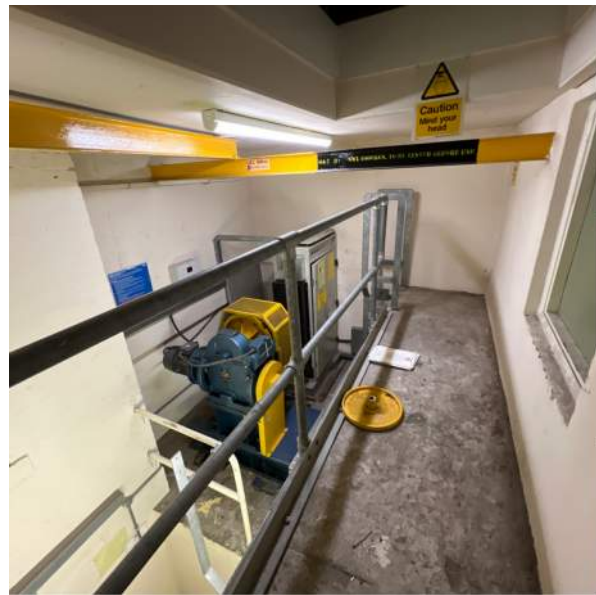
## Main Roof

Comments: A pitched roof constructed above existing original flat roof slab. Steel frame supporting purlins with aluminium standing / mineral wool core profiled panels.  
160mm thick RC core walls noted in motor room.

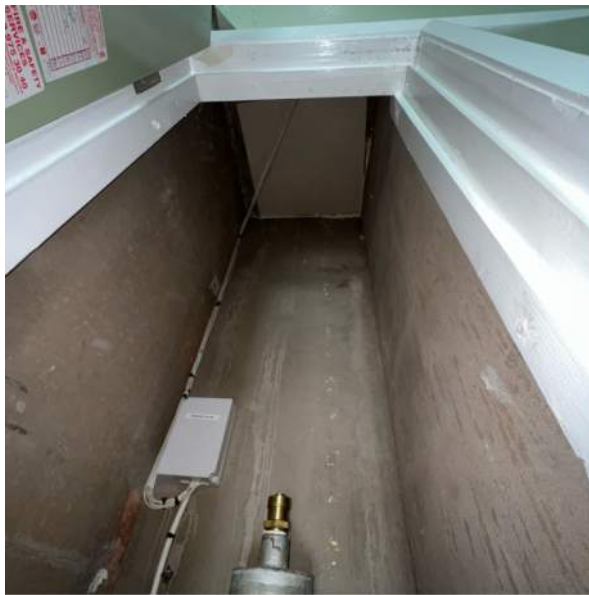
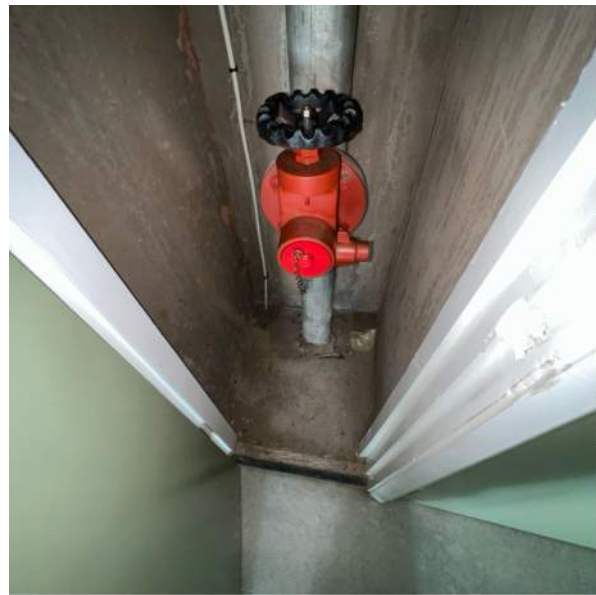
## 8th Floor Hallway

Comments: No jams or distortions noted to hallway doors to indicate any serviceability issues. Generally walls covered with finishes in hallway, likely to consist a mixture of concrete shear walls, embedded columns and masonry infill walls. Limited structure exposed. Concrete walls noted via dry riser cupboards. Electrical cupboard shows block infill walls with plaster.

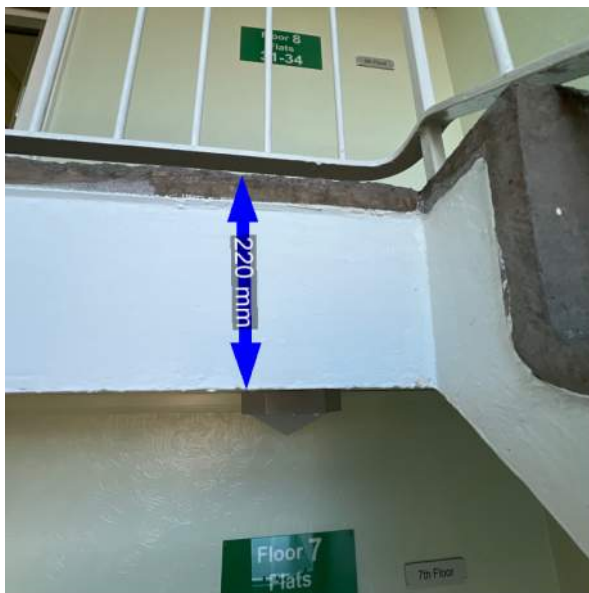
## 8th Floor Staircases

Comments: Insitu concrete stairs with steel hand railing fixed to stairs. Walls and floors appear to be fairly level.  
Stair walls covered with finishes however these would likely form the main concrete shear core walls. Partly infill/non-load bearing wall noted for one side of stair case wall.

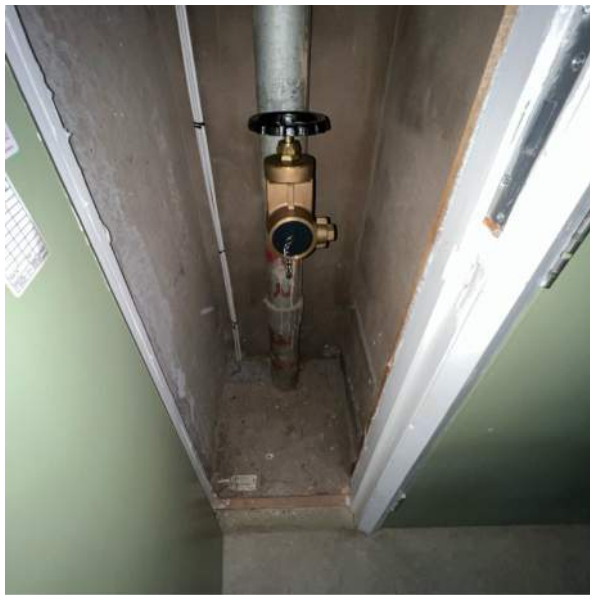
## 5th Floor Hallway

Comments: No jams or distortions noted to hallway doors to indicate any serviceability issues. Generally walls covered with finishes in hallway, likely to consist a mixture of concrete shear walls, embedded columns and masonry infill walls. Limited structure exposed. Concrete walls noted via dry riser cupboards. Electrical cupboard shows block infill walls with plaster.

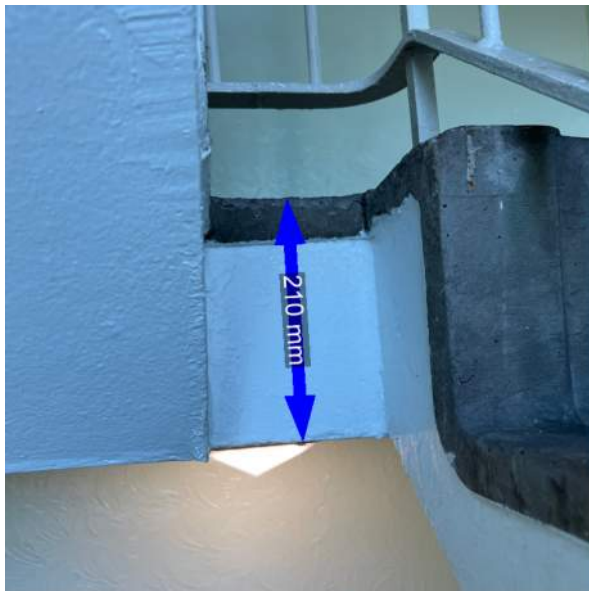
## 5th Floor Staircases

Comments: Insitu concrete stairs with steel hand railing fixed to stairs. Walls and floors appear to be fairly level.  
Stair walls covered with finishes however these would likely form the main concrete shear core walls. Partly infill/non-load bearing wall noted for one side of stair case wall.

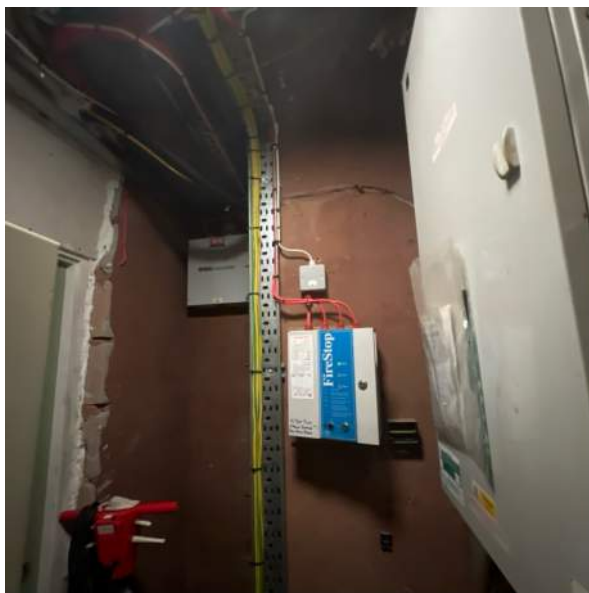
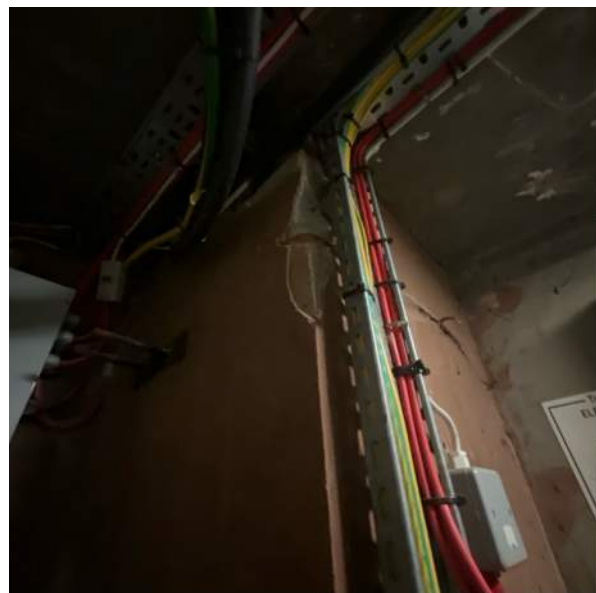
## Ground Floor Hallway

Comments: No jams or distortions noted to hallway doors to indicate any serviceability issues. Generally walls covered with finishes in hallway, likely to consist a mixture of concrete shear walls, embedded columns and block infill walls. Limited structure exposed. Partly visible concrete walls noted via riser cupboard and under stair case closet.

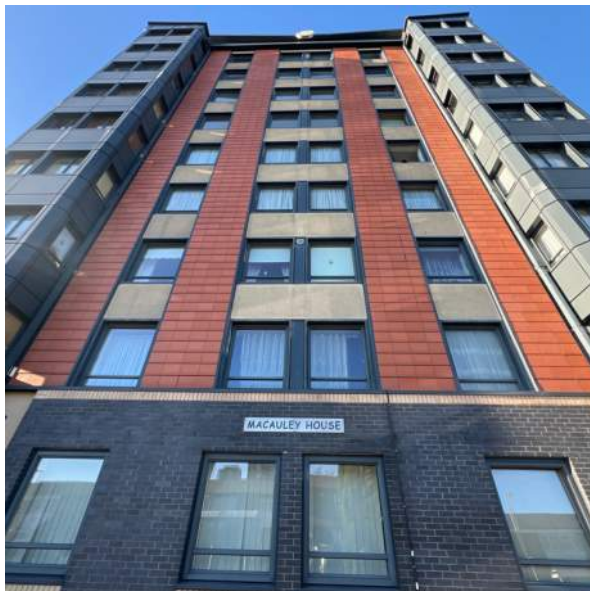
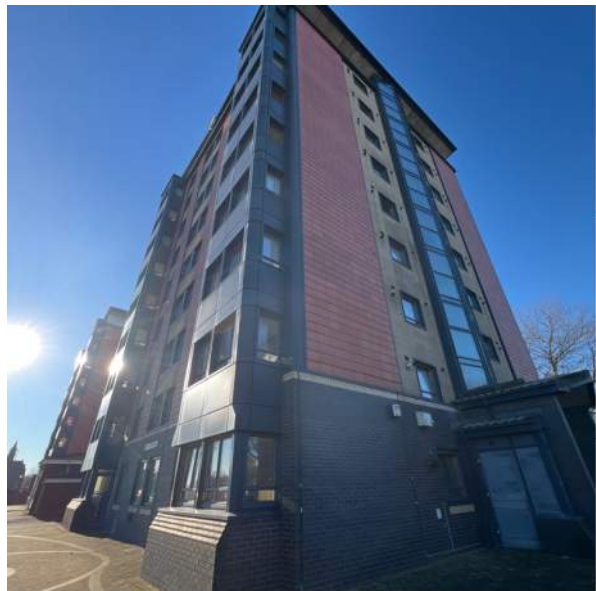
Ground floor level consists of brickwork. Remaining elevations consist of a mixture of rendered and cladded facade.

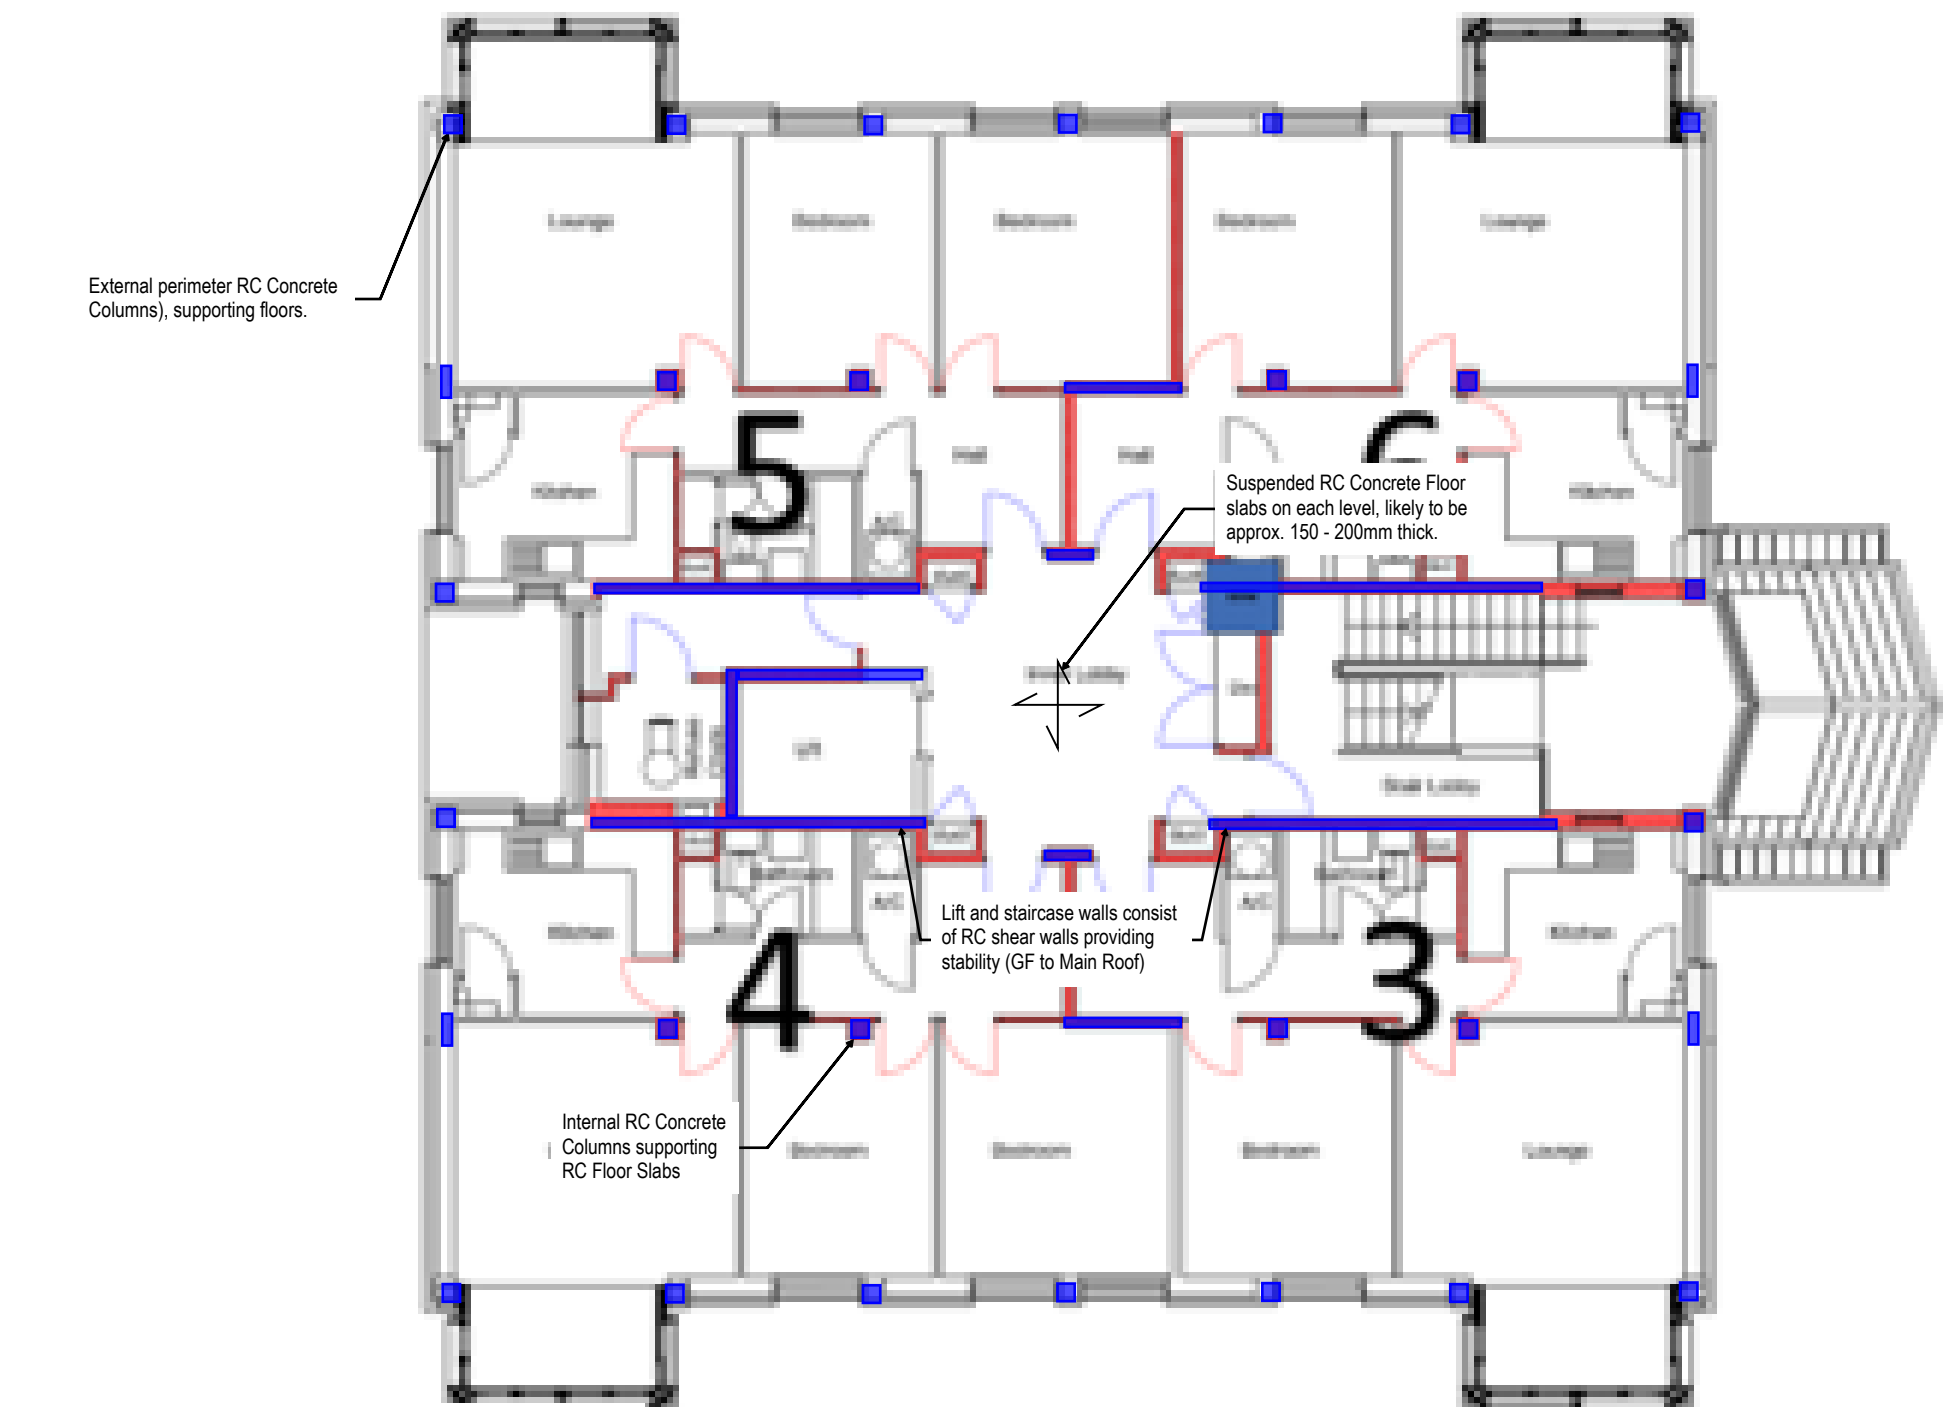
External perimeter RC Concrete Columns), supporting floors.

Suspended RC Concrete Floor slabs on each level, likely to be approx. 150 - 200mm thick.
