VISUAL STRUCTURAL APPRAISAL

Aspen House

Beaconview Road  
West Bromwich  
B71 3EN

26<sup>th</sup> February 2025

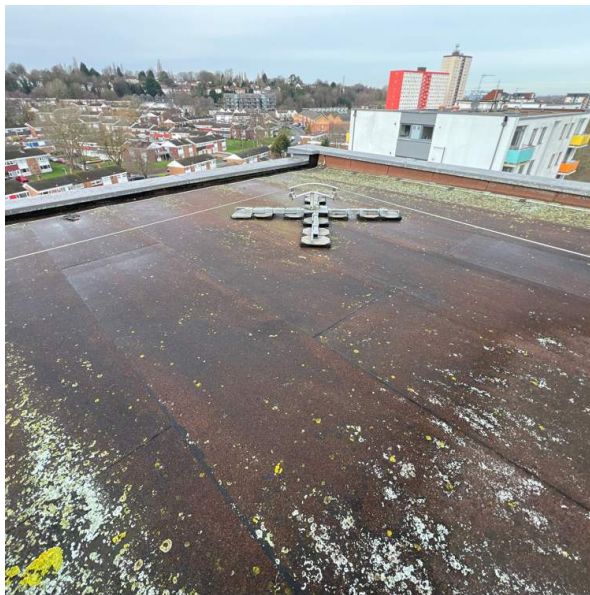
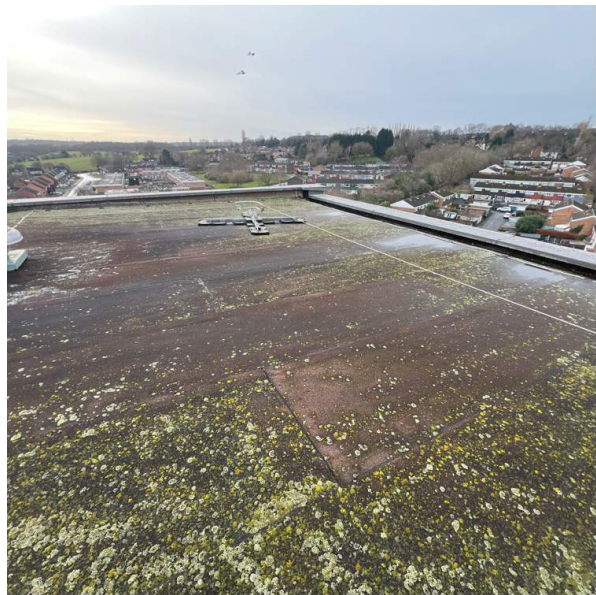
## Main Roof

Comments: Flat roof, RC concrete slab with insulated PIR board and felt coverings.

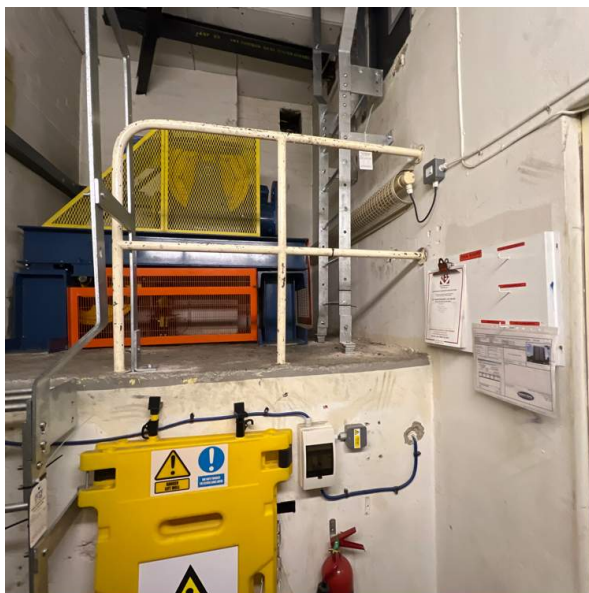
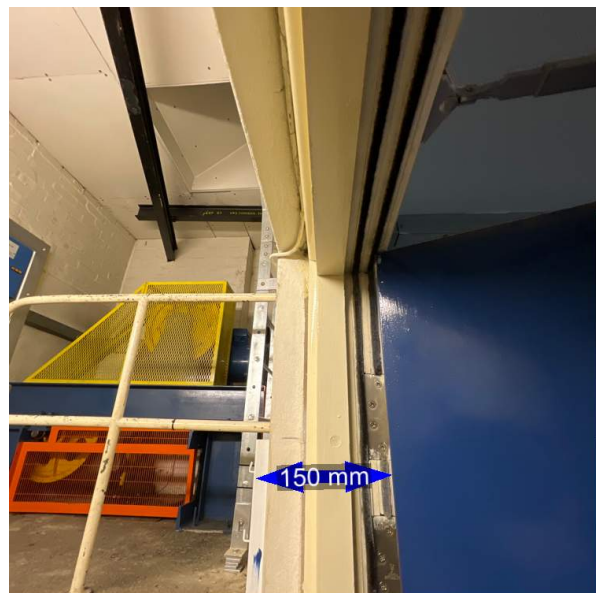
## 8th Floor Hallway

Comments: No jams or distortions noted to hallway doors to indicate any serviceability issues. Generally walls covered with finishes in hallway, likely to consist a mixture of concrete shear walls, embedded columns and masonry infill walls. Limited structure exposed. Concrete walls and infill masonry (non-load bearing) walls noted in riser cupboards.

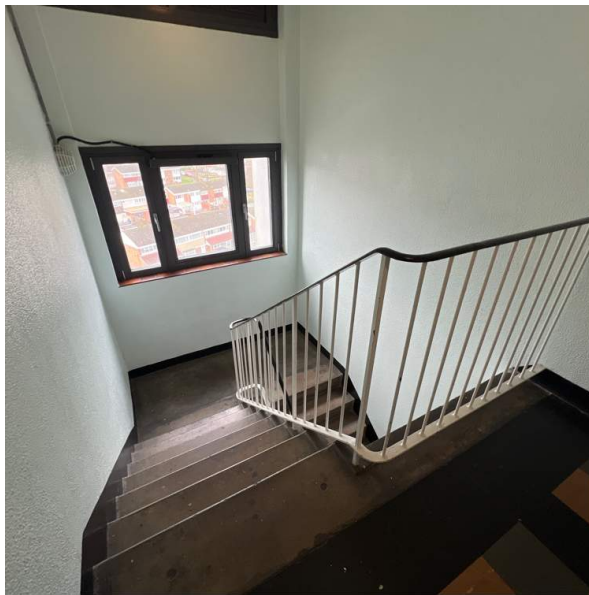
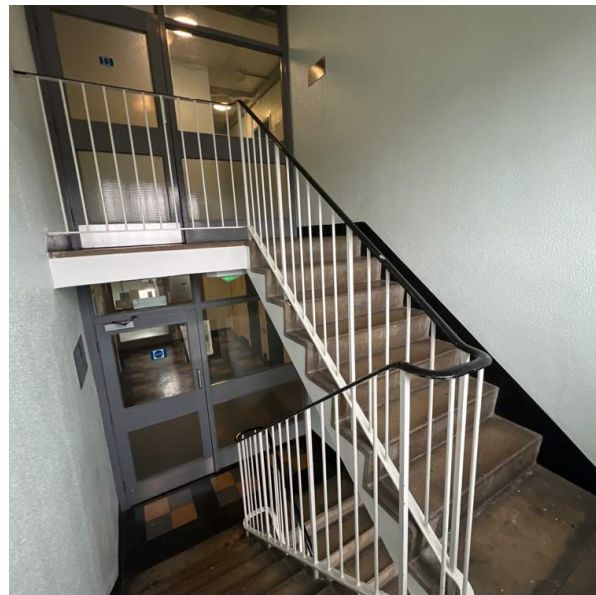
## 8th Floor Staircases

Comments: Insitu concrete stairs with steel hand railing fixed to stairs. Walls and floors appear to be fairly level.  
Stair walls covered with finishes however these would likely form the main concrete shear core walls.

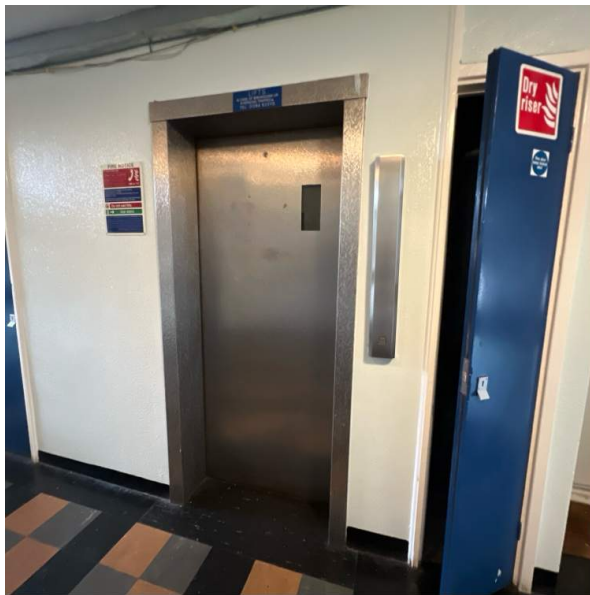
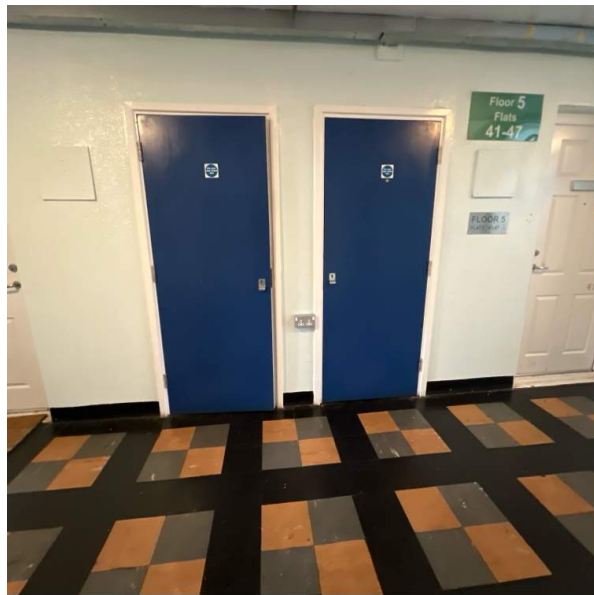
## 5th Floor Hallway

Comments: No jams or distortions noted to hallway doors to indicate any serviceability issues. Generally walls covered with finishes in hallway, likely to consist a mixture of concrete shear walls, embedded columns and masonry infill walls. Limited structure exposed. Concrete walls and infill masonry (non-load bearing) walls noted in riser cupboards.

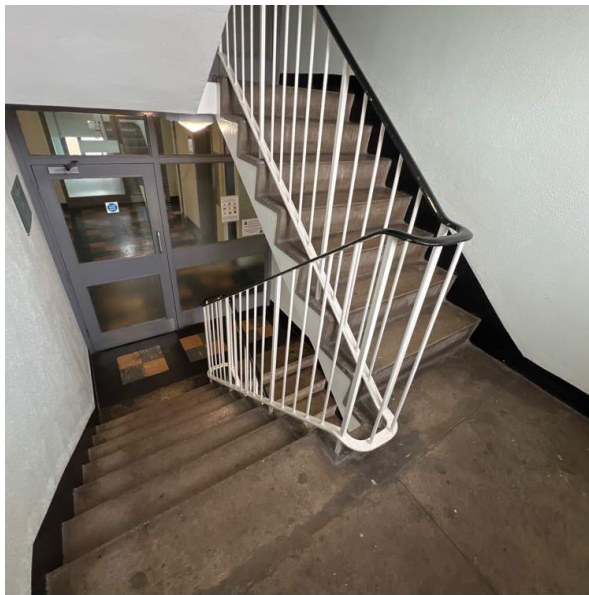
## 5th Floor Staircases

Comments: Insitu concrete stairs with steel hand railing fixed to stairs. Walls and floors appear to be fairly level.  
Stair walls covered with finishes however these would likely form the main concrete shear core walls.

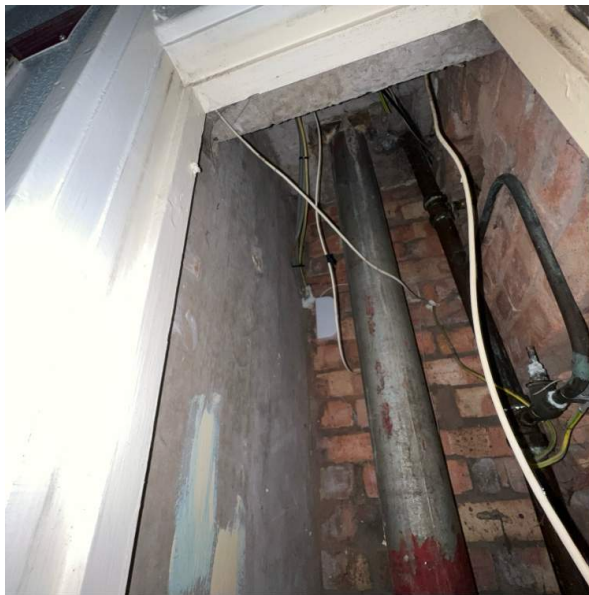
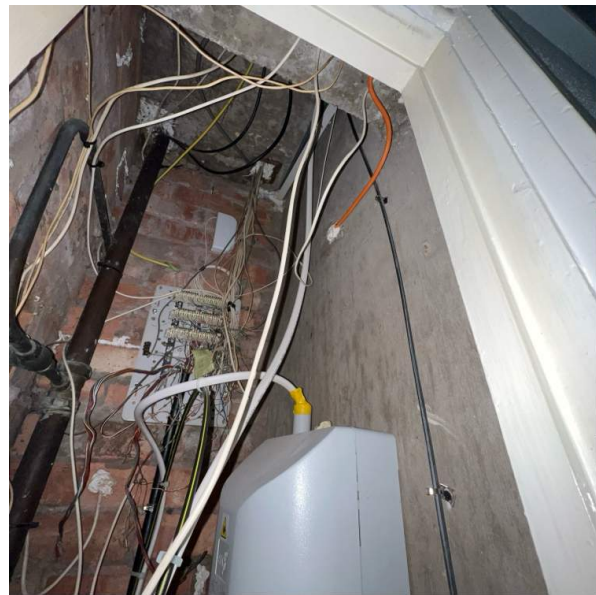
## Ground Floor Hallway

Comments: No jams or distortions noted to hallway doors to indicate any serviceability issues. Generally walls covered with finishes in hallway, likely to consist a mixture of concrete shear walls, embedded columns and masonry infill walls. Limited structure exposed. Concrete walls and infill masonry (non-load bearing) walls noted in riser cupboards.

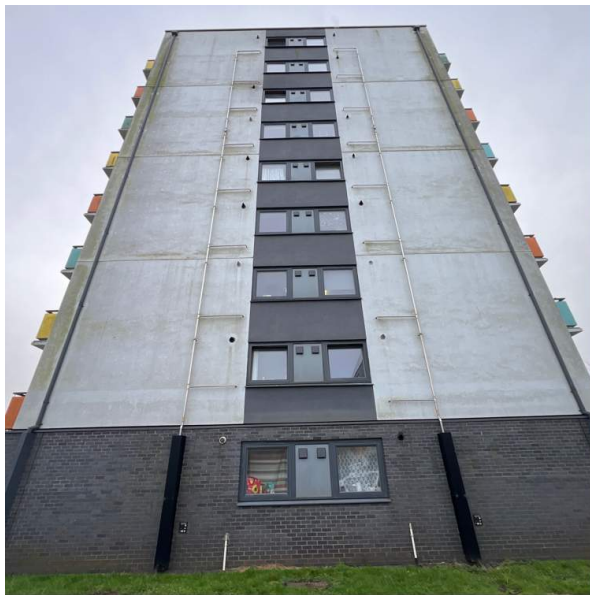
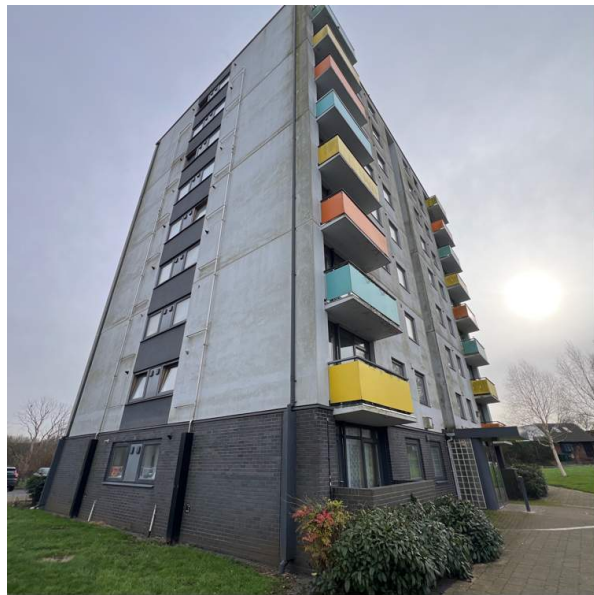
Ground floor level consists of brickwork. Remaining elevations consist of a rendered facade. Cladded panels to balconies.
