**FIRNTEC**  
BUILDING COMPLIANCE

VISUAL STRUCTURAL APPRAISAL

Beech House

Meadow Avenue  
West Bromwich  
B71 3EJ

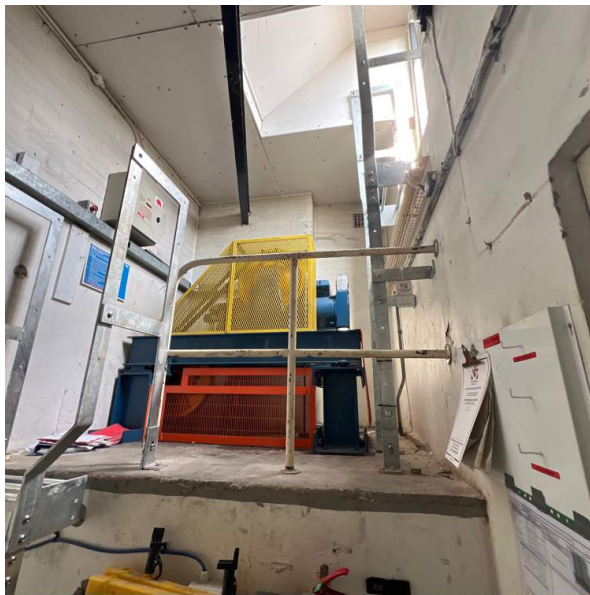
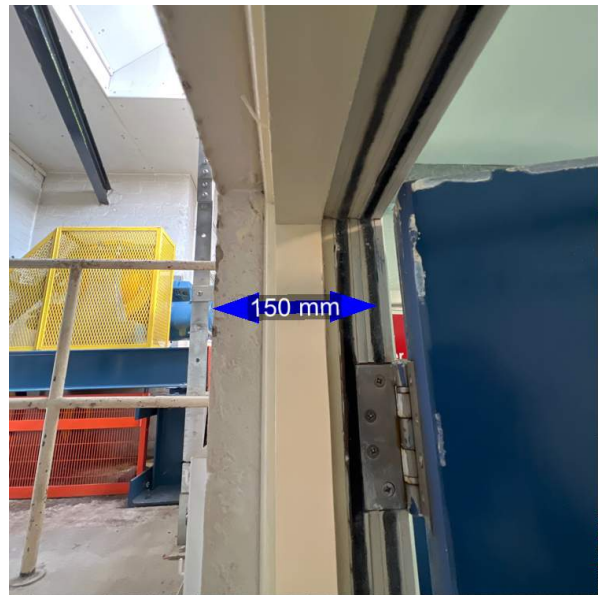
## 8th Floor Hallway

Comments: No jams or distortions noted to hallway doors to indicate any serviceability issues. Generally walls covered with finishes in hallway, likely to consist a mixture of concrete shear walls, embedded columns and masonry infill walls. Limited structure exposed. Concrete walls and infill masonry (non-load bearing) walls noted in riser cupboards. Concrete walls noted to be approx. 150mm thick.

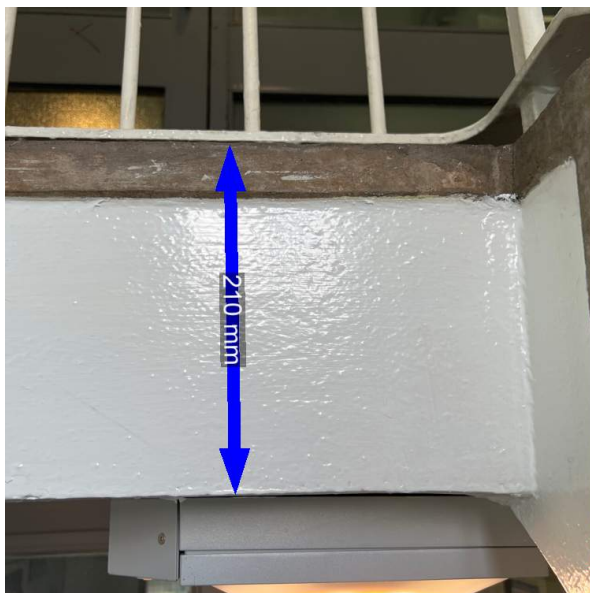
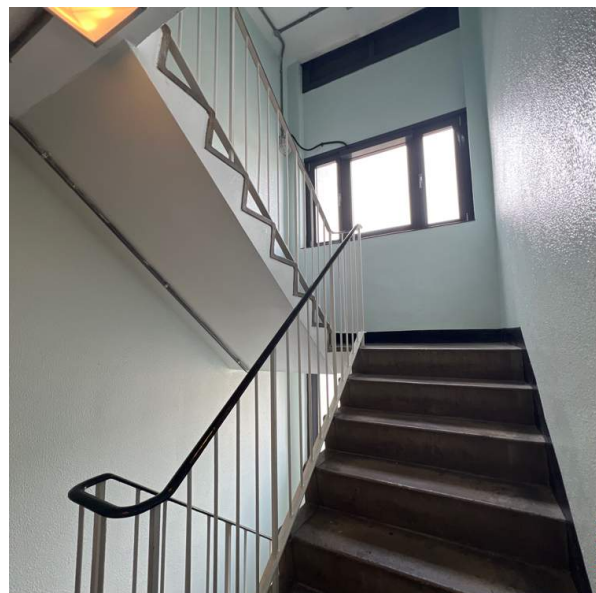
## 8th Floor Staircases

Comments: Insitu concrete stairs with steel hand railing fixed to stairs. Walls and floors appear to be fairly level.  
Stair walls covered with finishes however these would likely form the main concrete shear core walls.

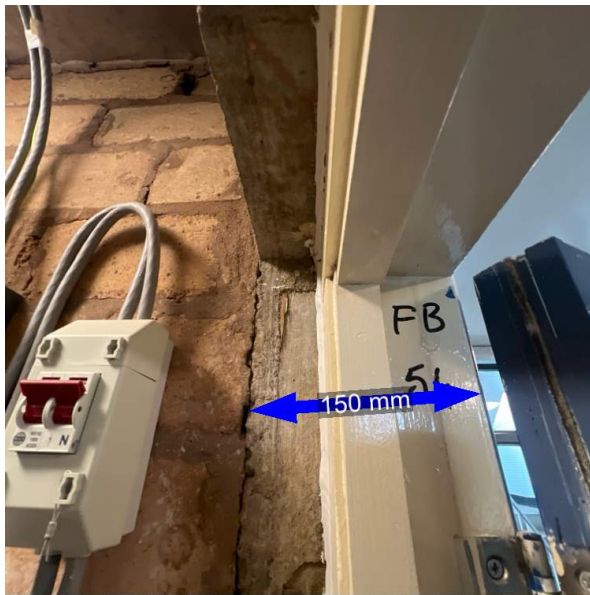
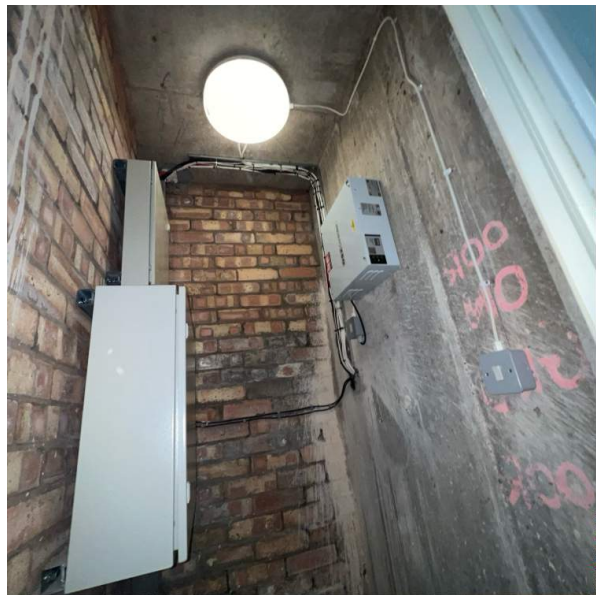
## 5th Floor Hallway

Comments: No jams or distortions noted to hallway doors to indicate any serviceability issues. Generally walls covered with finishes in hallway, likely to consist a mixture of concrete shear walls, embedded columns and masonry infill walls. Limited structure exposed. Concrete walls and infill masonry (non-load bearing) walls noted in riser cupboards.

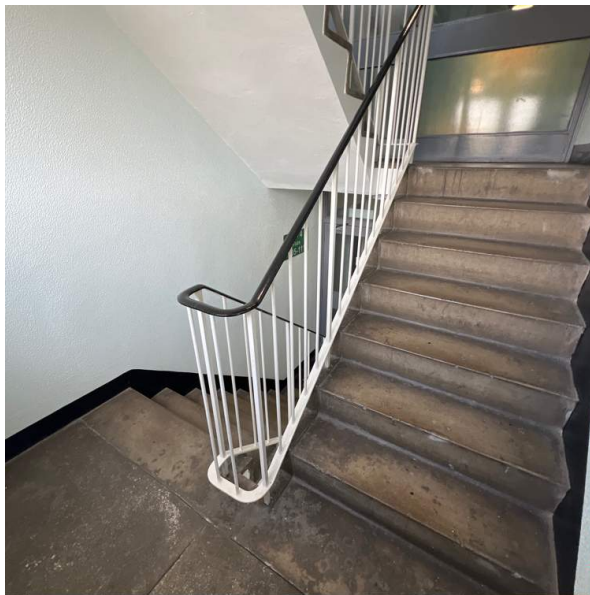
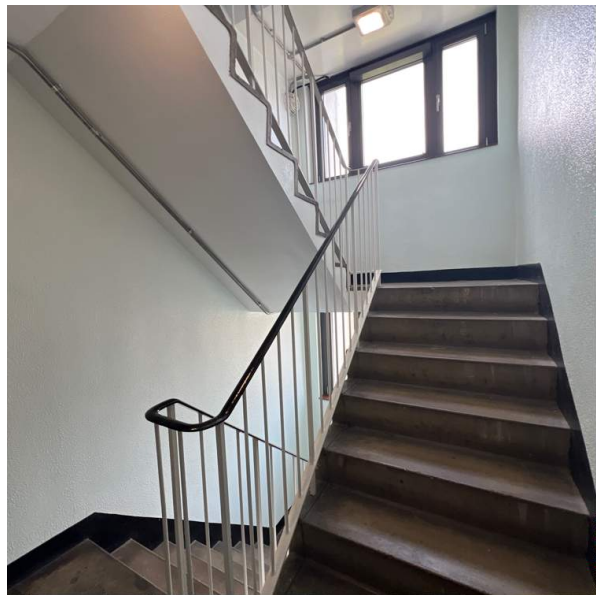
## 5th Floor Staircases

Comments: Insitu concrete stairs with steel hand railing fixed to stairs. Walls and floors appear to be fairly level.  
Stair walls covered with finishes however these would likely form the main concrete shear core walls.

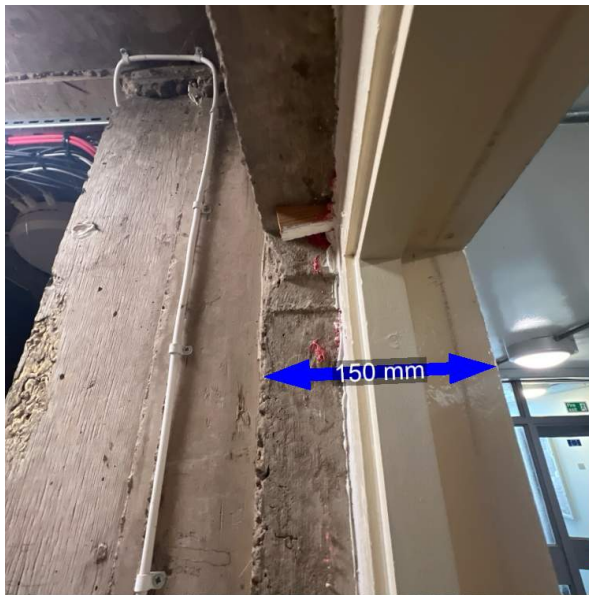
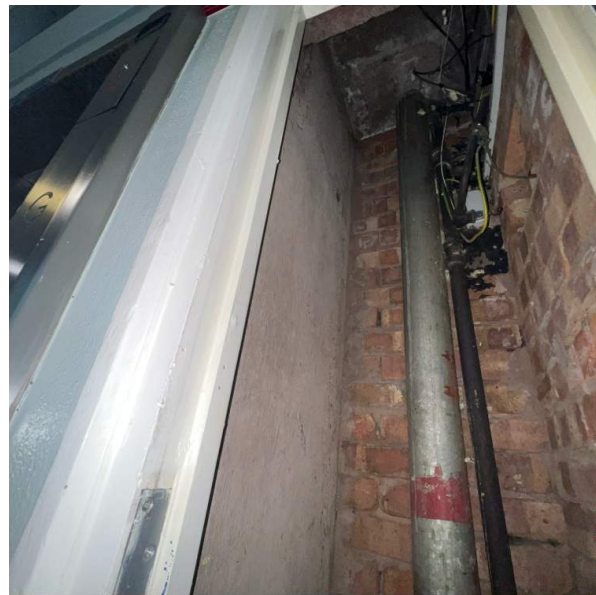
## Ground Floor Hallway

Comments: No jams or distortions noted to hallway doors to indicate any serviceability issues. Generally walls covered with finishes in hallway, likely to consist a mixture of concrete shear walls, embedded columns and masonry infill walls. Limited structure exposed. Concrete walls and infill masonry (non-load bearing) walls noted in riser cupboards.

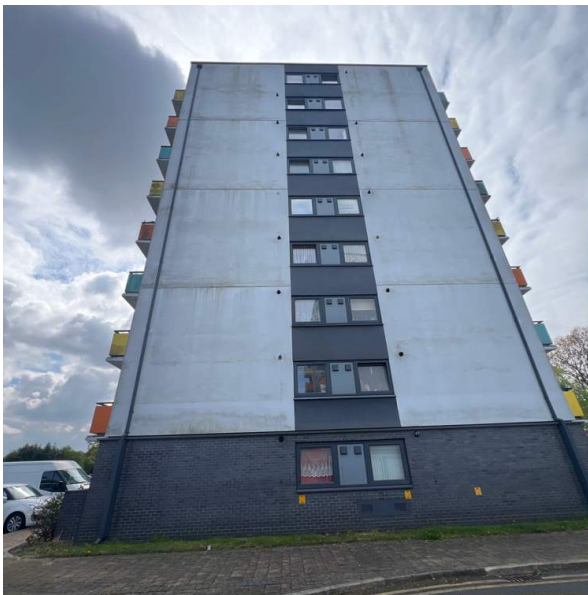
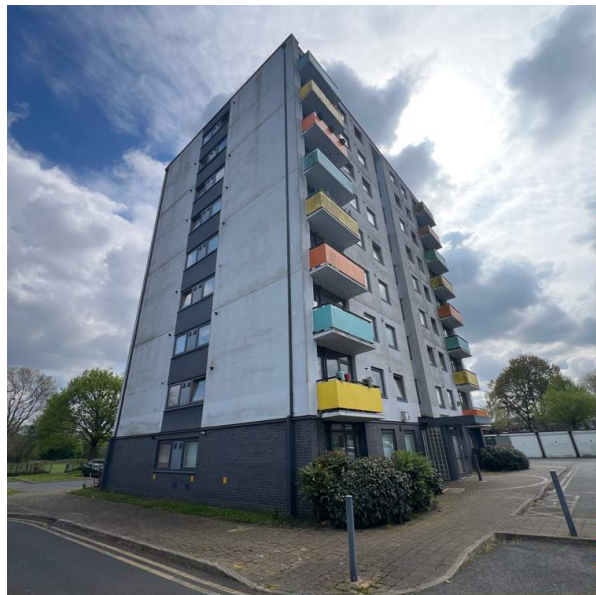
Ground floor level consists of brickwork. Remaining elevations consist of a rendered facade. Cladded panels to balconies.
