**FIRNTEC**  
BUILDING COMPLIANCE

VISUAL STRUCTURAL APPRAISAL

Willow House

Meadow Avenue  
West Bromwich  
B71 3EN

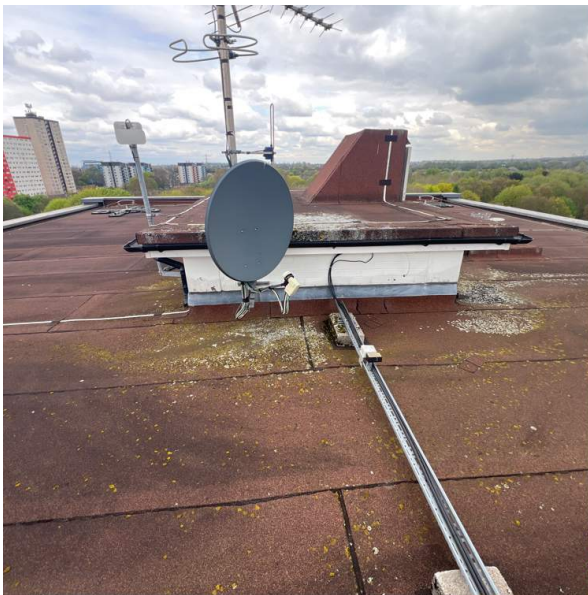
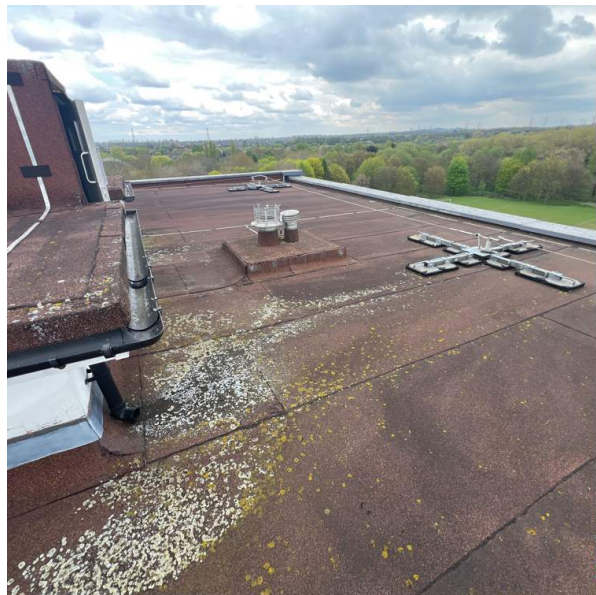
## Main Roof

Comments: Flat roof, RC concrete slab with insulated PIR board and felt coverings.

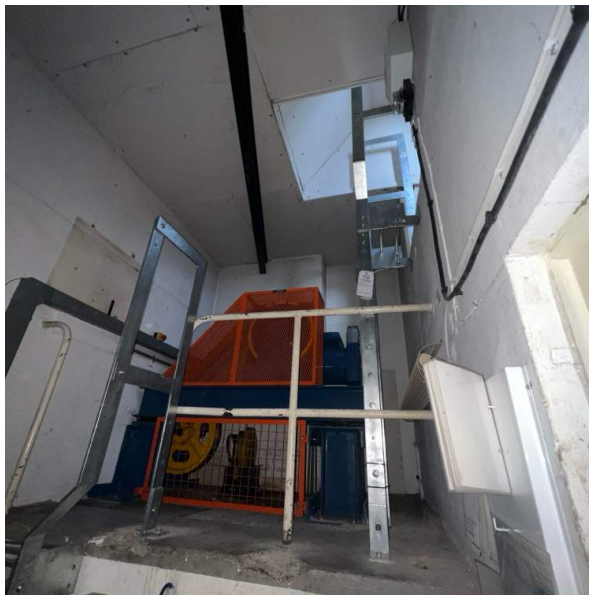
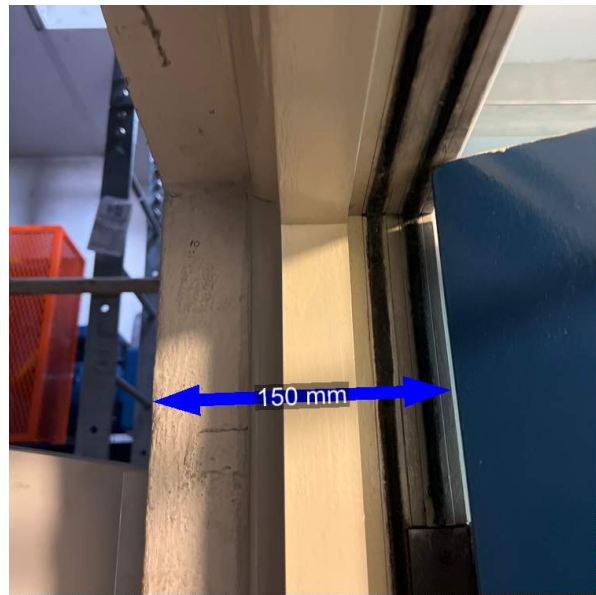
## 8th Floor Hallway

Comments: No jams or distortions noted to hallway doors to indicate any serviceability issues. Generally walls covered with finishes in hallway, likely to consist a mixture of concrete shear walls, embedded columns and masonry infill walls. Limited structure exposed. Concrete walls and infill masonry (non-load bearing) walls noted in riser cupboards. Concrete walls noted to be approx. 150mm thick.

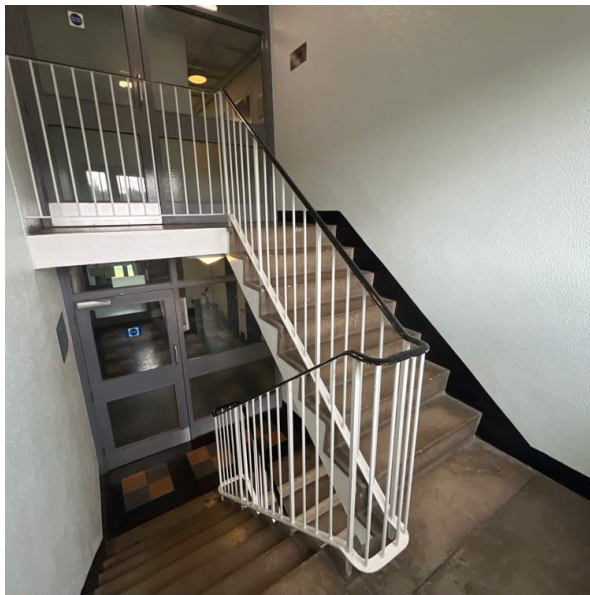
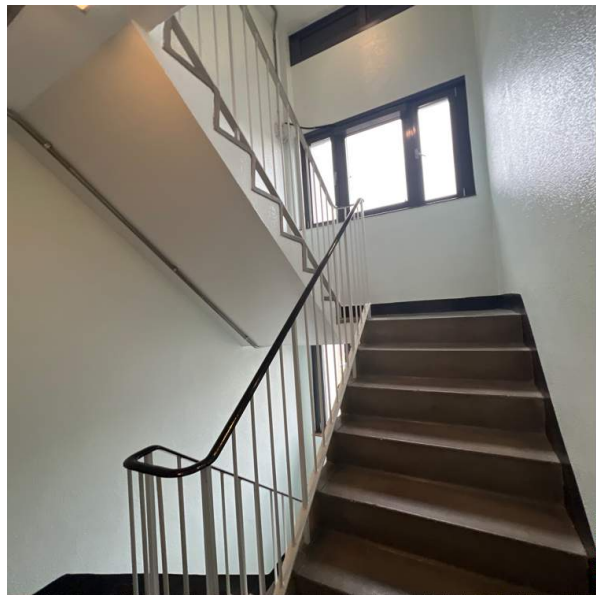
## 8th Floor Staircases

Comments: Insitu concrete stairs with steel hand railing fixed to stairs. Walls and floors appear to be fairly level.  
Stair walls covered with finishes however these would likely form the main concrete shear core walls.

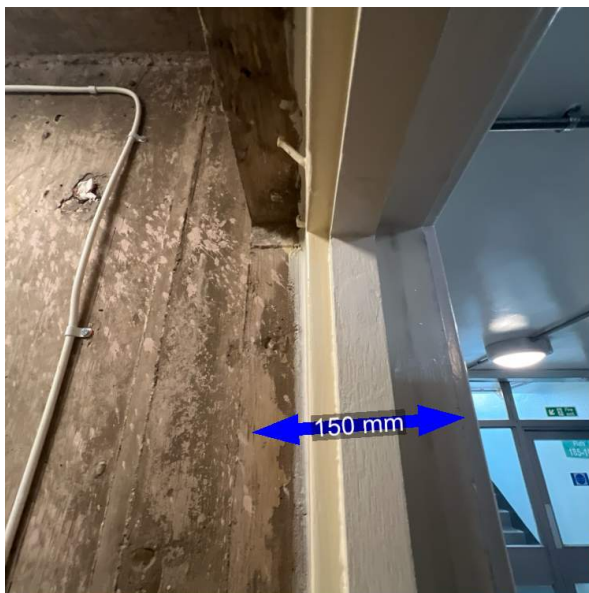
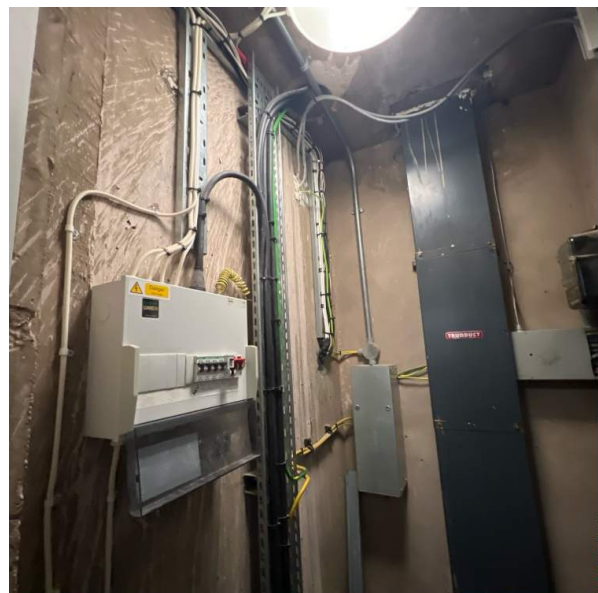
## 5th Floor Hallway

Comments: No jams or distortions noted to hallway doors to indicate any serviceability issues. Generally walls covered with finishes in hallway, likely to consist a mixture of concrete shear walls, embedded columns and masonry infill walls. Limited structure exposed. Concrete walls and infill masonry (non-load bearing) walls noted in riser cupboards.

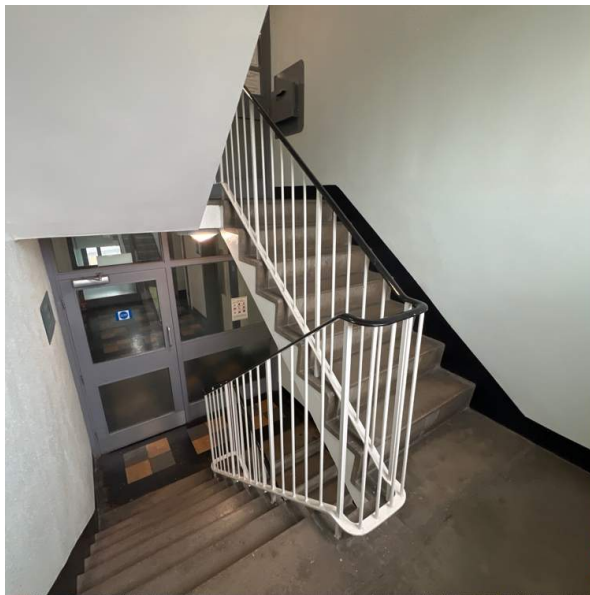
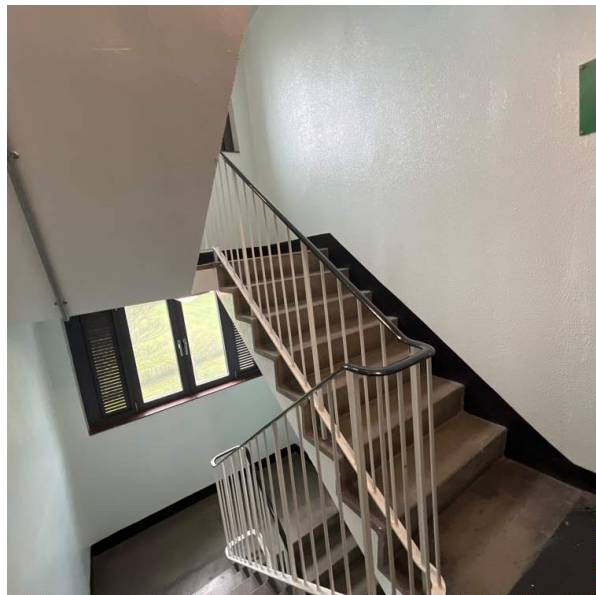
## 5th Floor Staircases

Comments: Insitu concrete stairs with steel hand railing fixed to stairs. Walls and floors appear to be fairly level.  
Stair walls covered with finishes however these would likely form the main concrete shear core walls.

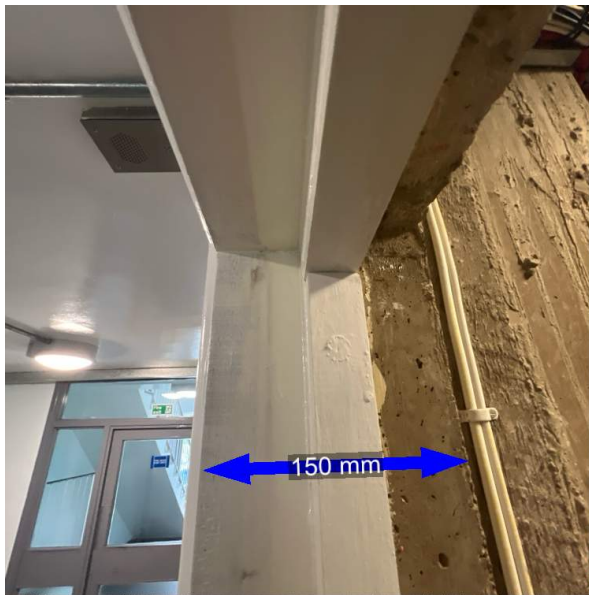
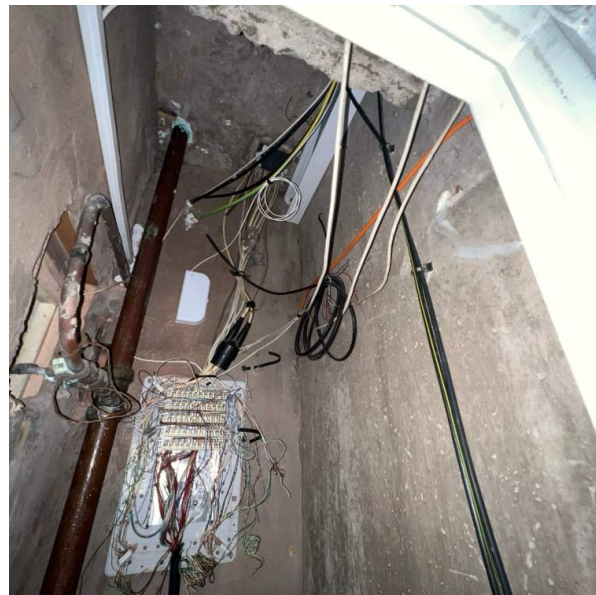
## Ground Floor Hallway

Comments: No jams or distortions noted to hallway doors to indicate any serviceability issues. Generally walls covered with finishes in hallway, likely to consist a mixture of concrete shear walls, embedded columns and masonry infill walls. Limited structure exposed. Concrete walls and infill masonry (non-load bearing) walls noted in riser cupboards.

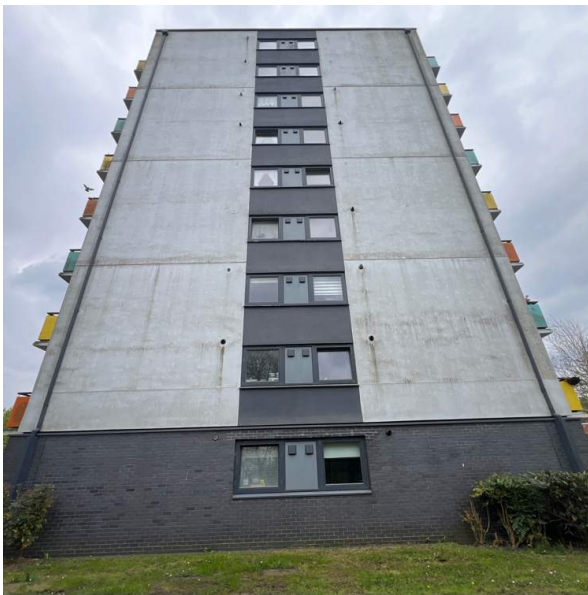
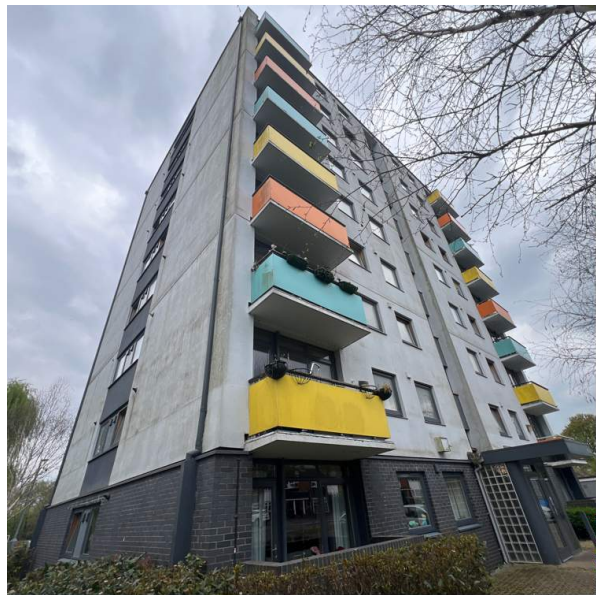
Ground floor level consists of brickwork. Remaining elevations consist of a rendered facade. Cladded panels to balconies.
