**FIRNTEC**  
BUILDING COMPLIANCE

VISUAL STRUCTURAL APPRAISAL

Moorlands Court

Reservoir Road  
Rowley Regis  
B65 9BM

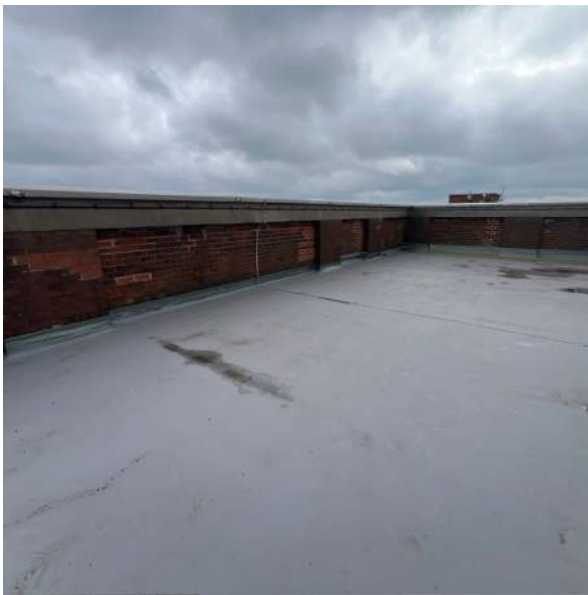
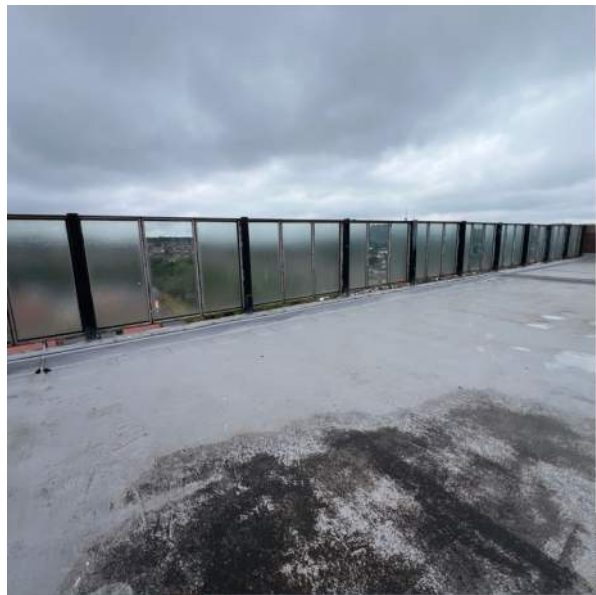
## Main Roof

Parapet walls noted to perimeter of roof.  
Insitu concrete roof slab. Masonry lift room located at roof level.

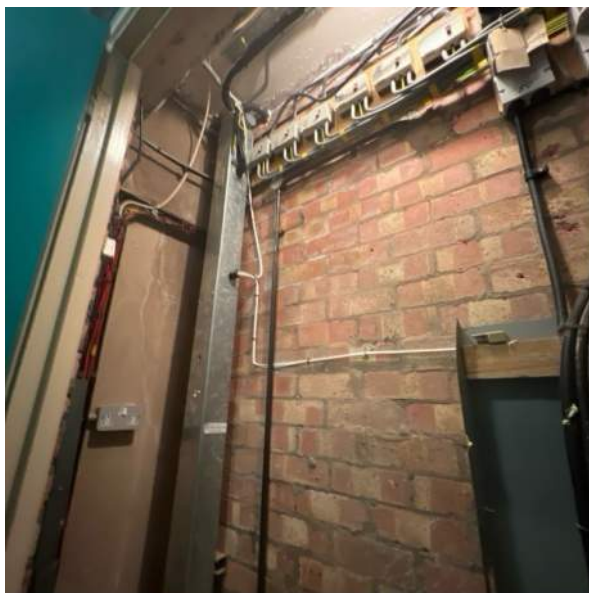
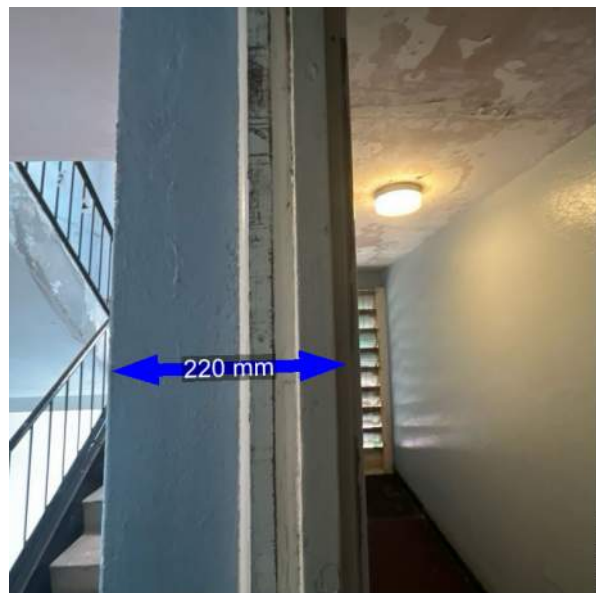
Comments: No jams or distortions noted to hallway doors to indicate any serviceability issues. Generally walls covered with finishes in hallway, likely to consist a mixture of concrete shear walls, embedded columns and block infill walls. Limited structure exposed. Partly visible concrete walls noted via electrical riser cupboards

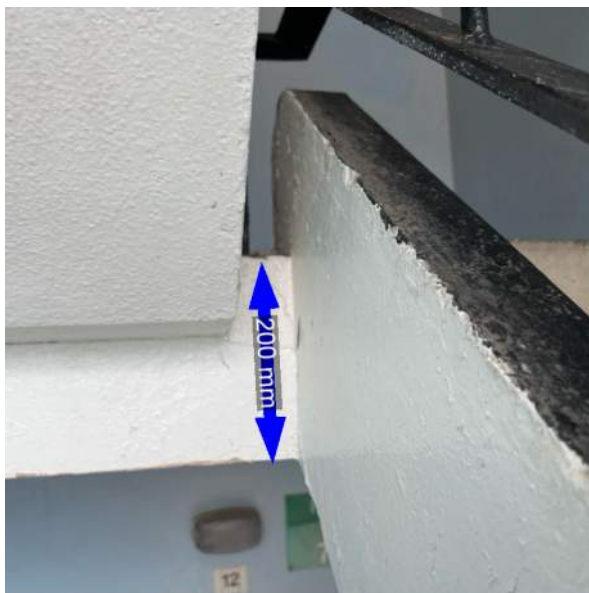
## 13th Floor Staircase

Insitu concrete stairs with steel hand railing fixed to stairs. Walls and floors appear to be fairly level.

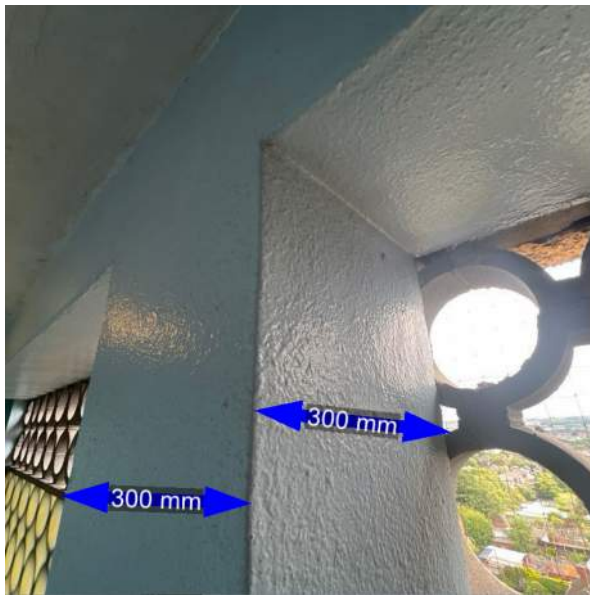
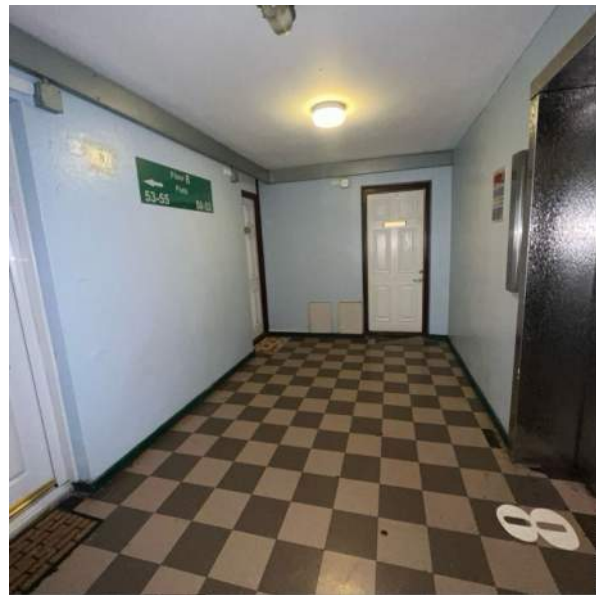
Comments: No jams or distortions noted to hallway doors to indicate any serviceability issues. Generally walls covered with finishes in hallway, likely to consist a mixture of concrete shear walls, embedded columns and block infill walls. Limited structure exposed. Partly visible concrete walls noted via electrical riser cupboards

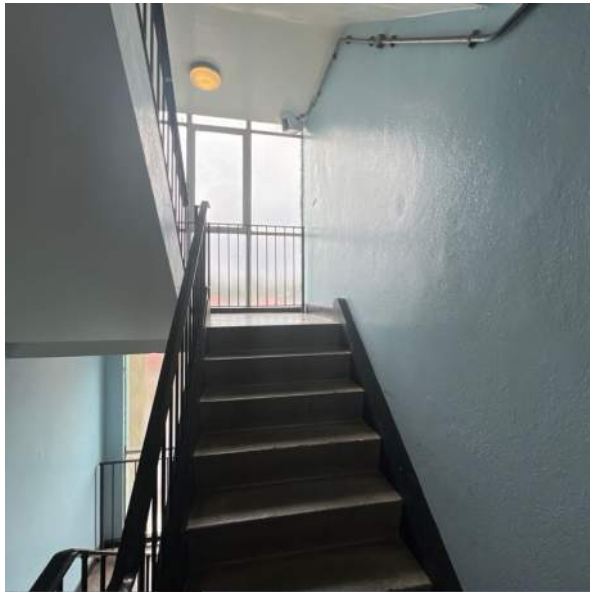
## 8th Floor Staircase

Comments: Insitu concrete stairs with steel hand railing fixed to stairs. Walls and floors appear to be fairly level.  
Stair walls covered with finishes however these would likely form the main concrete shear core walls. Stair walls approx. 220mm thick.

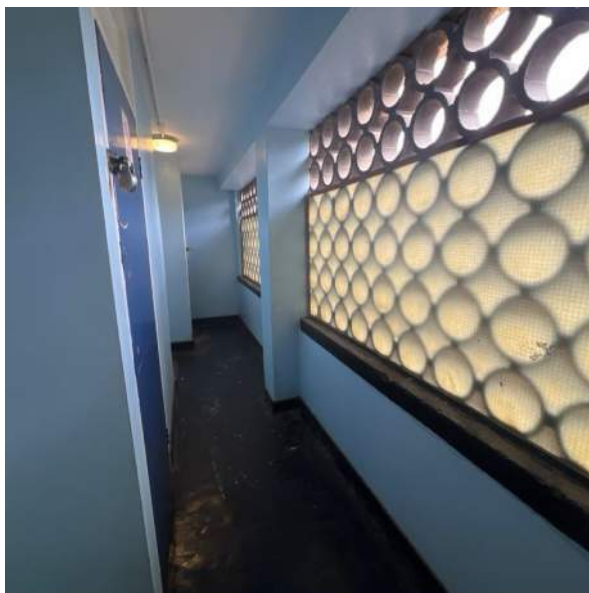
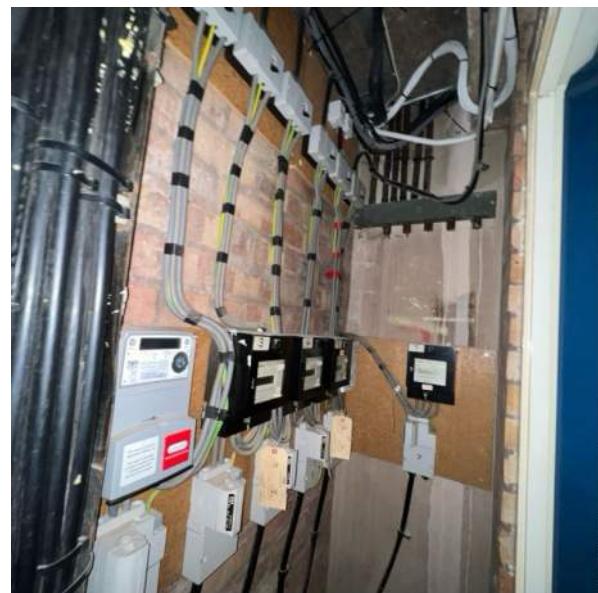
Comments: No jams or distortions noted to hallway doors to indicate any serviceability issues. Generally walls covered with finishes in hallway, likely to consist a mixture of concrete shear walls, embedded columns and block infill walls. Limited structure exposed. Partly visible concrete walls noted via electrical riser cupboards. RC Columns noted in hallway.

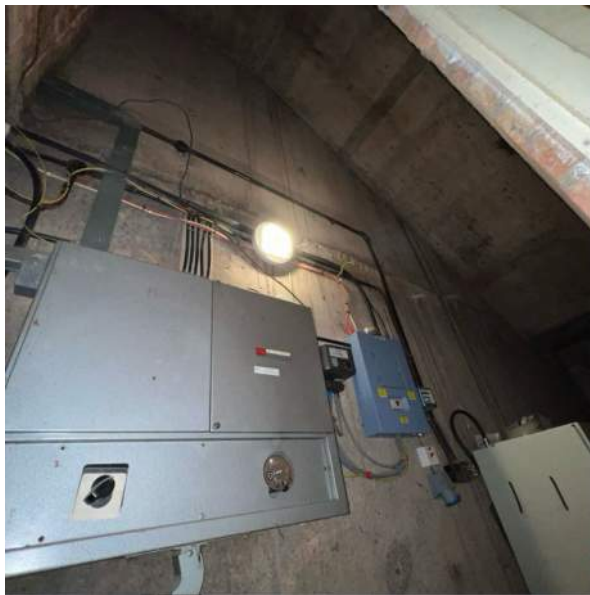
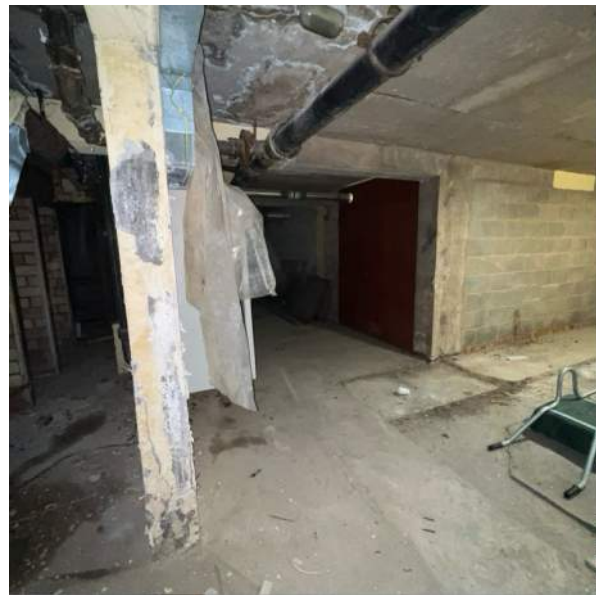
## Basement

RC structural elements (Shear walls, Columns etc) visible in basement area.

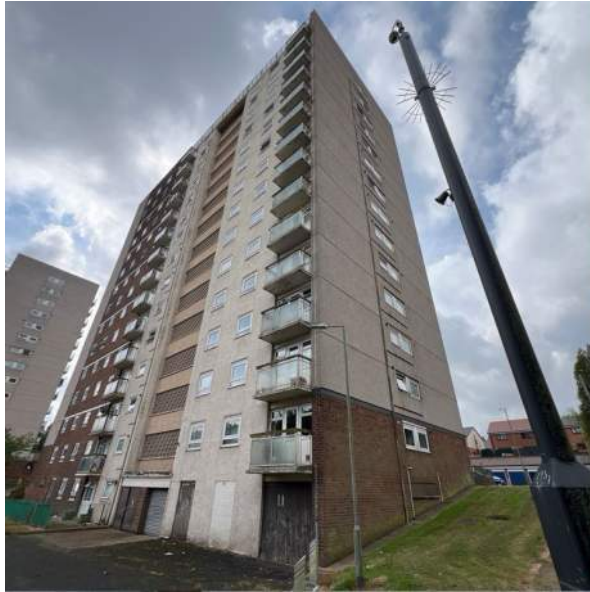
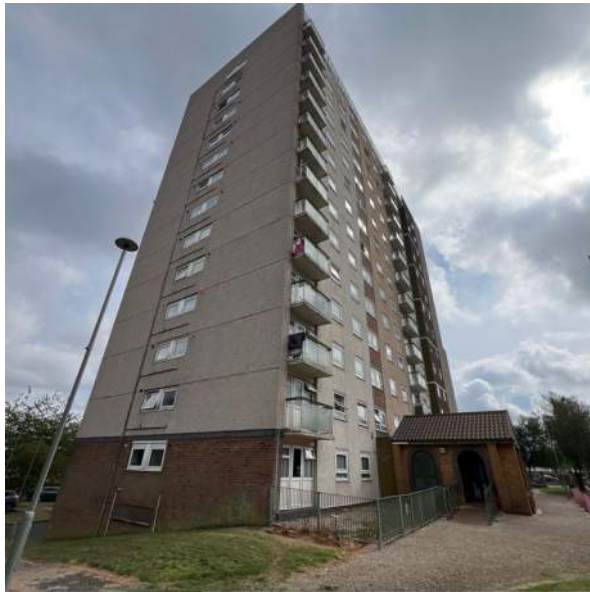
## Elevations

External facade consists of brickwork and render. Brickwork supported via floor slab at each level.
