VISUAL STRUCTURAL APPRAISAL

Mountford House

Glover Street  
West Bromwich  
B70 6DS

29<sup>th</sup> November 2024

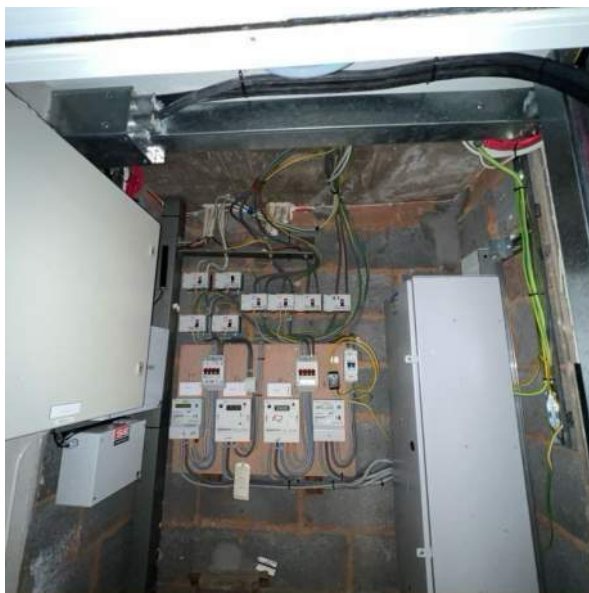
Comments: No jams or distortions noted to hallway doors to indicate any serviceability issues. Generally walls covered with finishes in hallway, likely to consist a mixture of concrete shear walls, embedded columns and block infill walls. Electrical cabinet shows infill blockwork.

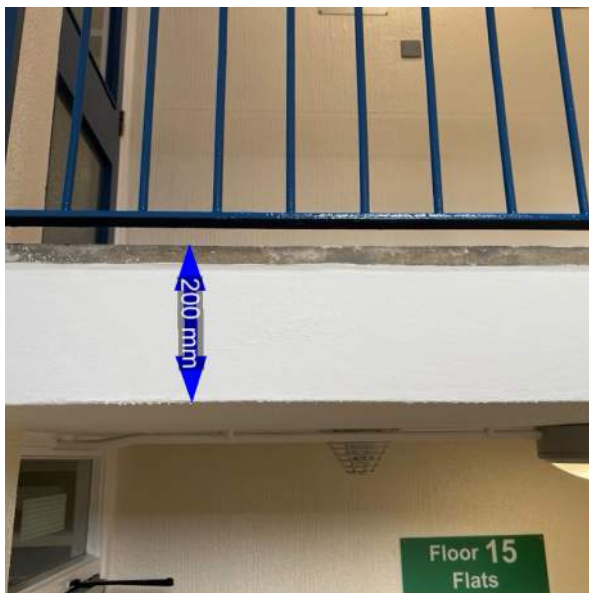
## 16th Floor Staircase

Insitu concrete stairs with steel hand railing fixed to stairs. Walls and floors appear to be fairly level.

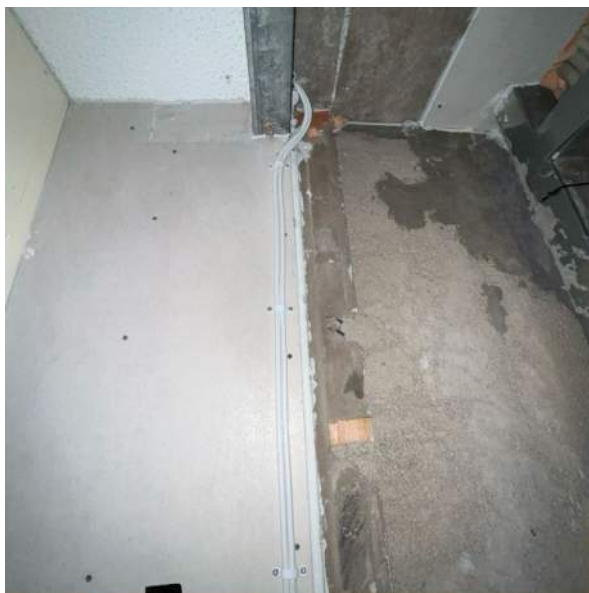
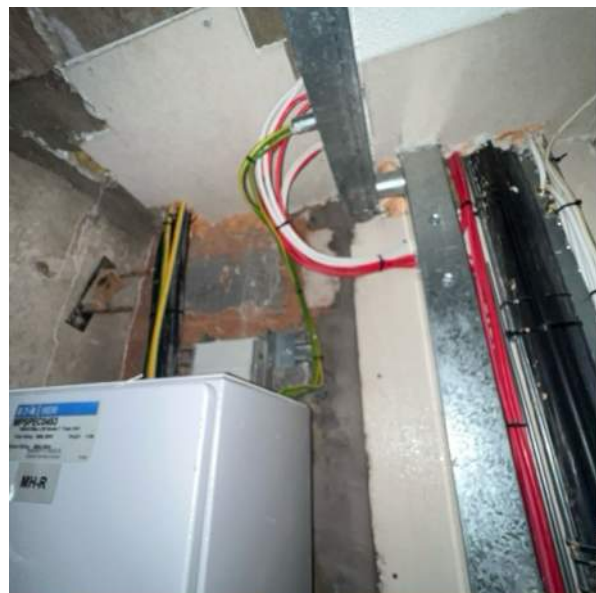
Comments: No jams or distortions noted to hallway doors to indicate any serviceability issues. Generally walls covered with finishes in hallway, likely to consist a mixture of concrete shear walls, embedded columns and block infill walls. Electrical cabinet shows infill blockwork.

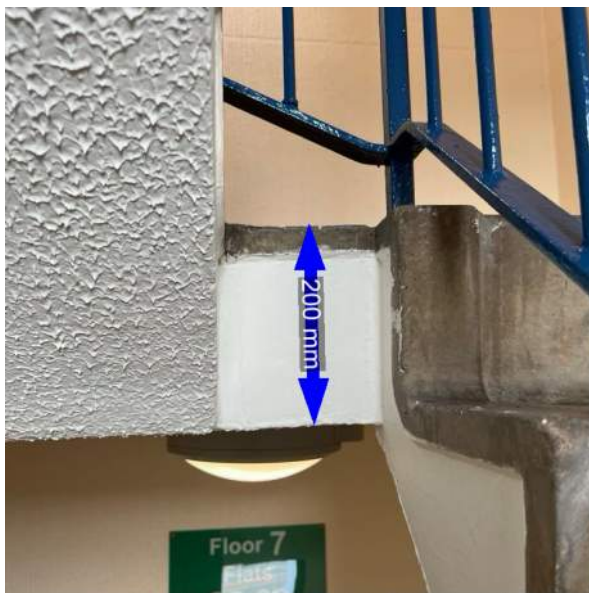
## 8th Floor Staircase

In situ concrete stairs with steel hand railing fixed to stairs. Walls and floors appear to be fairly level.

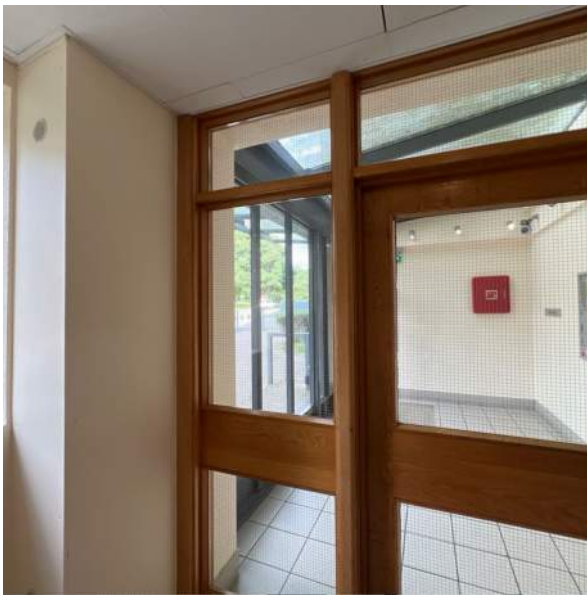
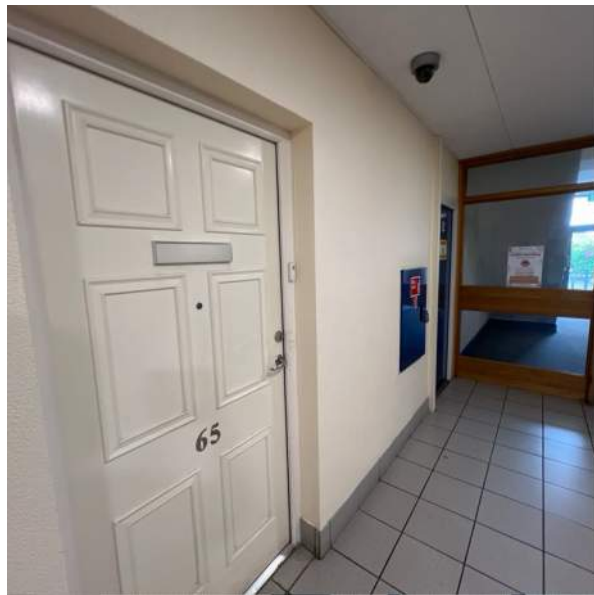
## Ground Floor Hallway

Comments: No jams or distortions noted to hallway doors to indicate any serviceability issues. Generally walls covered with finishes in hallway, likely to consist a mixture of concrete shear walls, embedded columns and block infill walls. RC Concrete Shear Core wall of lift visibly noted from riser cupboard and meterage room. Other internal main walls noted to solid concrete walls, these are likely to be shear core walls forming part of the primary structural elements.

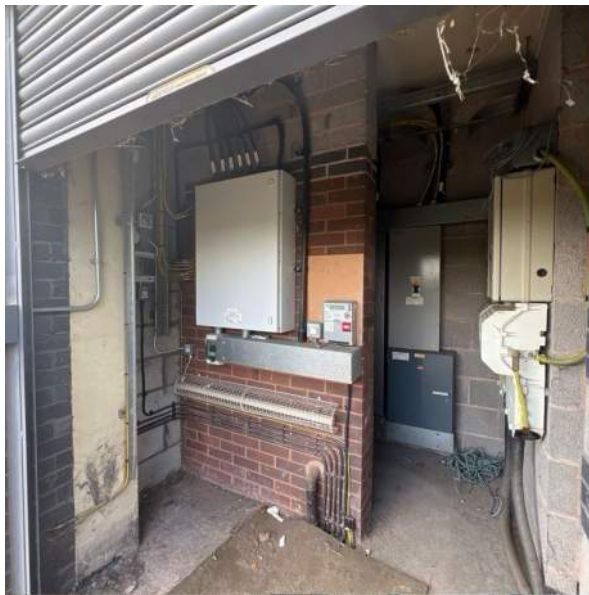
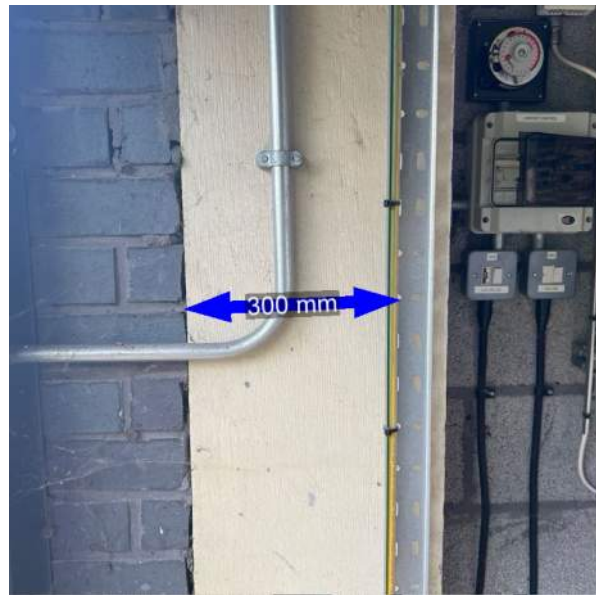
## Bin Store and Storage Areas

Shear concrete walls (300mm wide including finishes) and embedded concrete columns (approx. 350mm wide) noted in bin store and storage areas. Concrete infill (non-load bearing walls) noted.

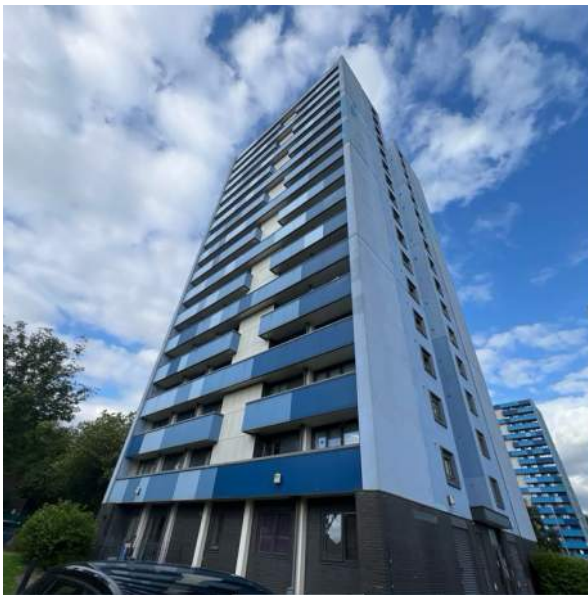
External ground floor level consists of brick work.  
Upper floors noted to have a rendered facade and cladding to balconies.  
Concrete columns (300mm wide) noted to perimeter which form part of the primary structural elements of the building.  
Staircase exterior appears to have a concrete panel facade feature.
