**FIRNTEC**  
BUILDING COMPLIANCE

VISUAL STRUCTURAL APPRAISAL

Neale House

31<sup>st</sup> January 2025

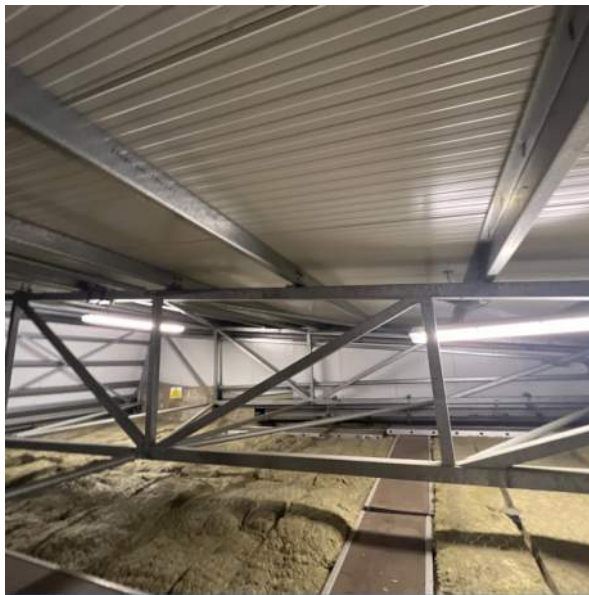
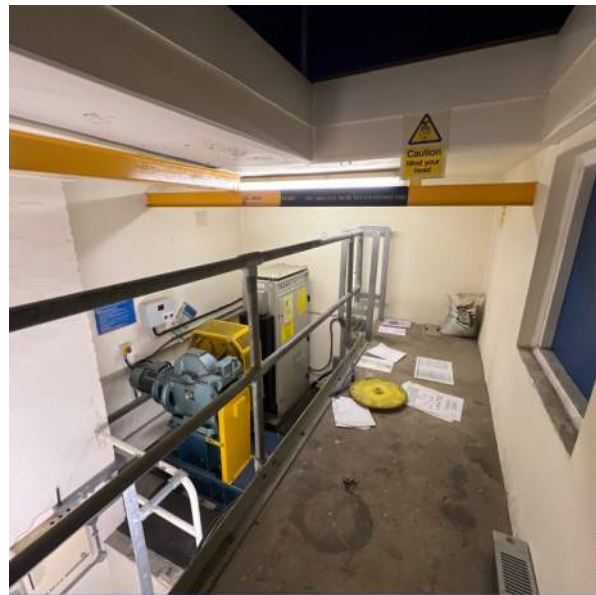
## Main Roof

Comments: A pitched roof constructed above existing original flat roof slab. Steel frame supporting purlins with aluminium standing / mineral wool core profiled panels.  
160mm thick RC core walls noted in motor room.

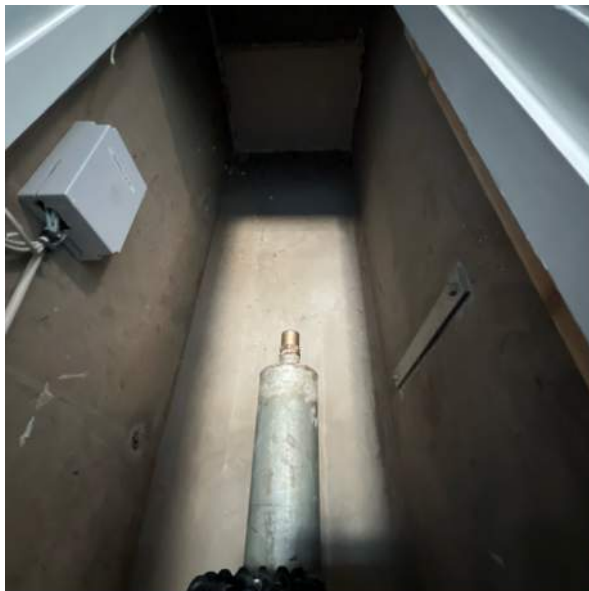
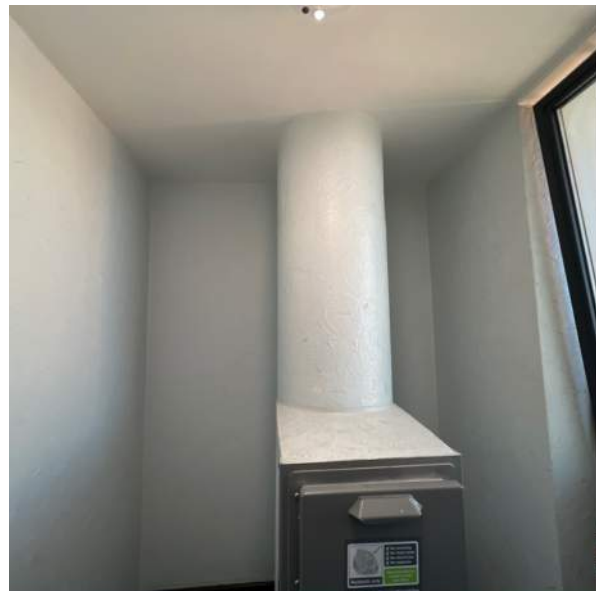
## 8th Floor Hallway

Comments: No jams or distortions noted to hallway doors to indicate any serviceability issues. Generally walls covered with finishes in hallway, likely to consist a mixture of concrete shear walls, embedded columns and masonry infill walls. Limited structure exposed. Concrete walls noted via dry riser cupboards. Electrical cupboard shows block infill walls with plaster.

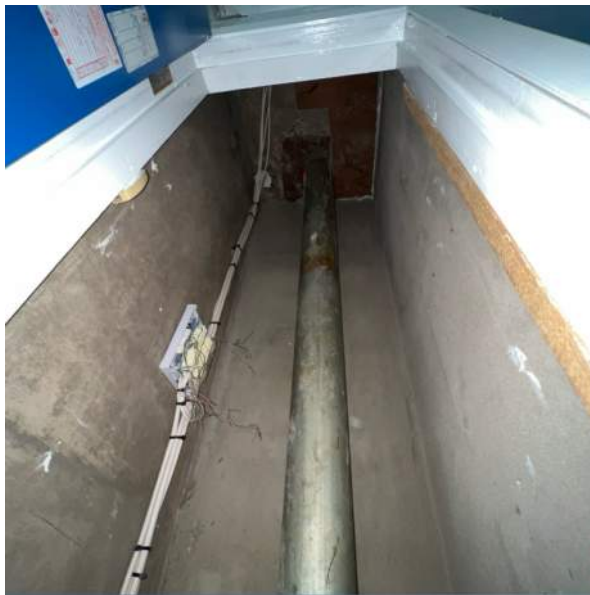
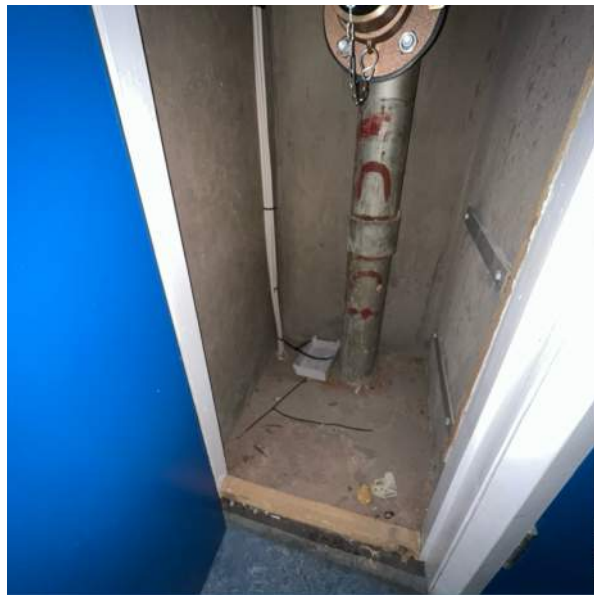
## 5th Floor Hallway

Comments: No jams or distortions noted to hallway doors to indicate any serviceability issues. Generally walls covered with finishes in hallway, likely to consist a mixture of concrete shear walls, embedded columns and masonry infill walls. Limited structure exposed. Concrete walls noted via dry riser cupboards. Electrical cupboard shows block infill walls with plaster.

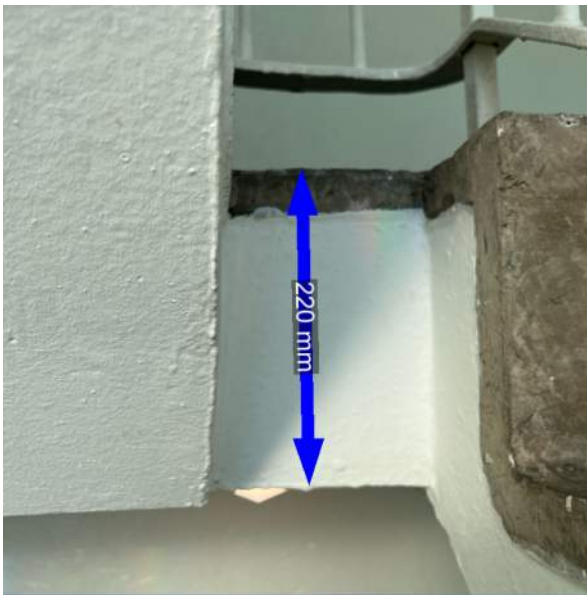
## 5th Floor Staircases

Comments: Insitu concrete stairs with steel hand railing fixed to stairs. Walls and floors appear to be fairly level.  
Stair walls covered with finishes however these would likely form the main concrete shear core walls. Partly infill/non-load bearing wall noted for one side of stair case wall.

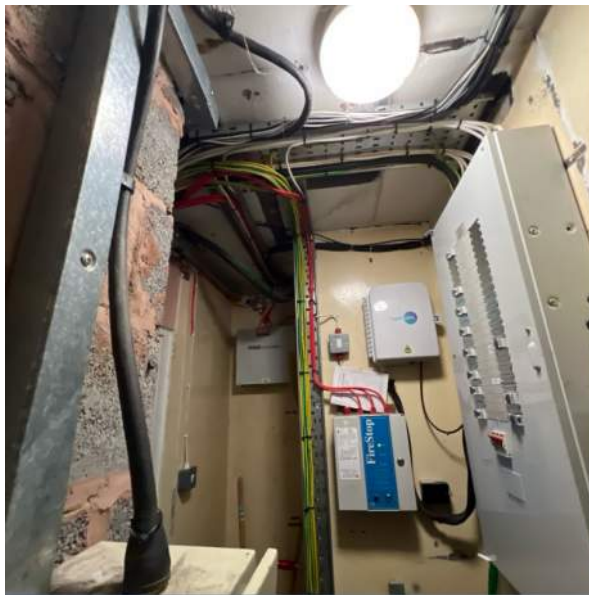
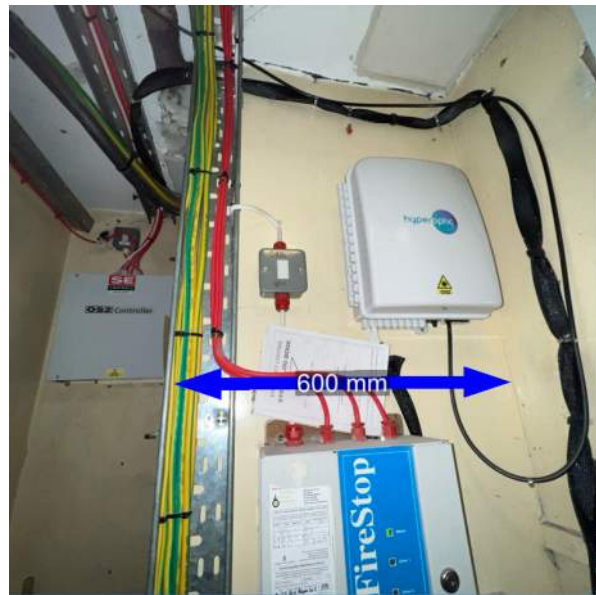
## Ground Floor Hallway

Comments: No jams or distortions noted to hallway doors to indicate any serviceability issues. Generally walls covered with finishes in hallway, likely to consist a mixture of concrete shear walls, embedded columns and block infill walls. Limited structure exposed. Partly visible concrete walls noted via riser cupboard and under stair case closet.

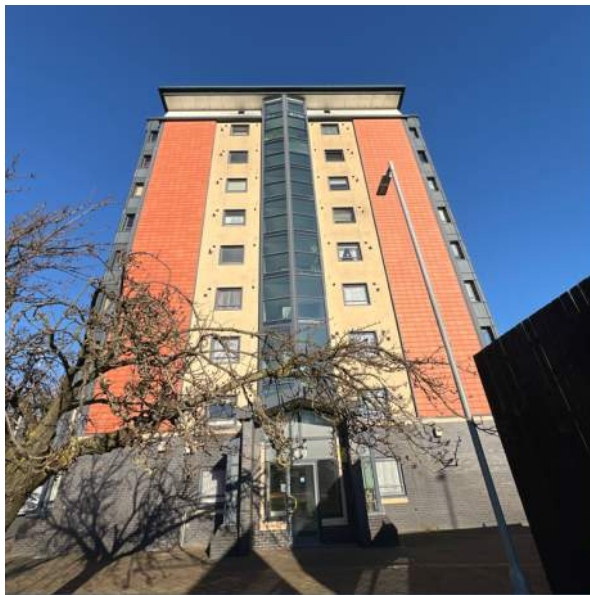
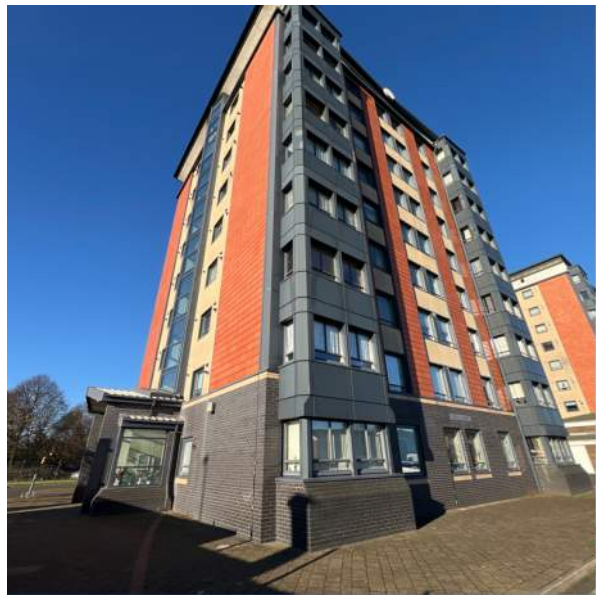
Ground floor level consists of brickwork. Remaining elevations consist of a mixture of rendered and cladded facade.

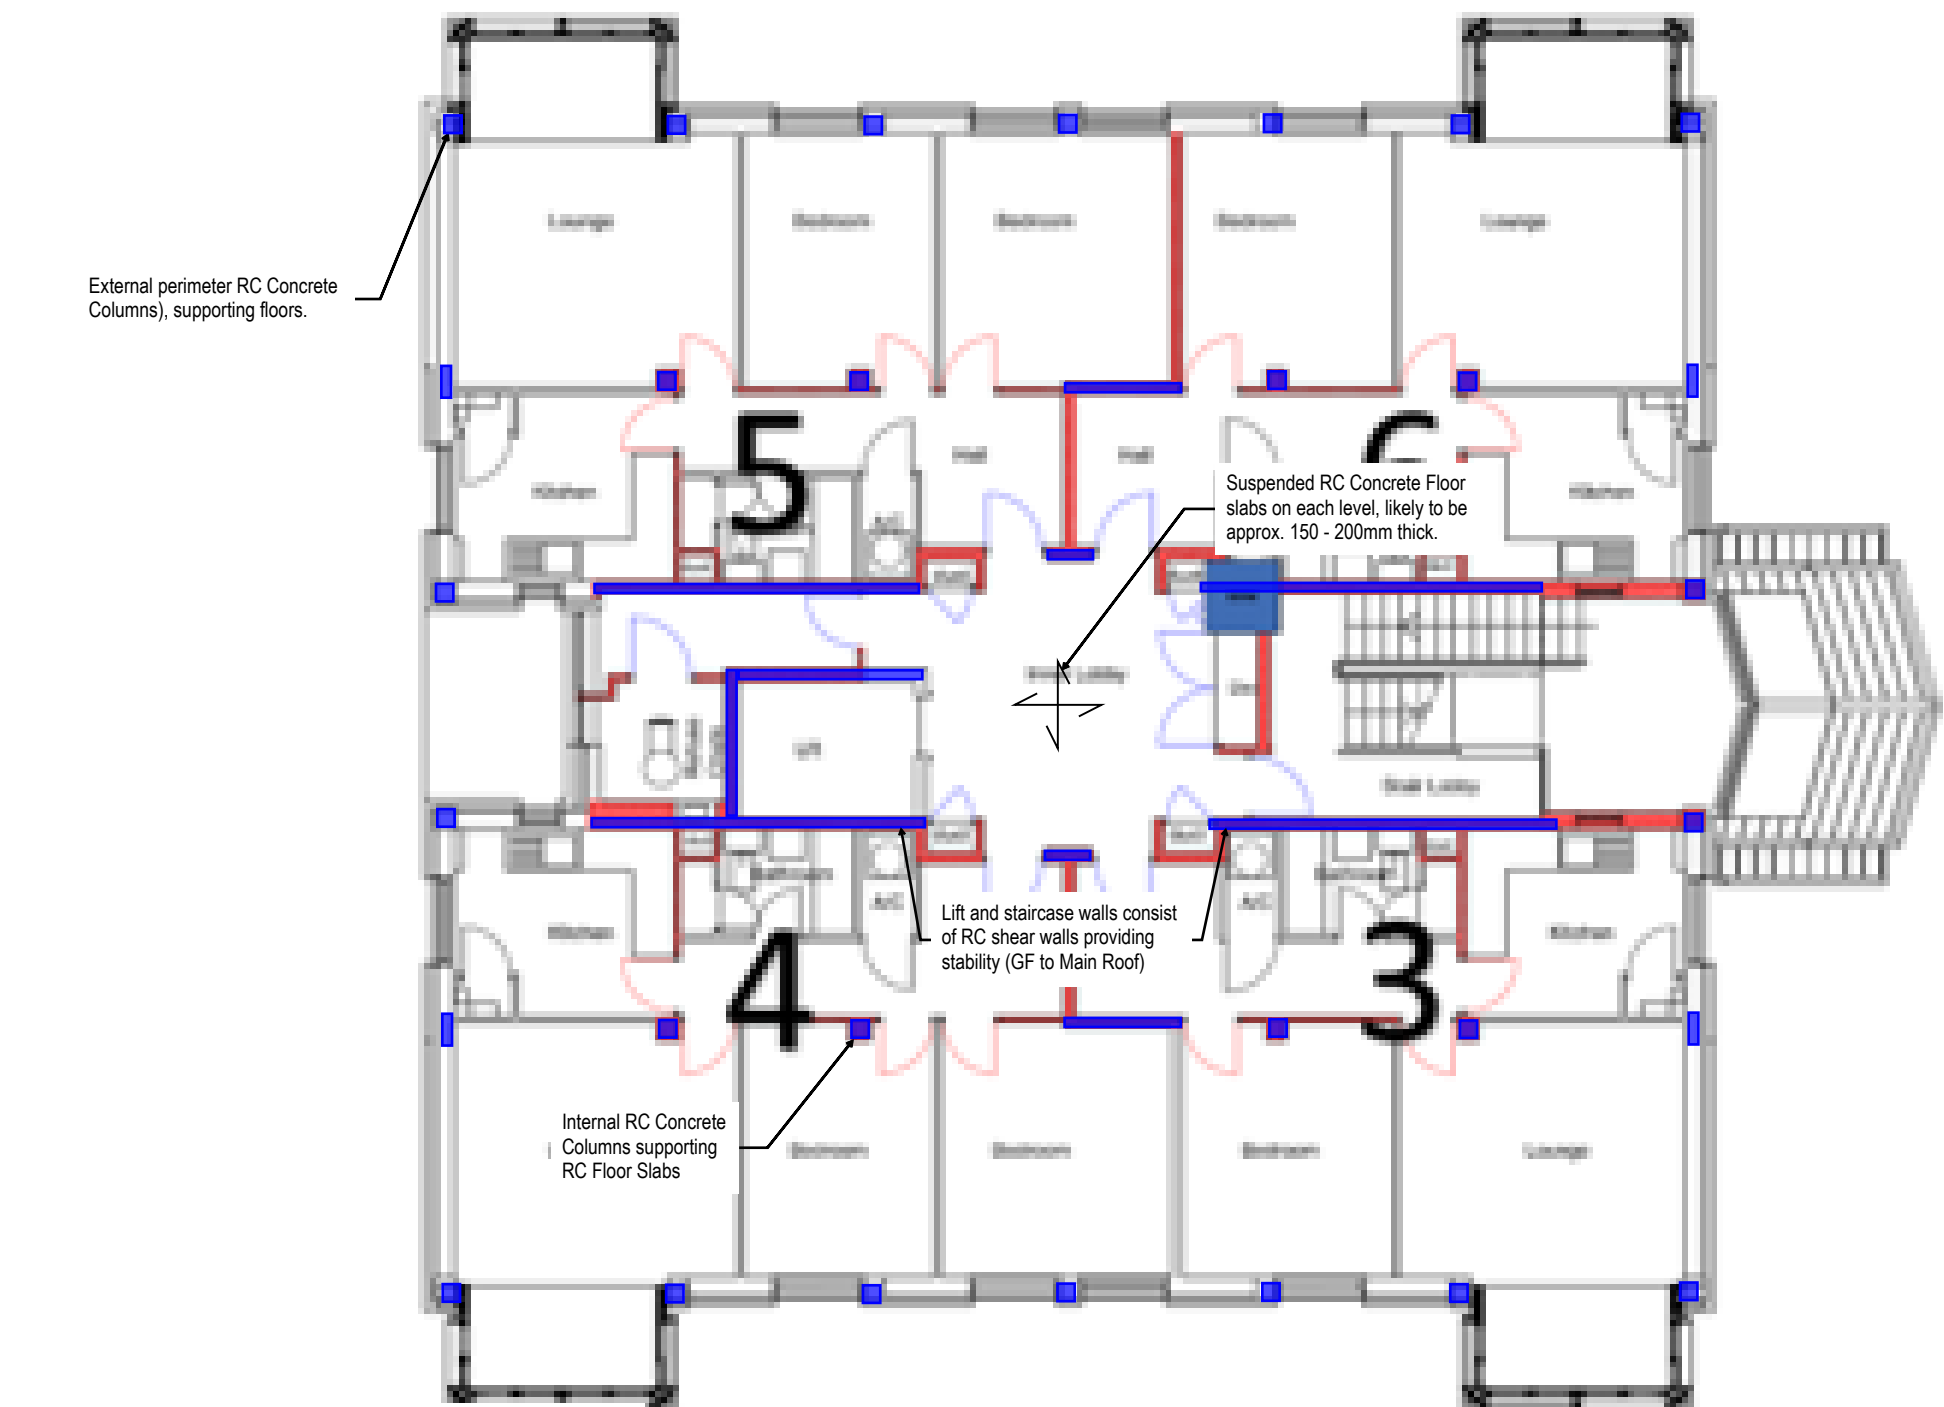
External perimeter RC Concrete Columns), supporting floors.

Suspended RC Concrete Floor slabs on each level, likely to be approx. 150 - 200mm thick.
