**FIRNTEC**  
BUILDING COMPLIANCE

VISUAL STRUCTURAL APPRAISAL

Nelson House

Upper Church Lane  
Tipton  
DY4 9PW

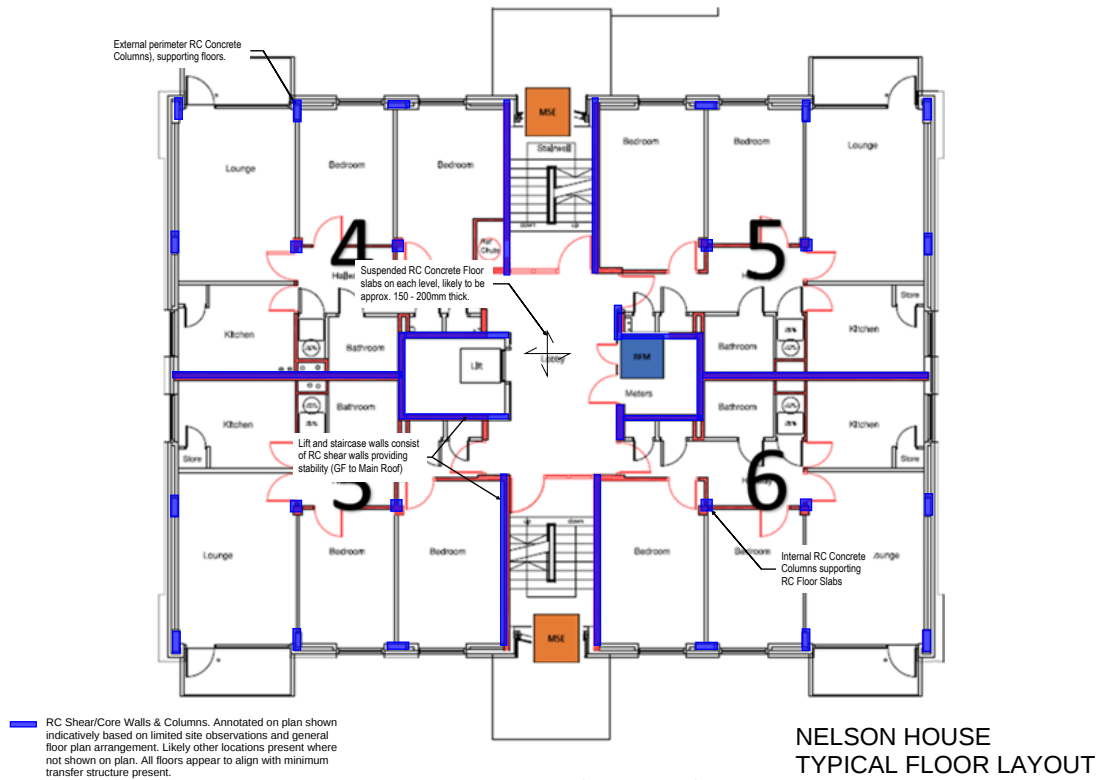
Figure 6: Diagram of typical floor plan

There were vertical concrete walls supporting the floor plates at every level. The elements visible matched the floor layout in Figure 6. The walls appear continuous from ground to roof with no transfer structure. The overall condition of the structure observed is good.

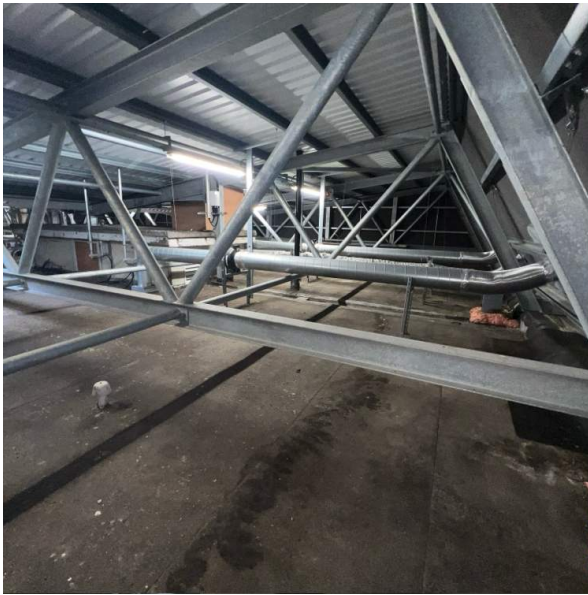
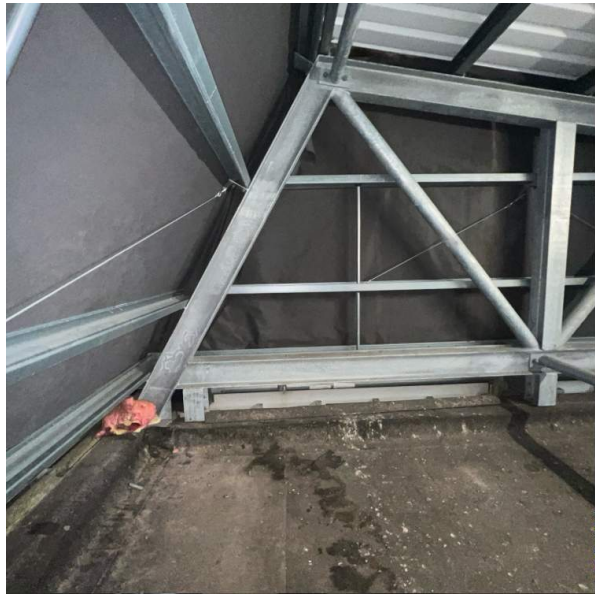
## Main Roof

Comments: Flat roof, RC concrete slab with insulated PIR board and felt coverings.  
Steel frame structure supporting pitched roof above constructed on originally flat roof.

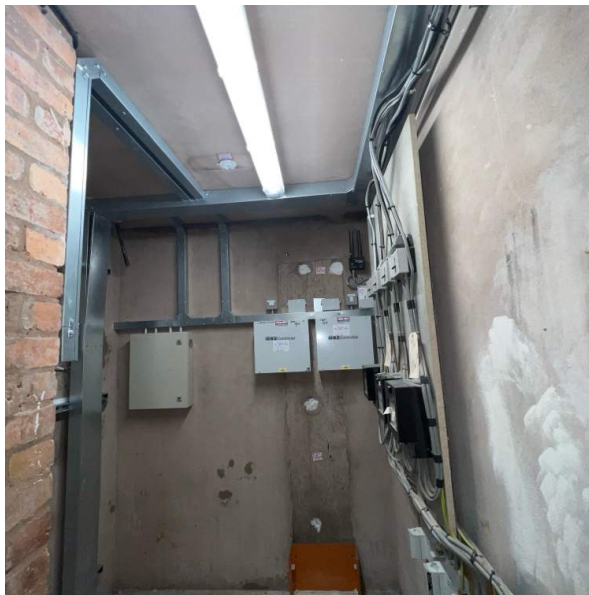
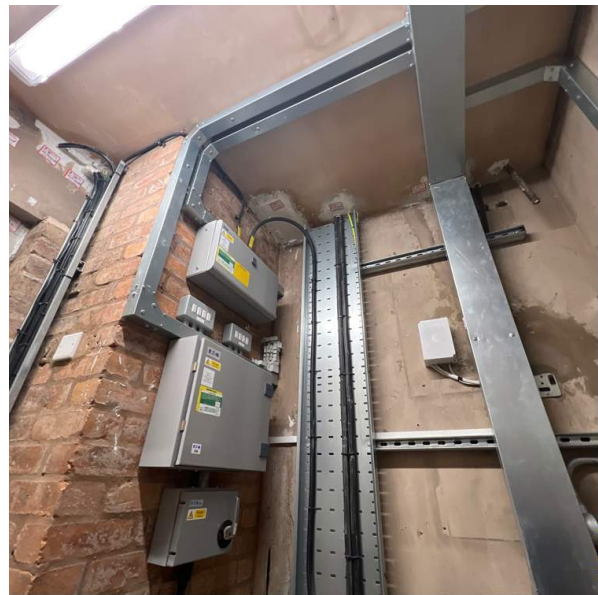
## 8th Floor Hallway

Comments: No jams or distortions noted to hallway doors to indicate any serviceability issues. Generally walls covered with finishes in hallway, likely to consist a mixture of concrete shear walls, embedded columns and masonry infill walls. Limited structure exposed. Concrete walls and infill masonry (non-load bearing) walls noted in riser cupboards and lift motor room. Concrete walls noted to be approx. 160mm thick.

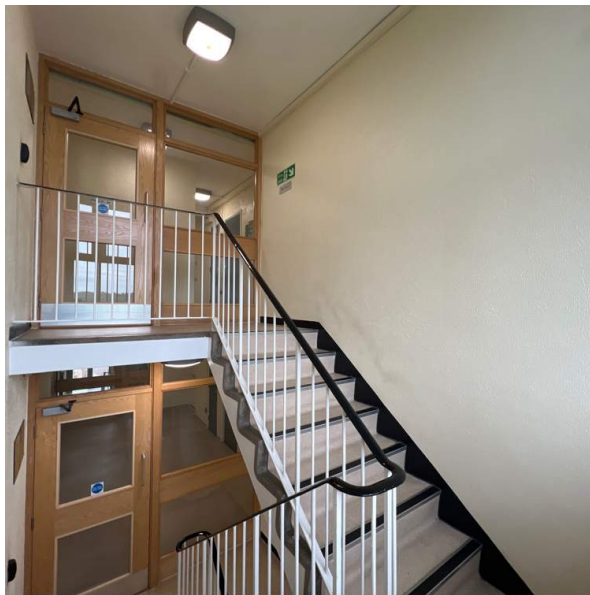
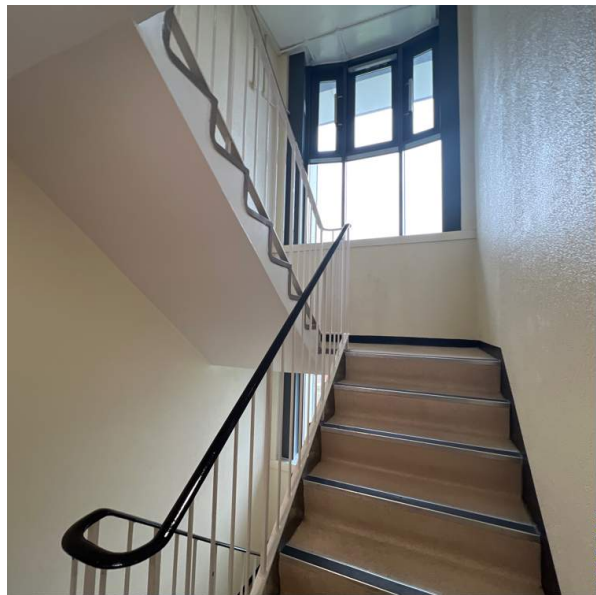
## 8th Floor Staircases

Comments: Insitu concrete stairs with steel hand railing fixed to stairs. Walls and floors appear to be fairly level.  
Stair walls covered with finishes however these would likely form the main concrete shear core walls.

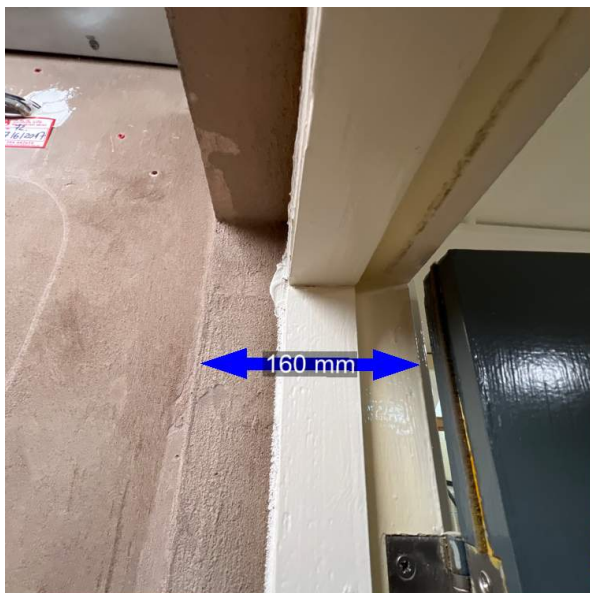
## 5th Floor Hallway

Comments: No jams or distortions noted to hallway doors to indicate any serviceability issues. Generally walls covered with finishes in hallway, likely to consist a mixture of concrete shear walls, embedded columns and masonry infill walls. Limited structure exposed. Concrete walls and infill masonry (non-load bearing) walls noted in riser cupboards. Concrete walls noted to be approx. 160mm thick.

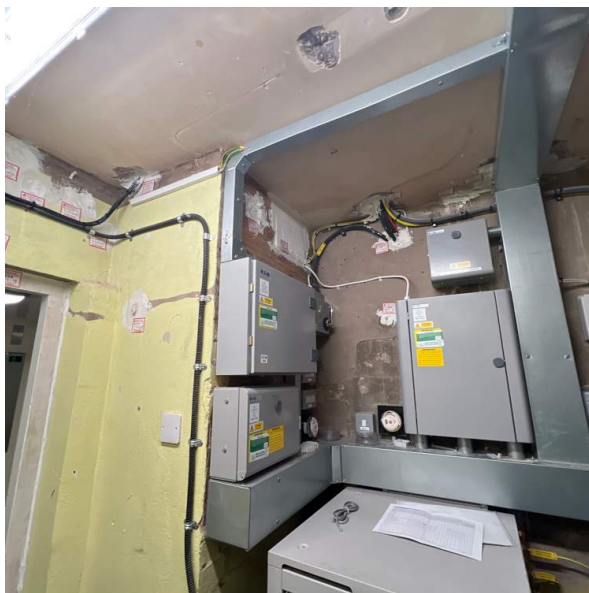
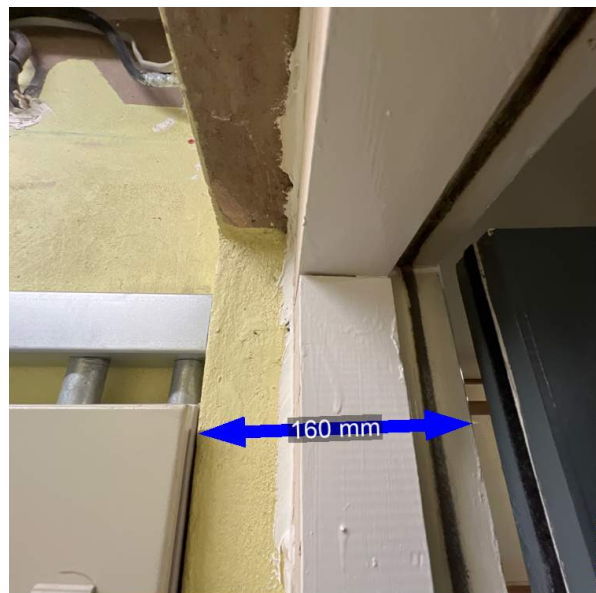
Comments: No jams or distortions noted to hallway doors to indicate any serviceability issues. Generally walls covered with finishes in hallway, likely to consist a mixture of concrete shear walls, embedded columns and masonry infill walls. Limited structure exposed. Concrete walls and infill masonry (non-load bearing) walls noted in riser cupboards.

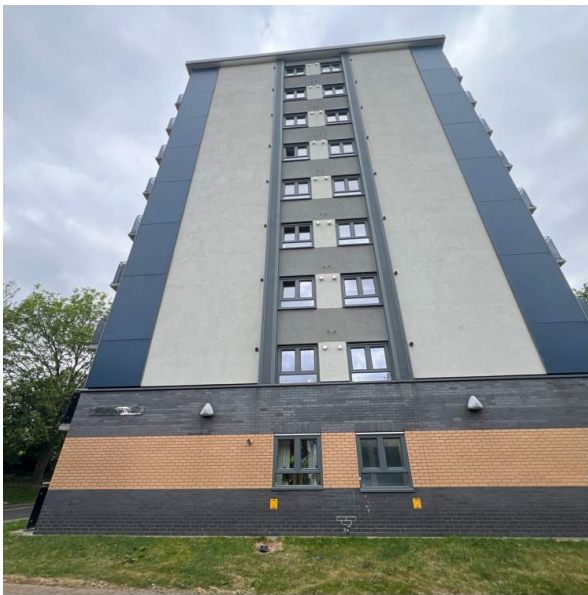
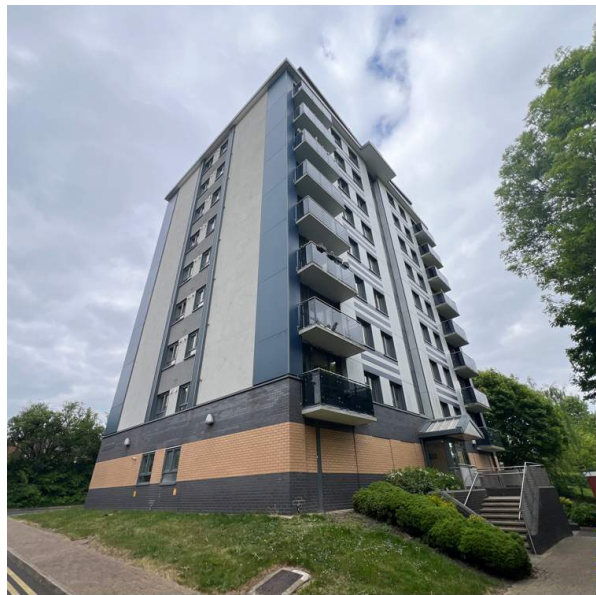
Comments: Brick work at ground floor level all sides. Upper floors cladded to front and rear elevations and rendered facade to side elevations. Cantilevered balconies noted on each level.
