**FIRNTEC**  
BUILDING COMPLIANCE

VISUAL STRUCTURAL APPRAISAL

Oak Court  
Acacia Avenue  
West Brom  
WS5 4BN

24<sup>th</sup> June 2025

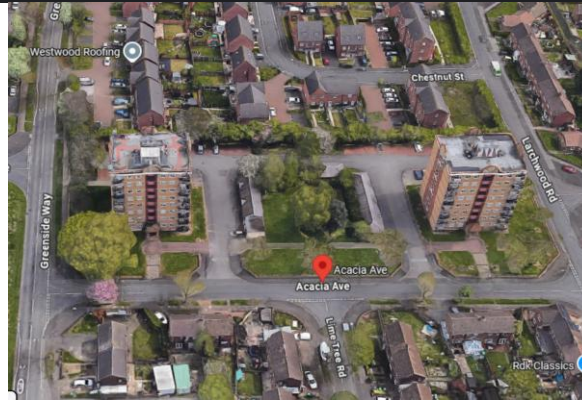
Figure 5. Oak Court to the Right

The elevations are cavity walls with external leaf of stretcher bond masonry supported off the exposed slab edge.

Each floor has 4 cantilevering balconies in opposing corners of the block. These were not accessible however from inspection they have been cast as part of the main concrete slab.

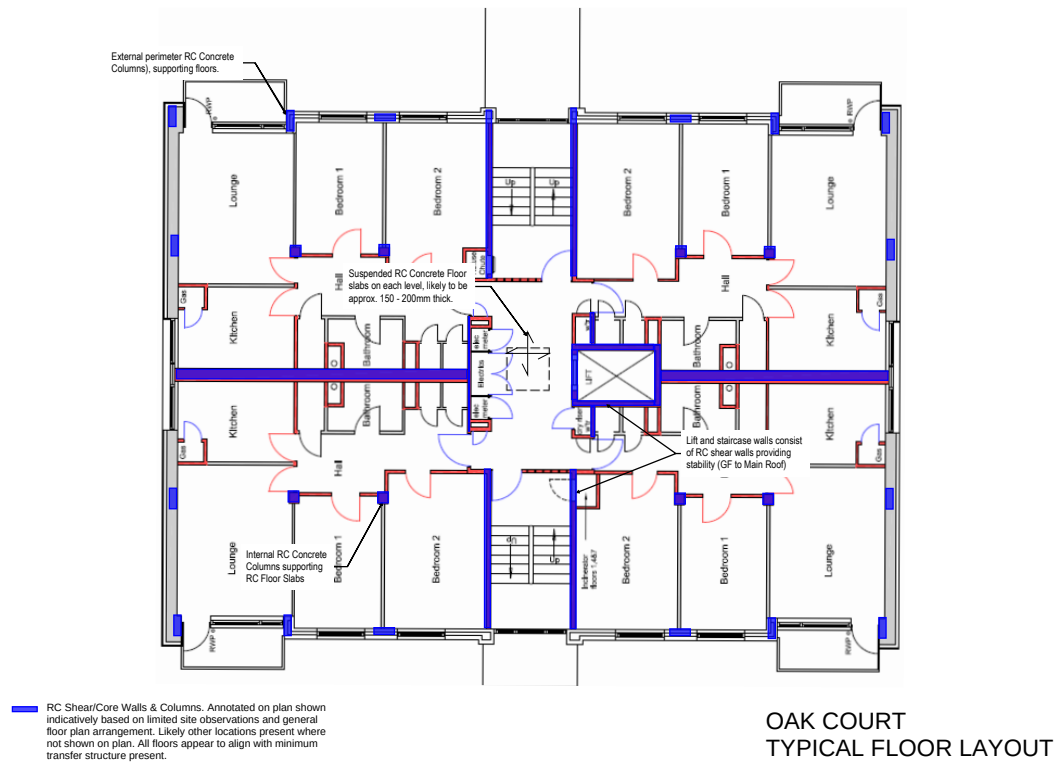
Figure 6: Diagram of typical floor plan

Figure 6 indicates the assumed structural layout for a typical upper floor level.

There were vertical concrete walls supporting the floor plates at every level. The elements visible matched the floor layout in Figure 6. The walls appear continuous from ground to roof with no transfer structure. The overall condition of the structure observed is good.

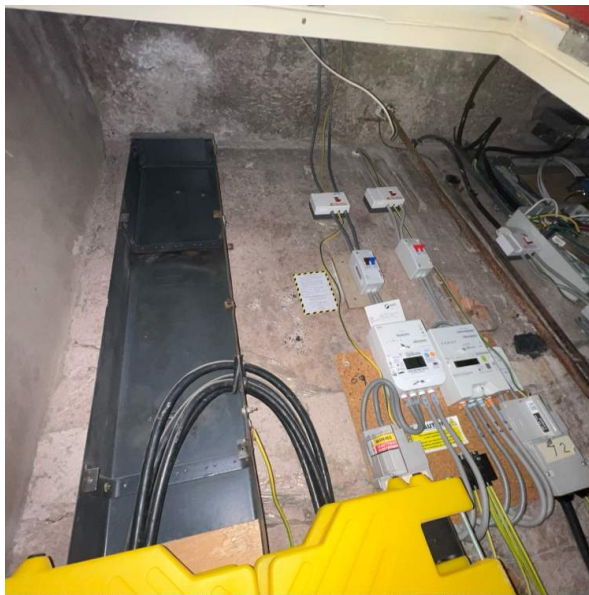
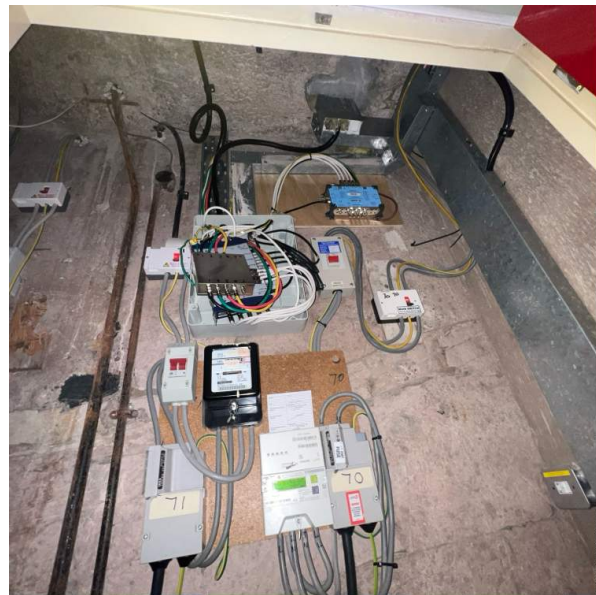
## 7th Floor Hallway

Comments: No jams or distortions noted to hallway doors to indicate any serviceability issues. Generally walls covered with finishes in hallway, likely to consist a mixture of concrete shear walls, embedded columns and masonry infill walls. Limited structure exposed. Concrete walls and infill masonry (non-load bearing) walls noted in riser cupboards.

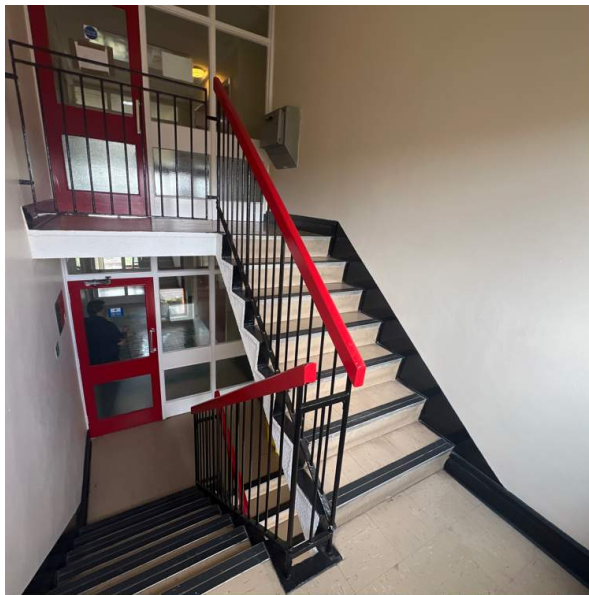
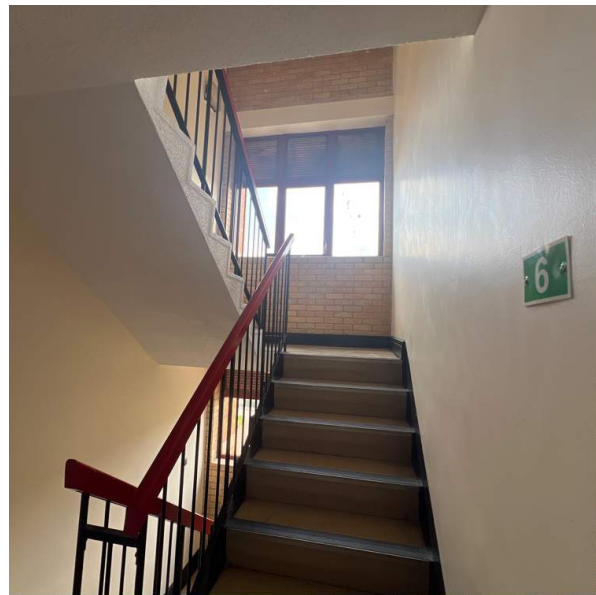
## 7th Floor Staircases

Comments: Insitu concrete stairs with steel hand railing fixed to stairs. Walls and floors appear to be fairly level.  
Stair walls covered with finishes however these would likely form the main concrete shear core walls.

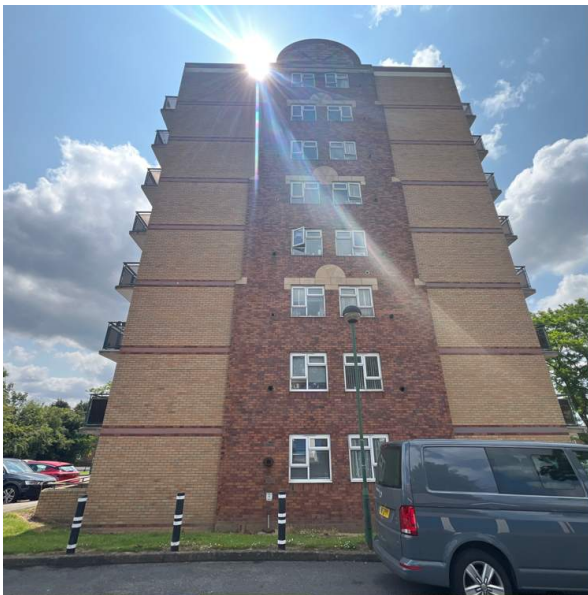
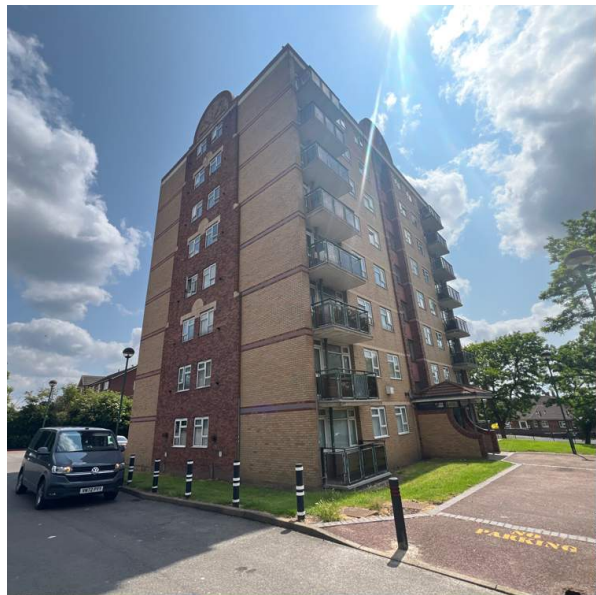
Comments: External facade consists of brick work on all levels to all elevations. Cantilevered balconies situated on each level.
