VISUAL STRUCTURAL APPRAISAL

Paget House  
Sedgeley Road East  
Tipton  
DY4 7TU

24<sup>th</sup> June 2025

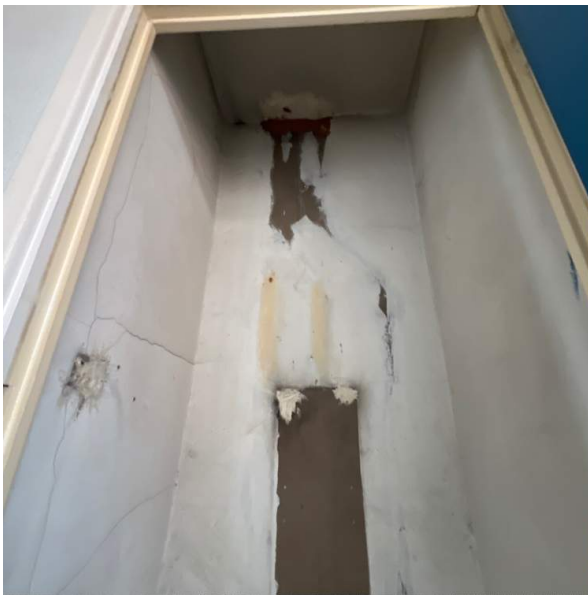
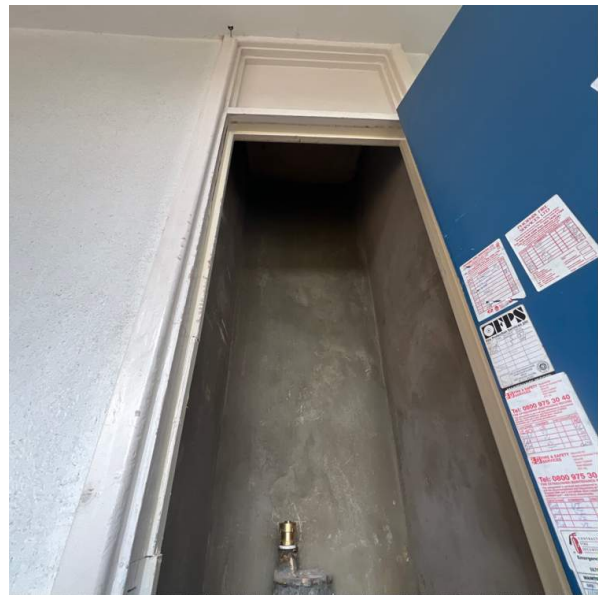
## 5th Floor Hallway

Comments: No jams or distortions noted to hallway doors to indicate any serviceability issues. Generally walls covered with finishes in hallway, likely to consist a mixture of concrete shear walls, embedded columns and masonry infill walls. Limited structure exposed. Concrete structure and rendered infill masonry (non-load bearing) walls noted in riser cupboards. Some superficial/non-structural cracks to finishes.

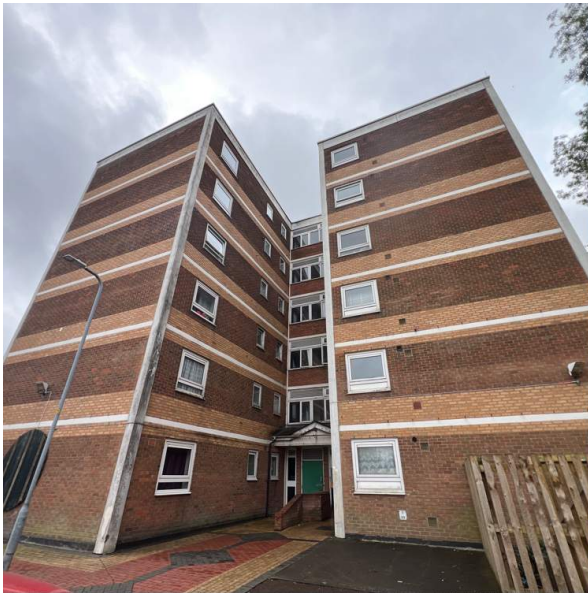
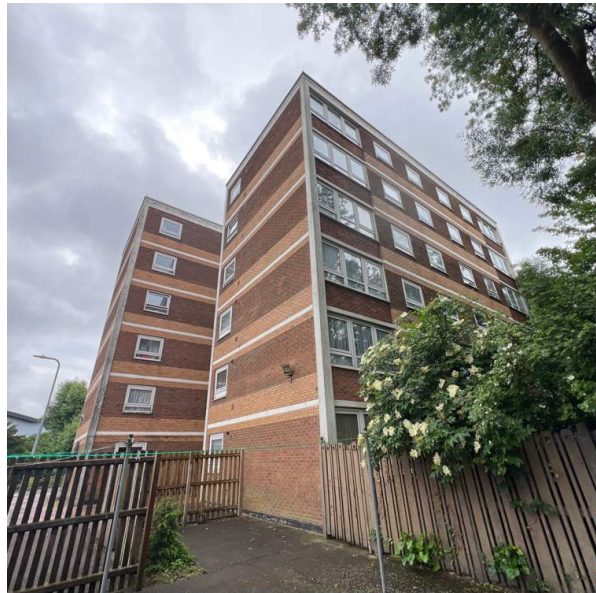
Comments: External facade consists of brick work to all elevations GF to top floor.  
Elevations generally in fair condition.  
RC columns forming part of main structural elements noted to perimeter of building.
