VISUAL STRUCTURAL APPRAISAL

1-82 Russell House

Holyhead Road  
Wednesbury  
WS10 7BA

13<sup>th</sup> November 2024

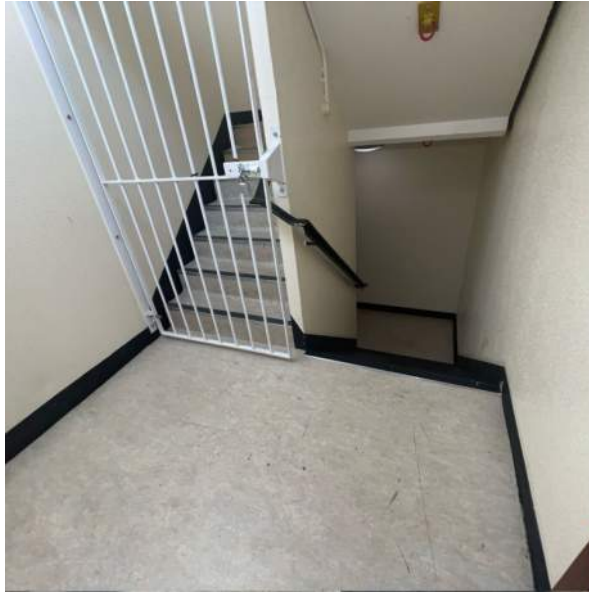
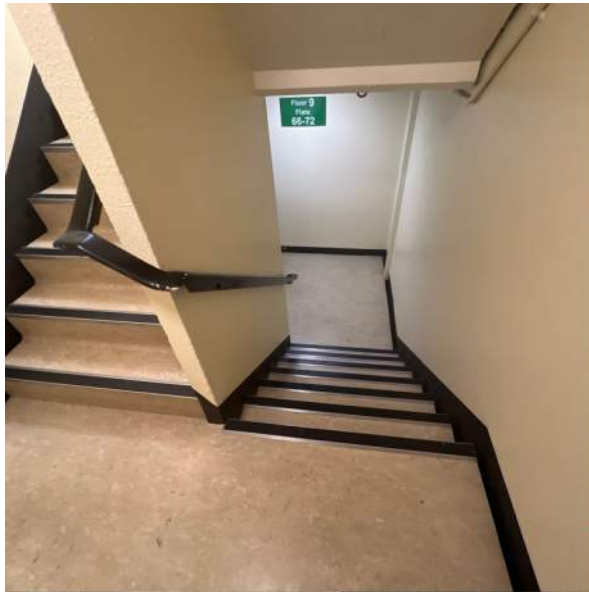
## 10th Floor Staircase

Comments: Walls and floors appear to be fairly level.  
Stair walls covered with finishes however these would likely form the main concrete shear core walls.

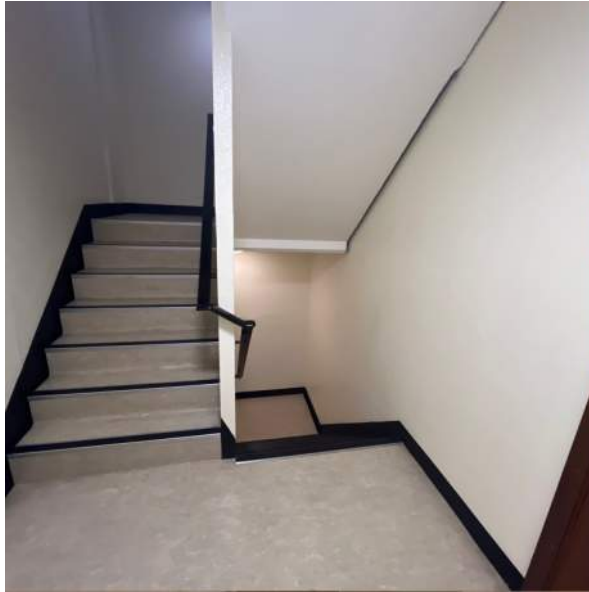
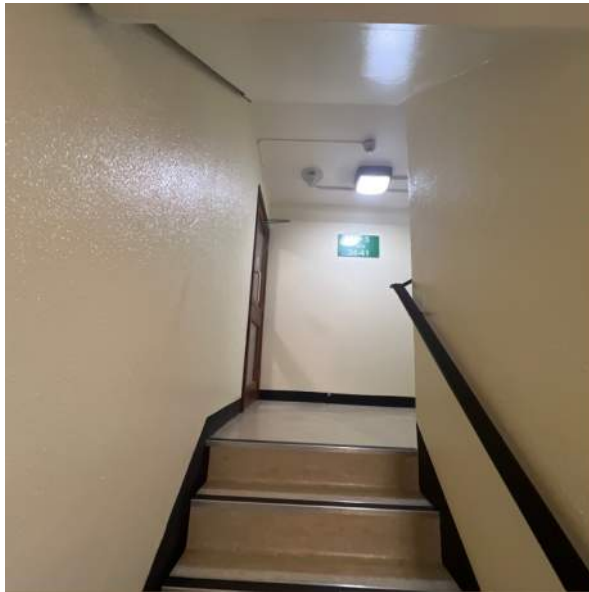
## 5th Floor Staircase

Comments: Walls and floors appear to be fairly level.  
Stair walls covered with finishes however these would likely form the main concrete shear core walls.

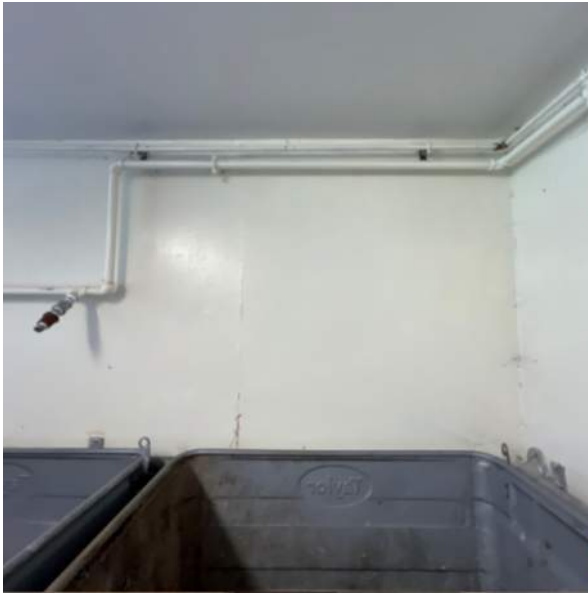
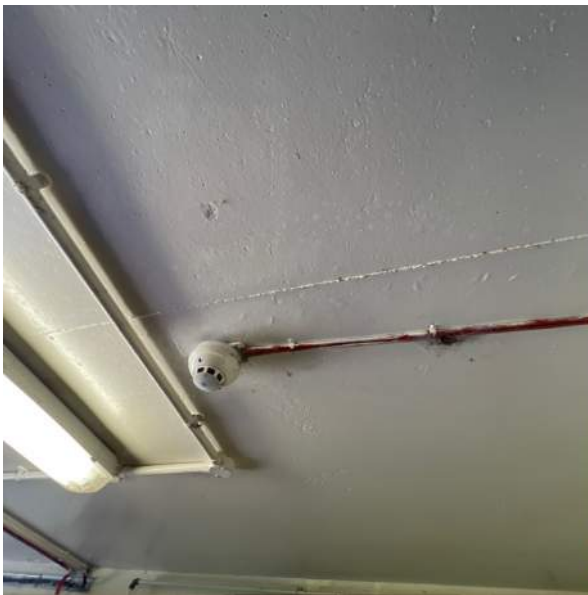
## Binstore

Comments: Concrete elements visible in binstore, mostly covered with finish.

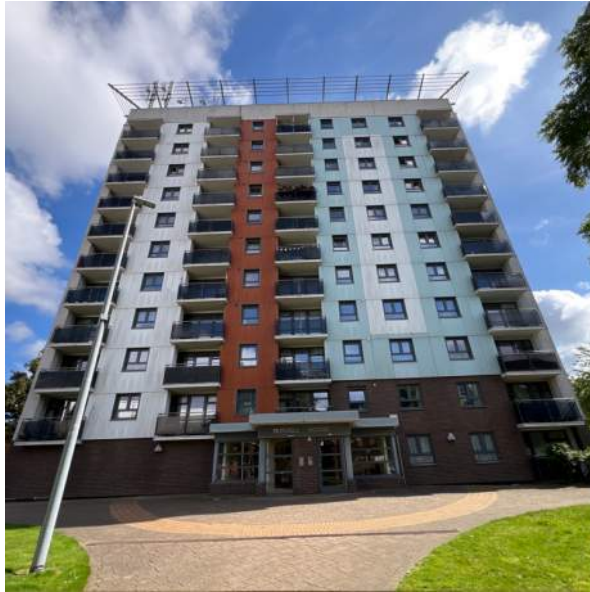
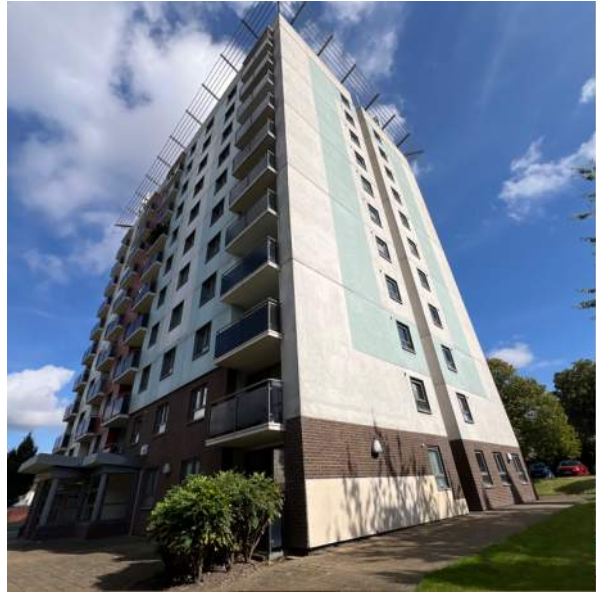
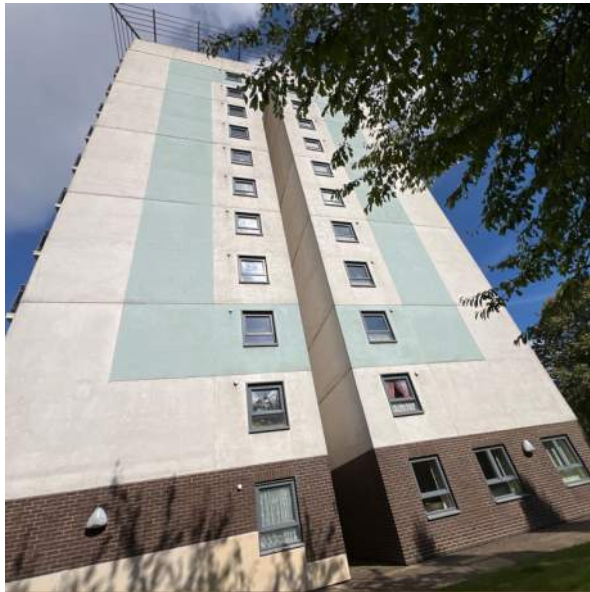
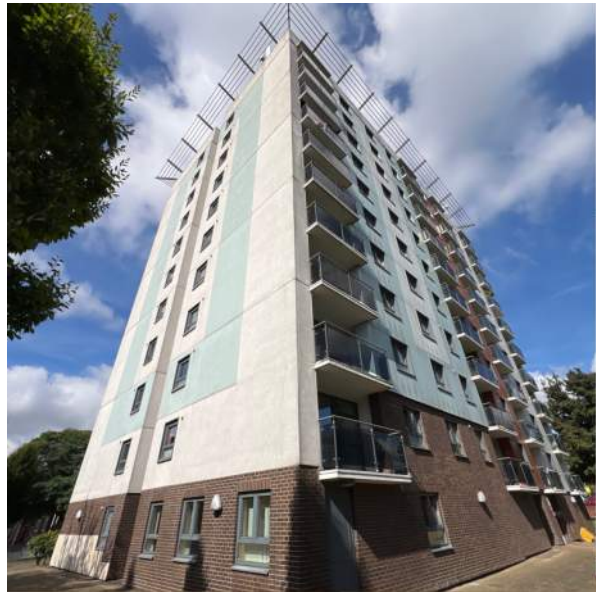
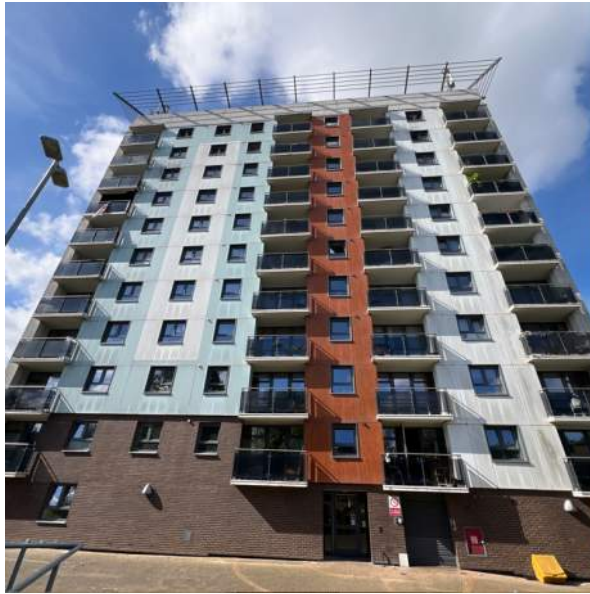
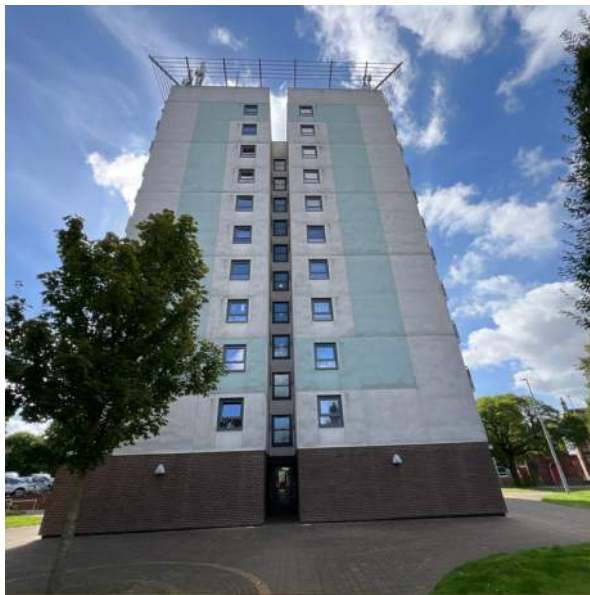
## Elevations

External facade consists of brickwork at ground floor and cladded facade to upper levels and render.

External perimeter appear to be formed of RC Concrete Wall Panels.

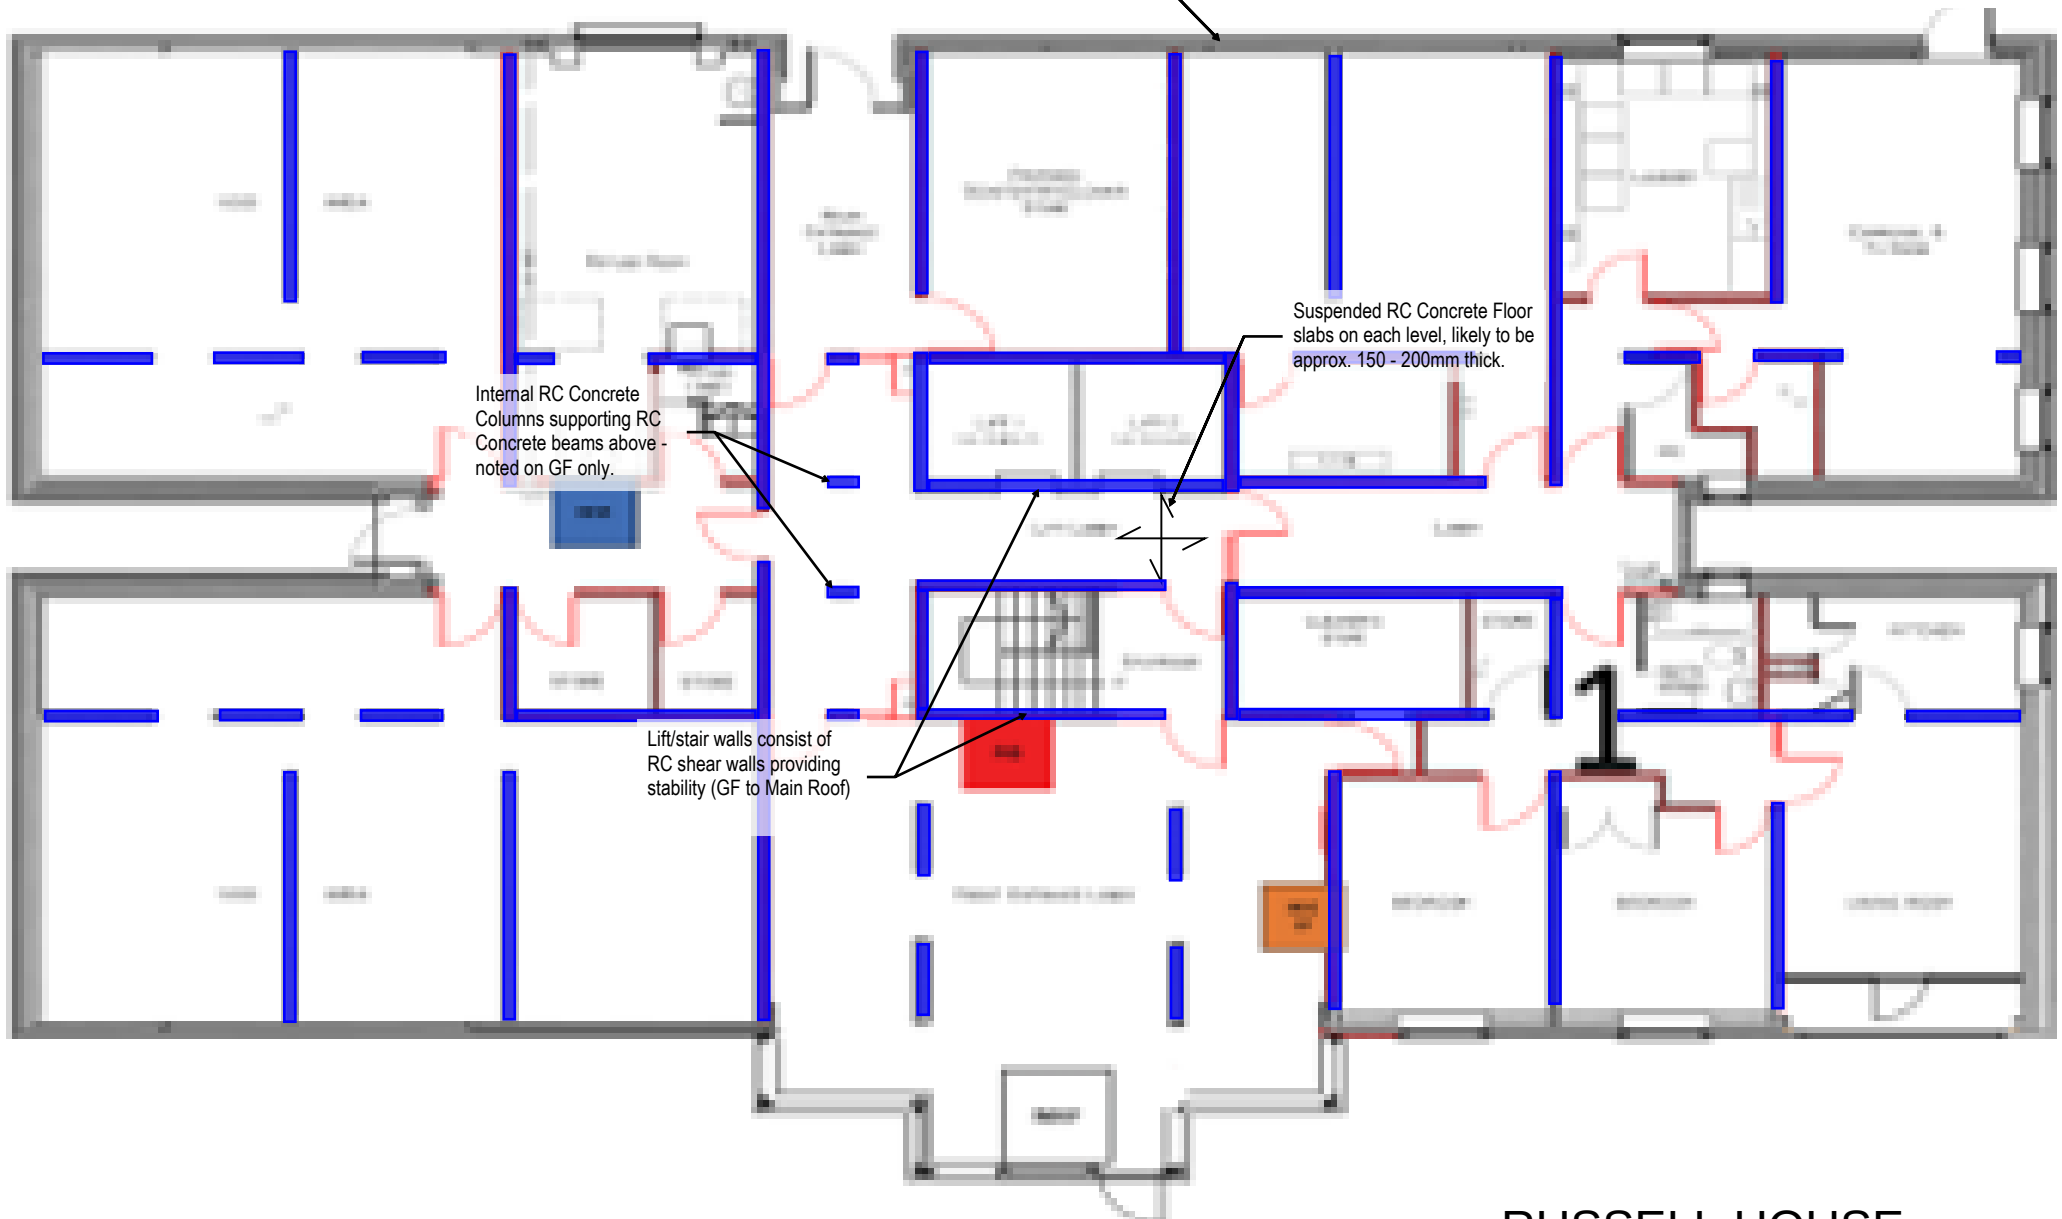
RUSSELL HOUSE  
TYPICAL FLOOR LAYOUT

RC Shear/Core Walls. Annotated on plan shown indicatively based on limited site observations and general floor plan arrangement. Likely other locations present where not shown on plan.
