**FIRNTEC**  
BUILDING COMPLIANCE

VISUAL STRUCTURAL APPRAISAL

Scott House  
Coniston Crescent  
Hamstead  
B43 5RD

27<sup>th</sup> May 2025

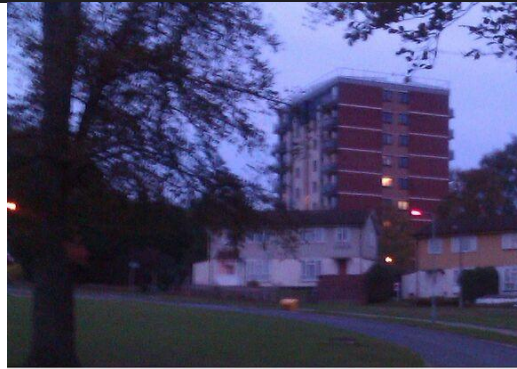
Figure 5. Archive photograph of Scotts House

Each floor has 4 cantilevering balconies in opposing corners of the block. These were not accessible however from inspection they have been cast as part of the main concrete slab.

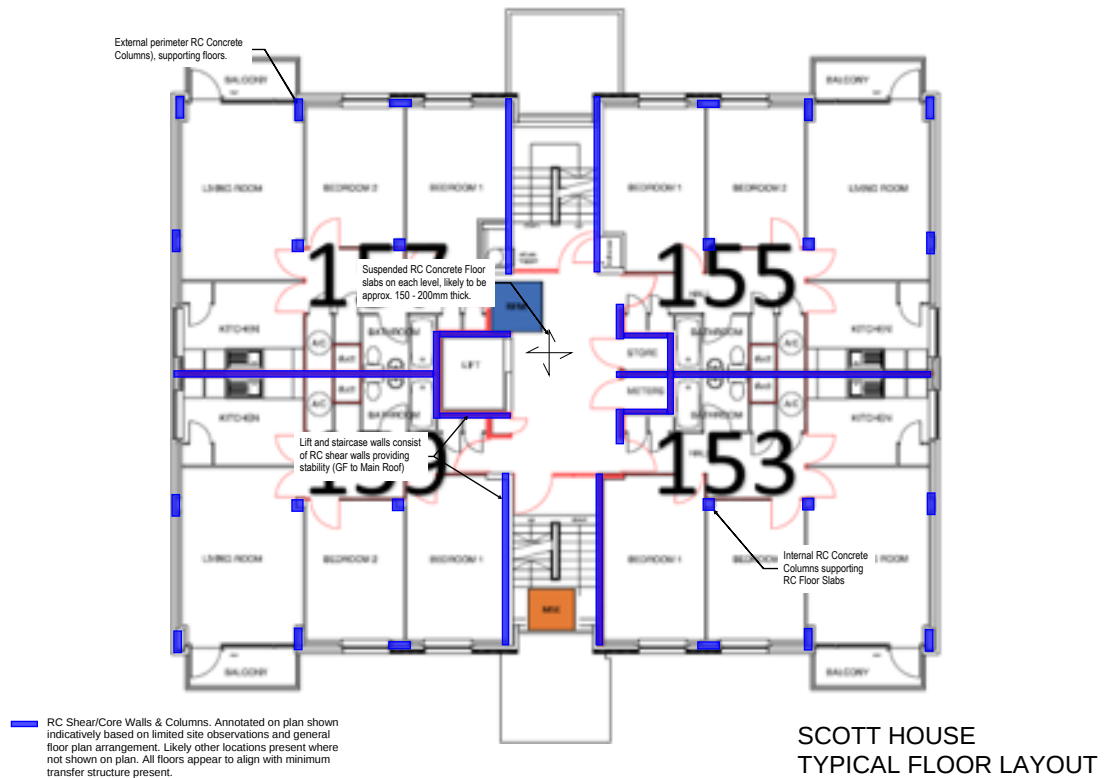
Figure 6: Diagram of typical floor plan

There were vertical concrete walls supporting the floor plates at every level. The elements visible matched the floor layout in Figure 6. The walls appear continuous from ground to roof with no transfer structure. The overall condition of the structure observed is good.

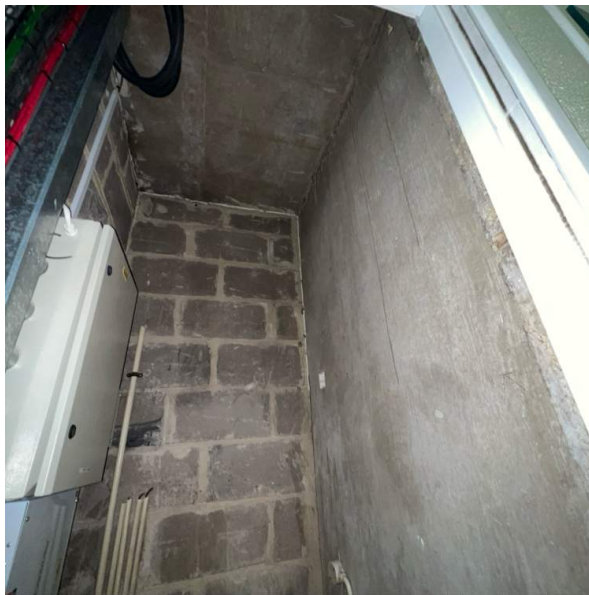
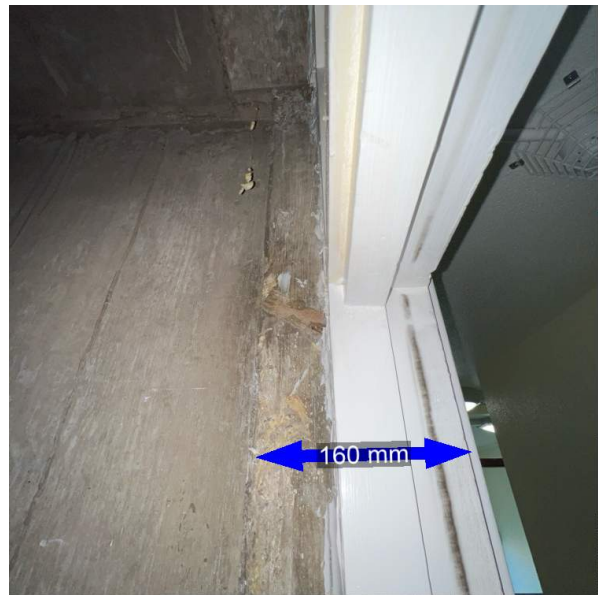
Comments: No jams or distortions noted to hallway doors to indicate any serviceability issues. Generally walls covered with finishes in hallway, likely to consist a mixture of concrete shear walls, embedded columns and masonry infill walls. Limited structure exposed. Concrete walls and infill masonry (non-load bearing) walls noted in riser cupboards and loft motor room. Concrete walls noted to be approx. 160mm thick.

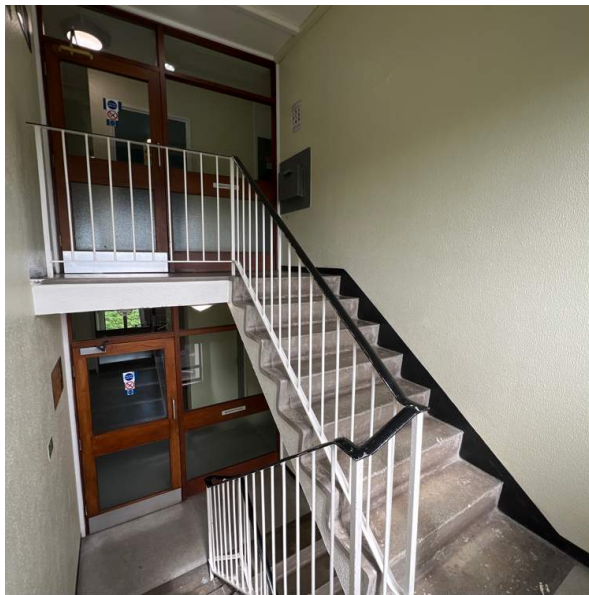
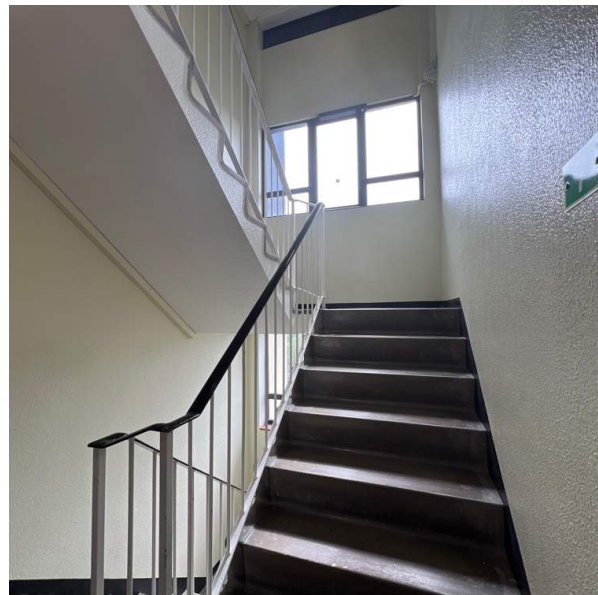
## 8th Floor Staircases

Comments: Insitu concrete stairs with steel hand railing fixed to stairs. Walls and floors appear to be fairly level.  
Stair walls covered with finishes however these would likely form the main concrete shear core walls.

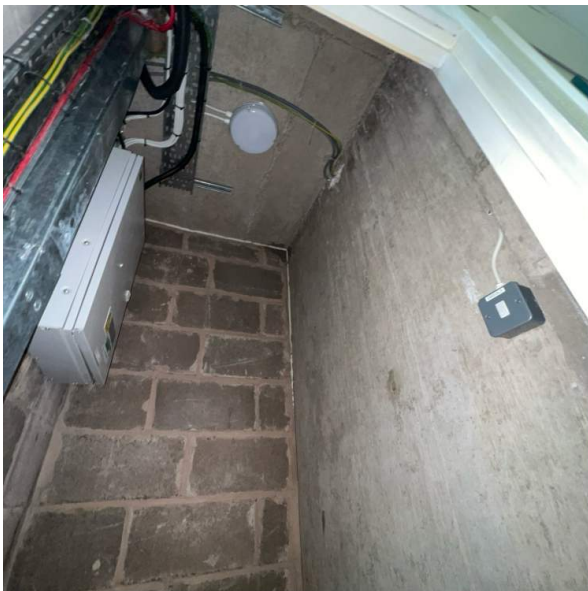
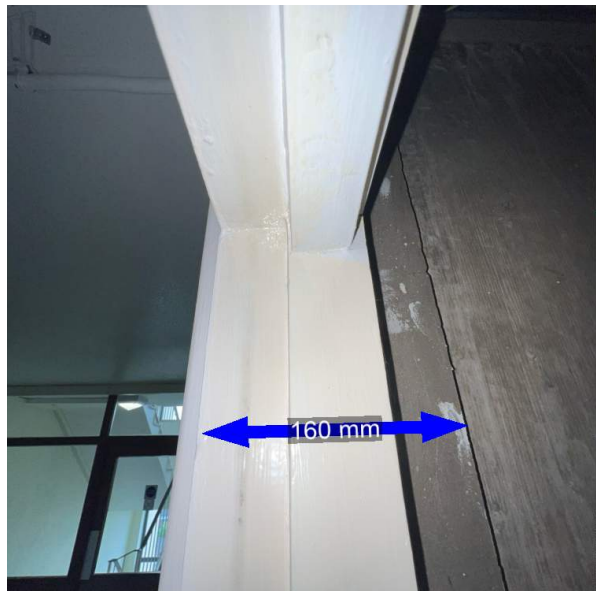
## 5th Floor Hallway

Comments: No jams or distortions noted to hallway doors to indicate any serviceability issues. Generally walls covered with finishes in hallway, likely to consist a mixture of concrete shear walls, embedded columns and masonry infill walls. Limited structure exposed. Concrete walls and infill masonry (non-load bearing) walls noted in riser cupboards. Concrete walls noted to be approx. 160mm thick.

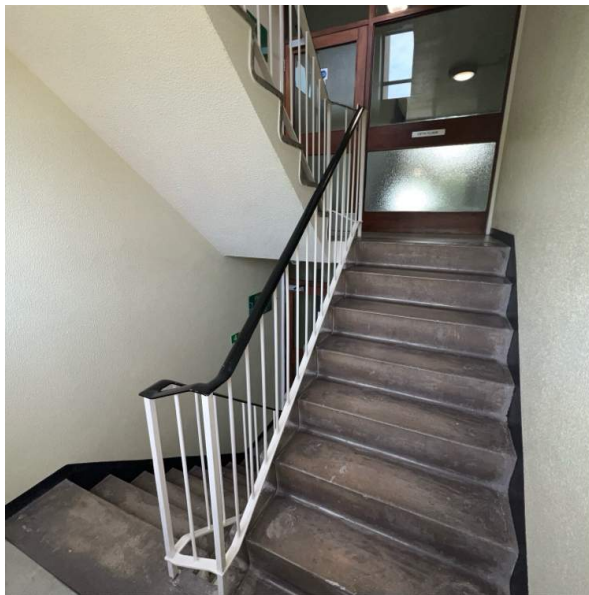
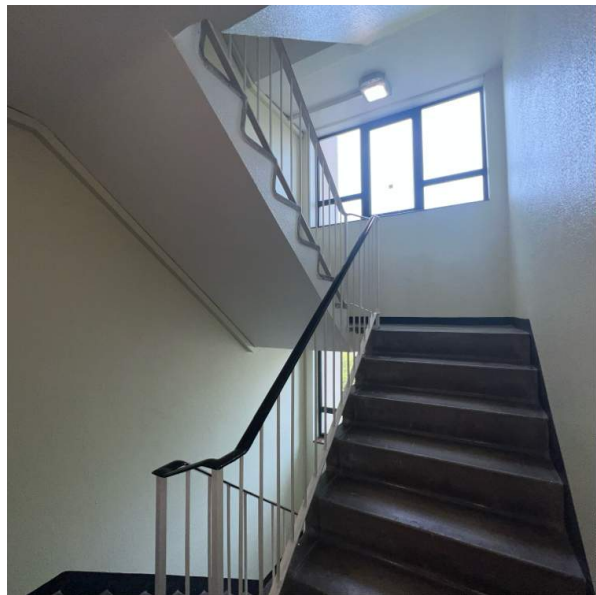
## 5th Floor Staircases

Comments: Insitu concrete stairs with steel hand railing fixed to stairs. Walls and floors appear to be fairly level.  
Stair walls covered with finishes however these would likely form the main concrete shear core walls.

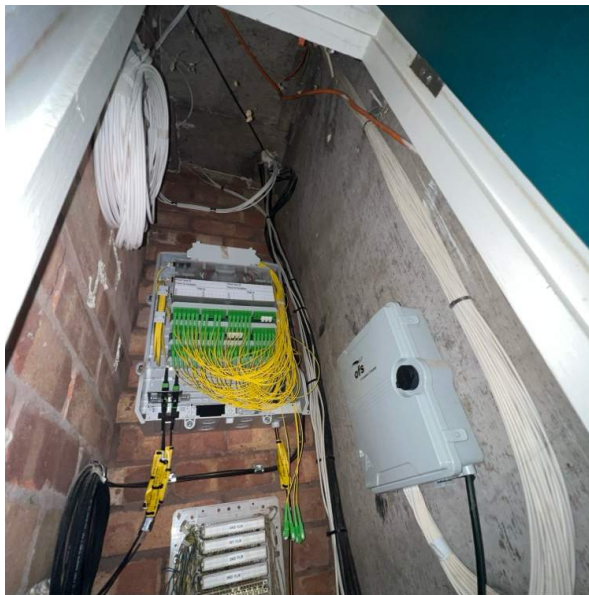
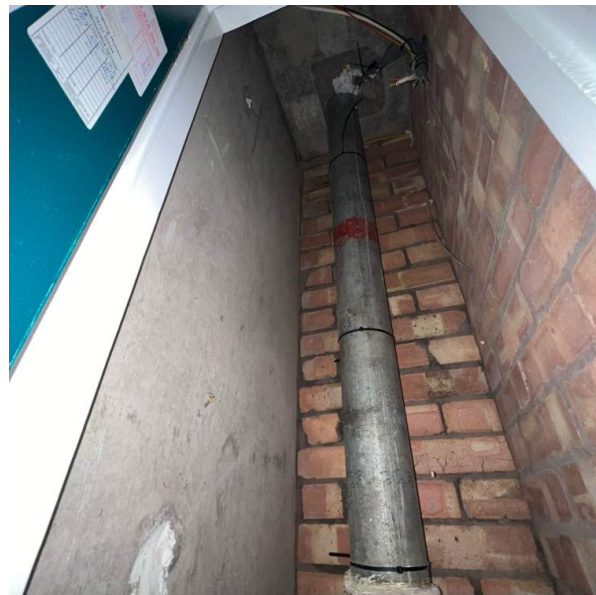
## Ground Floor Hallway

Comments: No jams or distortions noted to hallway doors to indicate any serviceability issues. Generally walls covered with finishes in hallway, likely to consist a mixture of concrete shear walls, embedded columns and masonry infill walls. Limited structure exposed. Concrete walls and infill masonry (non-load bearing) walls noted in riser cupboards.

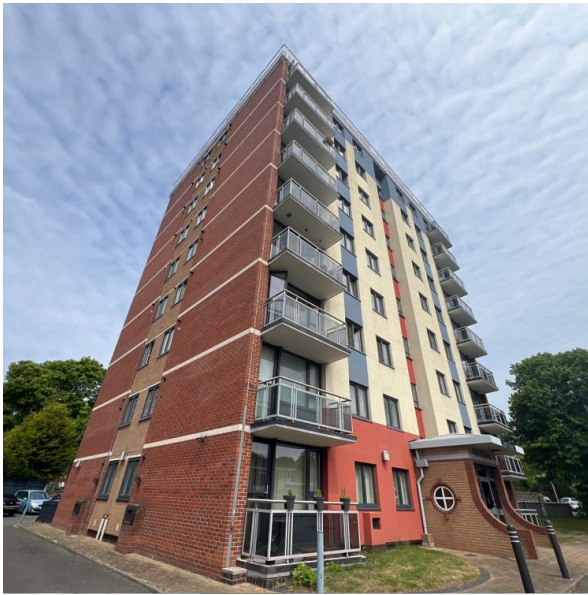
Comments: Front and rear elevations noted to have rendered facades. Side elevations consist of brickwork.  
Cantilevered balconies noted on each level.
