**FIRNTEC**  
BUILDING COMPLIANCE

VISUAL STRUCTURAL APPRAISAL

Sheapecoate House

31<sup>st</sup> January 2025

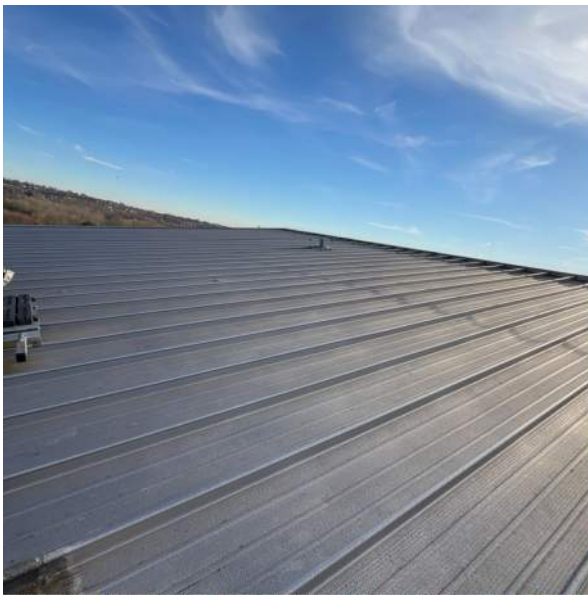
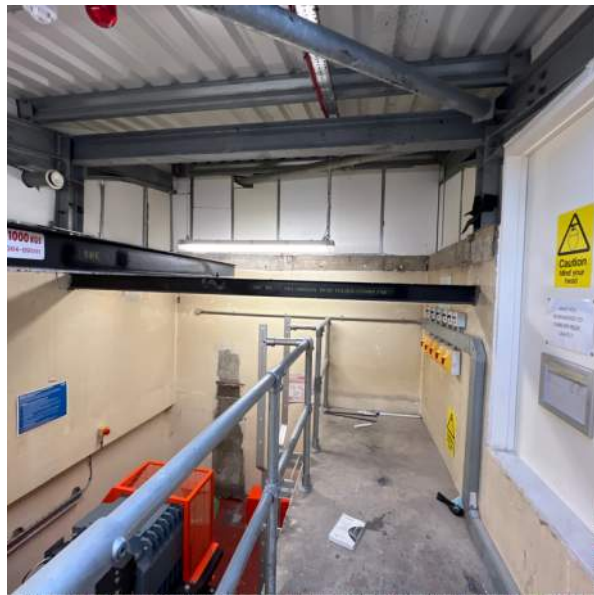
## Main Roof

Comments: A pitched roof constructed above existing original flat roof slab. Steel frame supporting purlins with aluminium standing / mineral wool core profiled panels.  
160mm thick RC core walls noted in motor room.

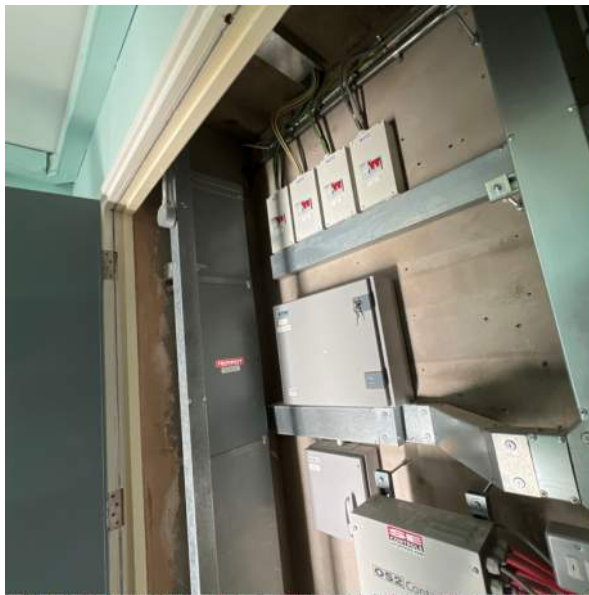
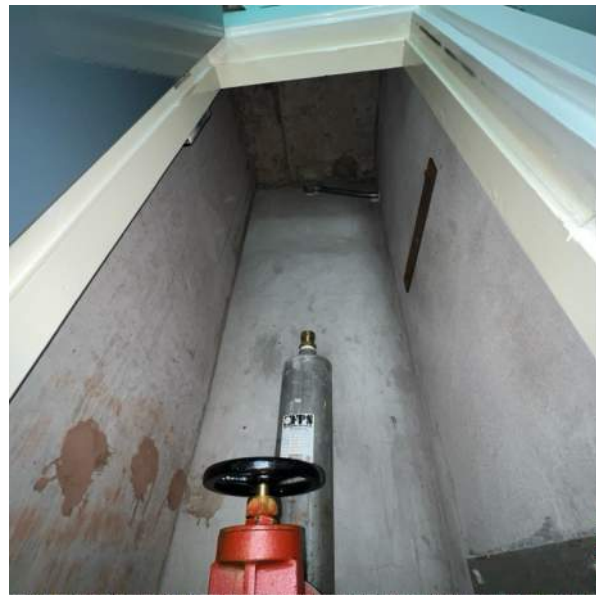
## 8th Floor Hallway

Comments: No jams or distortions noted to hallway doors to indicate any serviceability issues. Generally walls covered with finishes in hallway, likely to consist a mixture of concrete shear walls, embedded columns and masonry infill walls. Limited structure exposed. Concrete walls noted via riser cupboards.

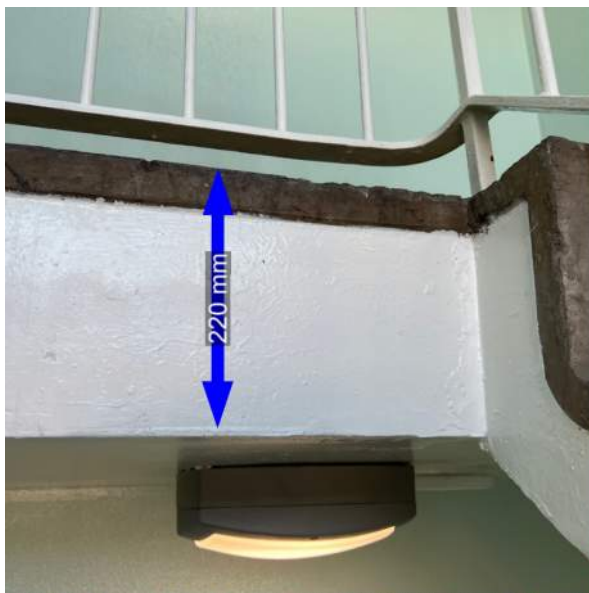
## 8th Floor Staircases

Comments: Insitu concrete stairs with steel hand railing fixed to stairs. Walls and floors appear to be fairly level.  
Stair walls covered with finishes however these would likely form the main concrete shear core walls. Partly infill/non-load bearing wall noted for one side of stair case wall.

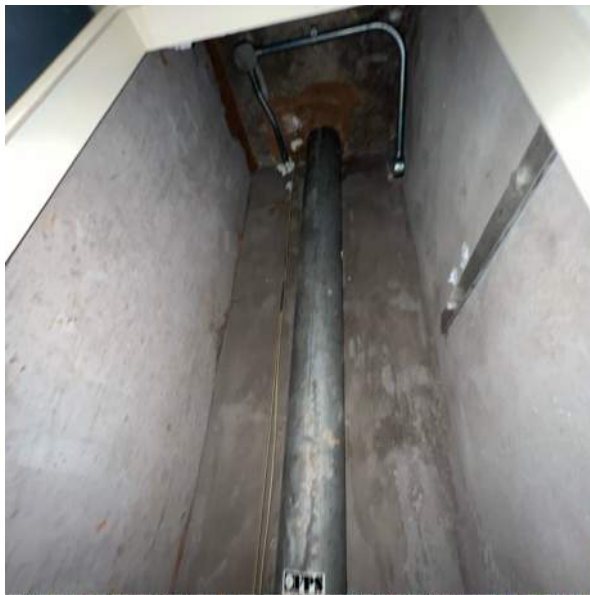
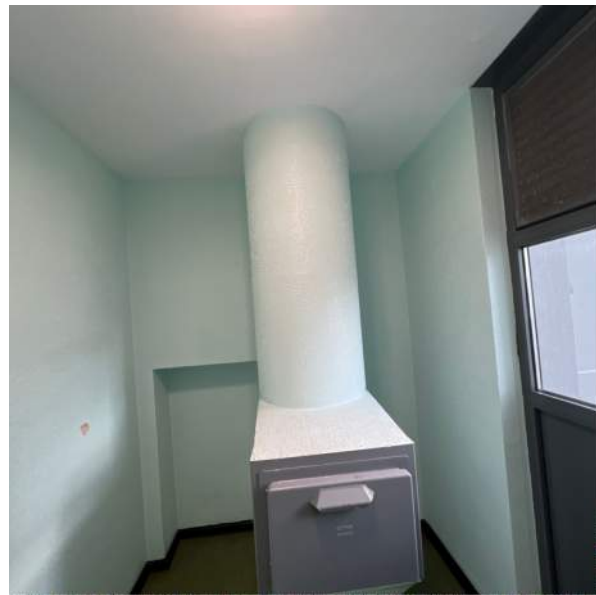
## 5th Floor Hallway

Comments: No jams or distortions noted to hallway doors to indicate any serviceability issues. Generally walls covered with finishes in hallway, likely to consist a mixture of concrete shear walls, embedded columns and masonry infill walls. Limited structure exposed. Concrete walls noted via riser cupboards.

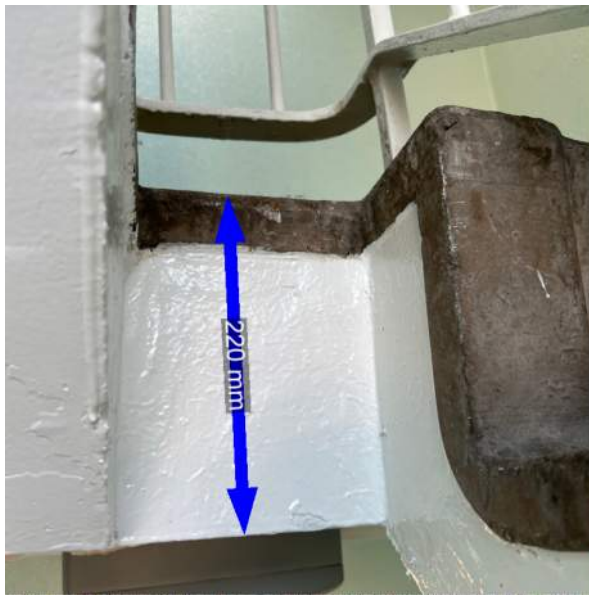
## 5th Floor Staircases

Comments: Insitu concrete stairs with steel hand railing fixed to stairs. Walls and floors appear to be fairly level.  
Stair walls covered with finishes however these would likely form the main concrete shear core walls. Partly infill/non-load bearing wall noted for one side of stair case wall.

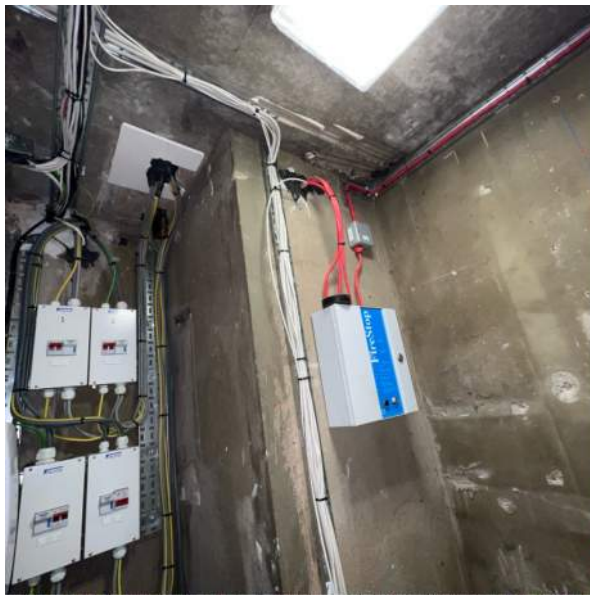
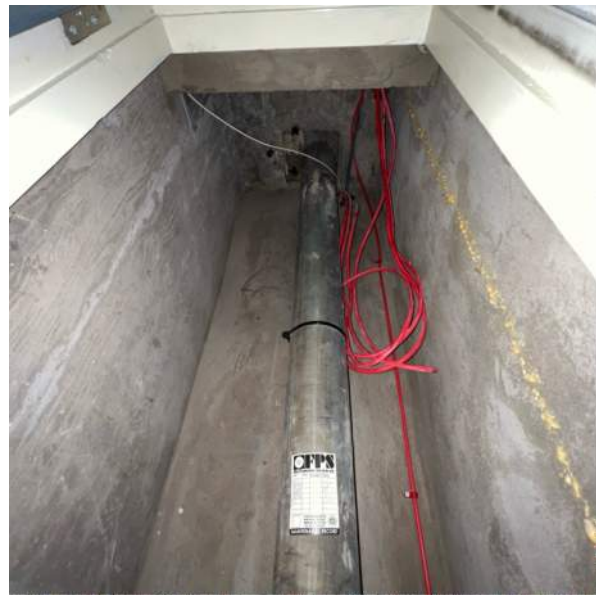
## Ground Floor Hallway

Comments: No jams or distortions noted to hallway doors to indicate any serviceability issues. Generally walls covered with finishes in hallway, likely to consist a mixture of concrete shear walls, embedded columns and block infill walls. Limited structure exposed. Partly visible concrete walls noted via electrical riser cupboards.

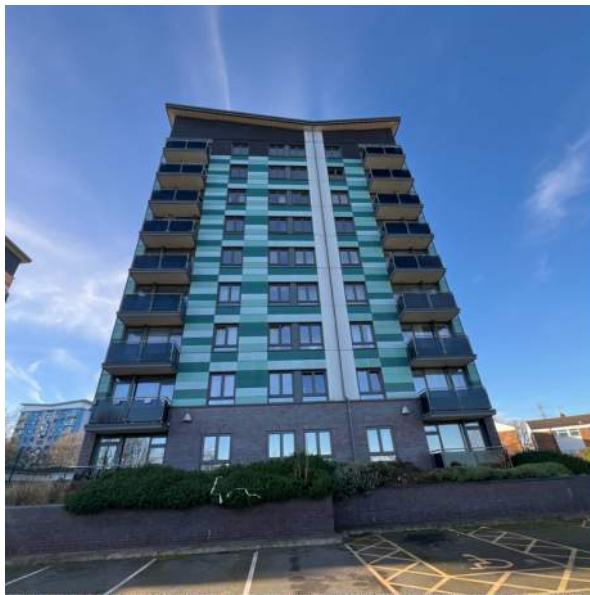
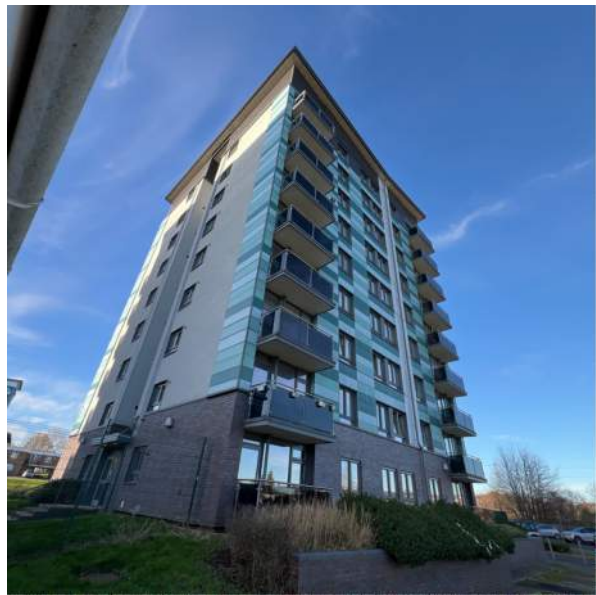
Ground floor level consists of brickwork. Remaining elevations consist of a mixture of rendered and cladded facade.
