VISUAL STRUCTURAL APPRAISAL

St Clements House

Hallam St  
West Bromwich  
B71 4HB

26<sup>th</sup> February 2025

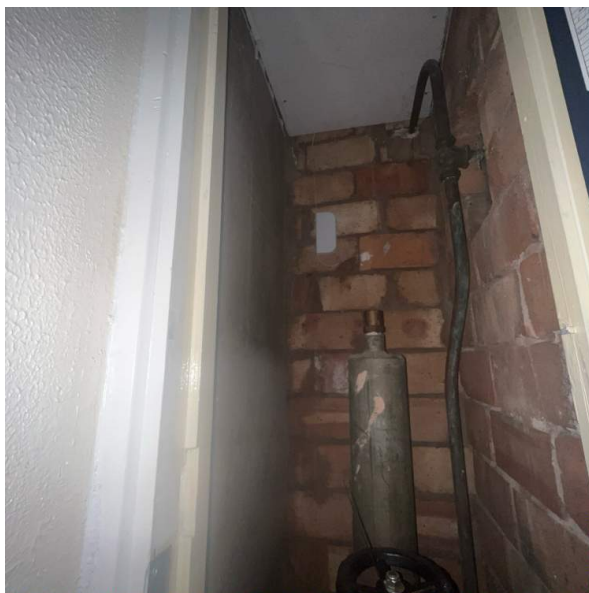
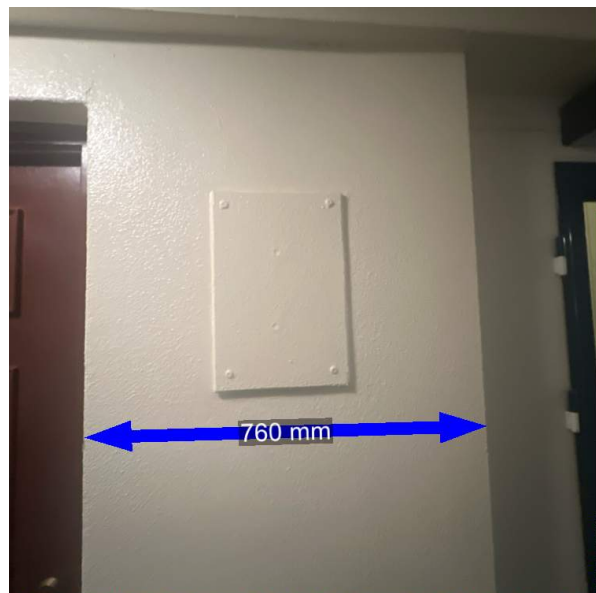
Comments: No jams or distortions noted to hallway doors to indicate any serviceability issues. Generally walls covered with finishes in hallway, likely to consist a mixture of concrete shear walls, embedded columns and masonry infill walls. Limited structure exposed. Concrete walls noted via riser cupboard and lift motor room.

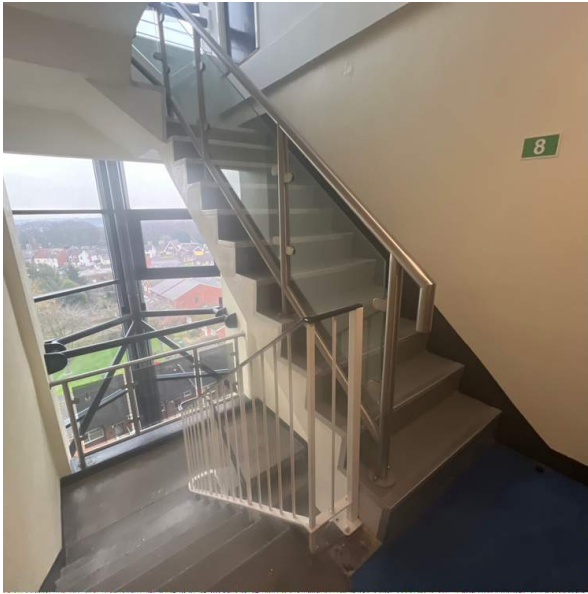
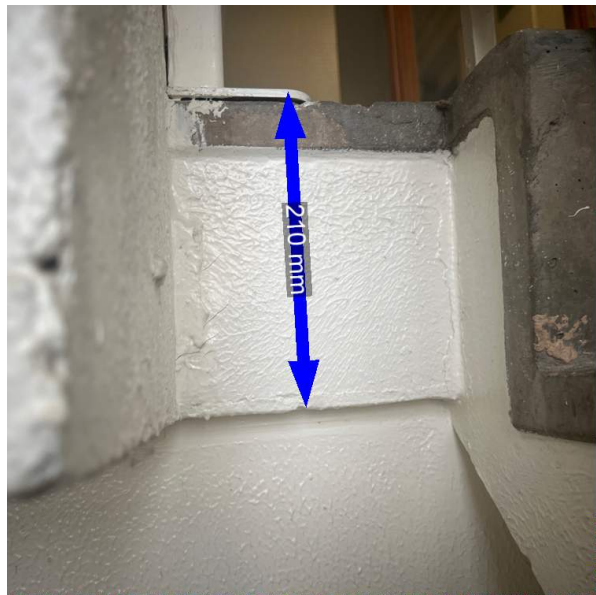
## 9th Floor Staircases

Comments: 2 sets of staircases present. Insitu concrete stairs with steel hand railing fixed to stairs. Walls and floors appear to be fairly level. Stair walls covered with finishes however these would likely form the main concrete shear core walls. A set of steel stairs also present leading to roof level.

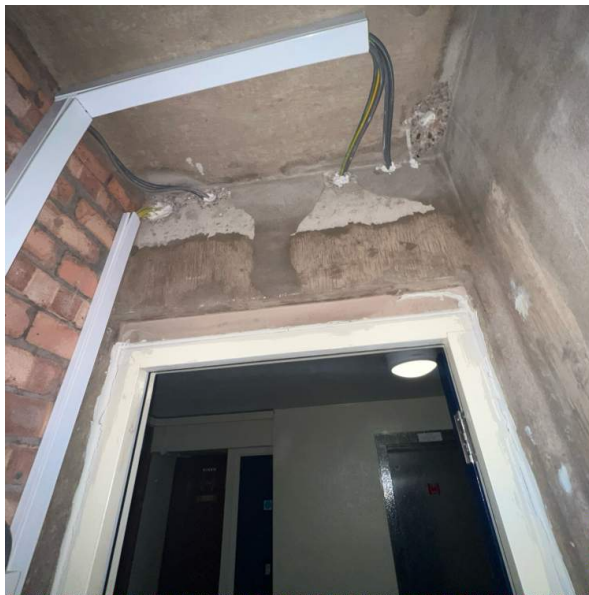
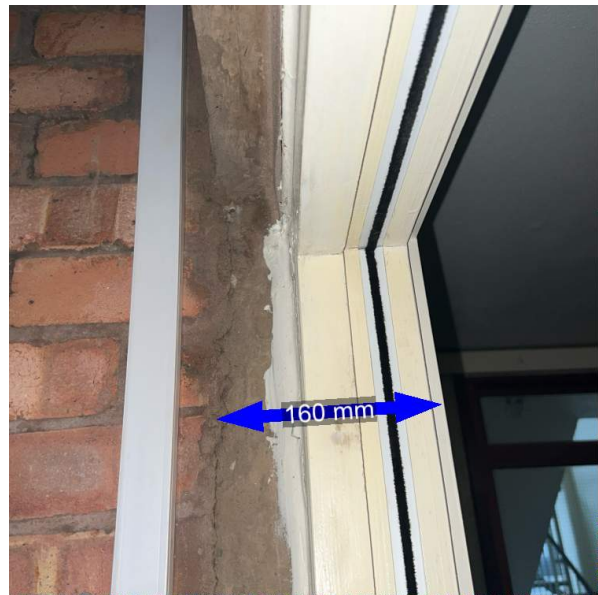
## 5th Floor Hallway

Comments: No jams or distortions noted to hallway doors to indicate any serviceability issues. Generally walls covered with finishes in hallway, likely to consist a mixture of concrete shear walls, embedded columns and masonry infill walls. Limited structure exposed. Concrete walls noted via riser cupboard. Lift walls appear to be solid concrete walls.

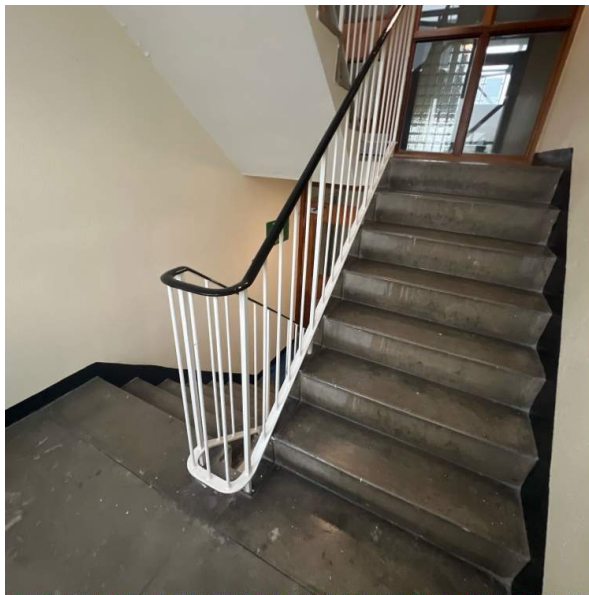
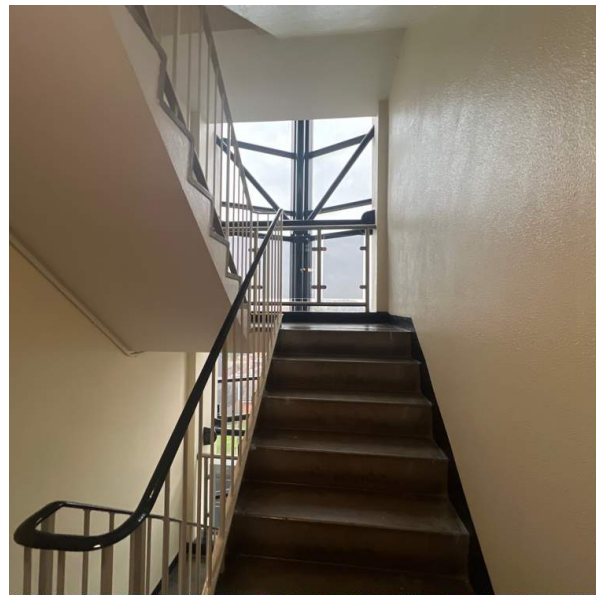
## 5th Floor Staircases

2 sets of staircases present. Insitu concrete stairs with steel hand railing fixed to stairs. Walls and floors appear to be fairly level. Stair walls covered with finishes however these would likely form the main concrete shear core walls.

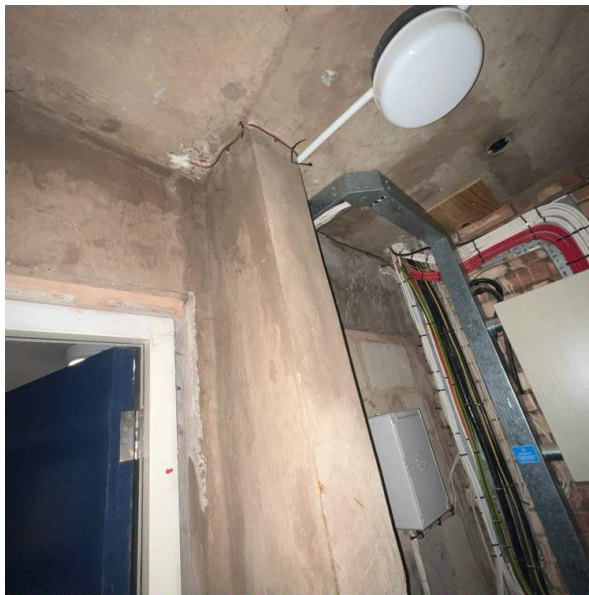
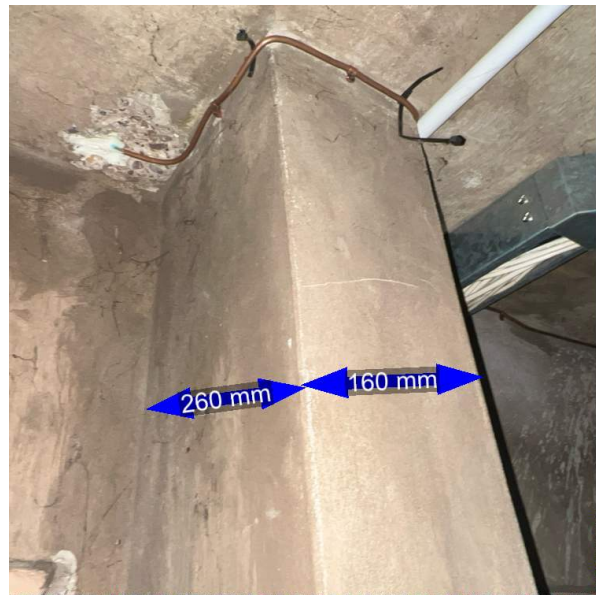
Comments: No jams or distortions noted to hallway doors to indicate any serviceability issues. Generally walls covered with finishes in hallway, likely to consist a mixture of concrete shear walls, embedded columns and block infill walls. Limited structure exposed. Partly visible concrete walls noted via electrical riser cupboard. RC columns noted in electric cupboard.

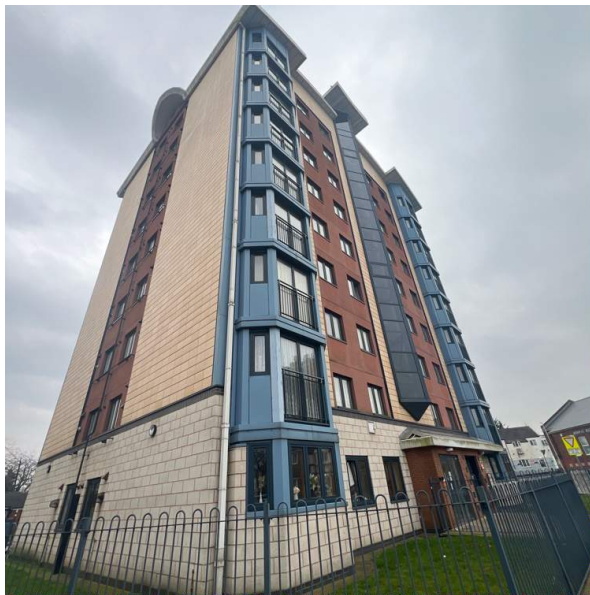
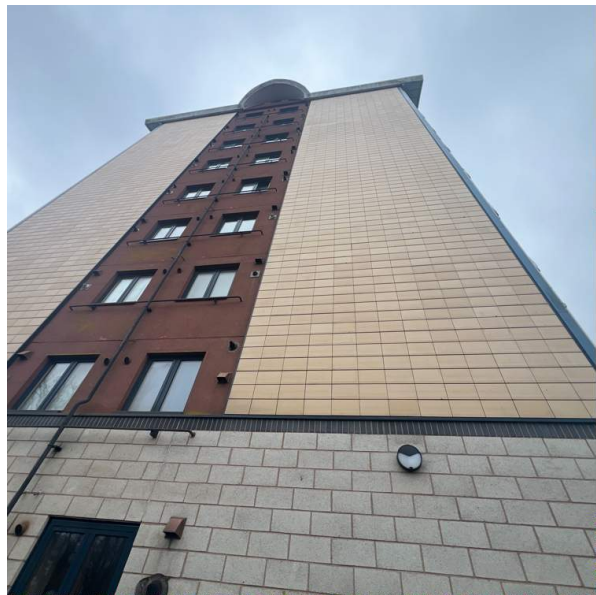
External facade consist of blockwork to the ground floor level. All other levels consist of a mixture of render, tiles and aluminium panel cladding and encased balconies.

External perimeter RC Concrete Columns), supporting floors.

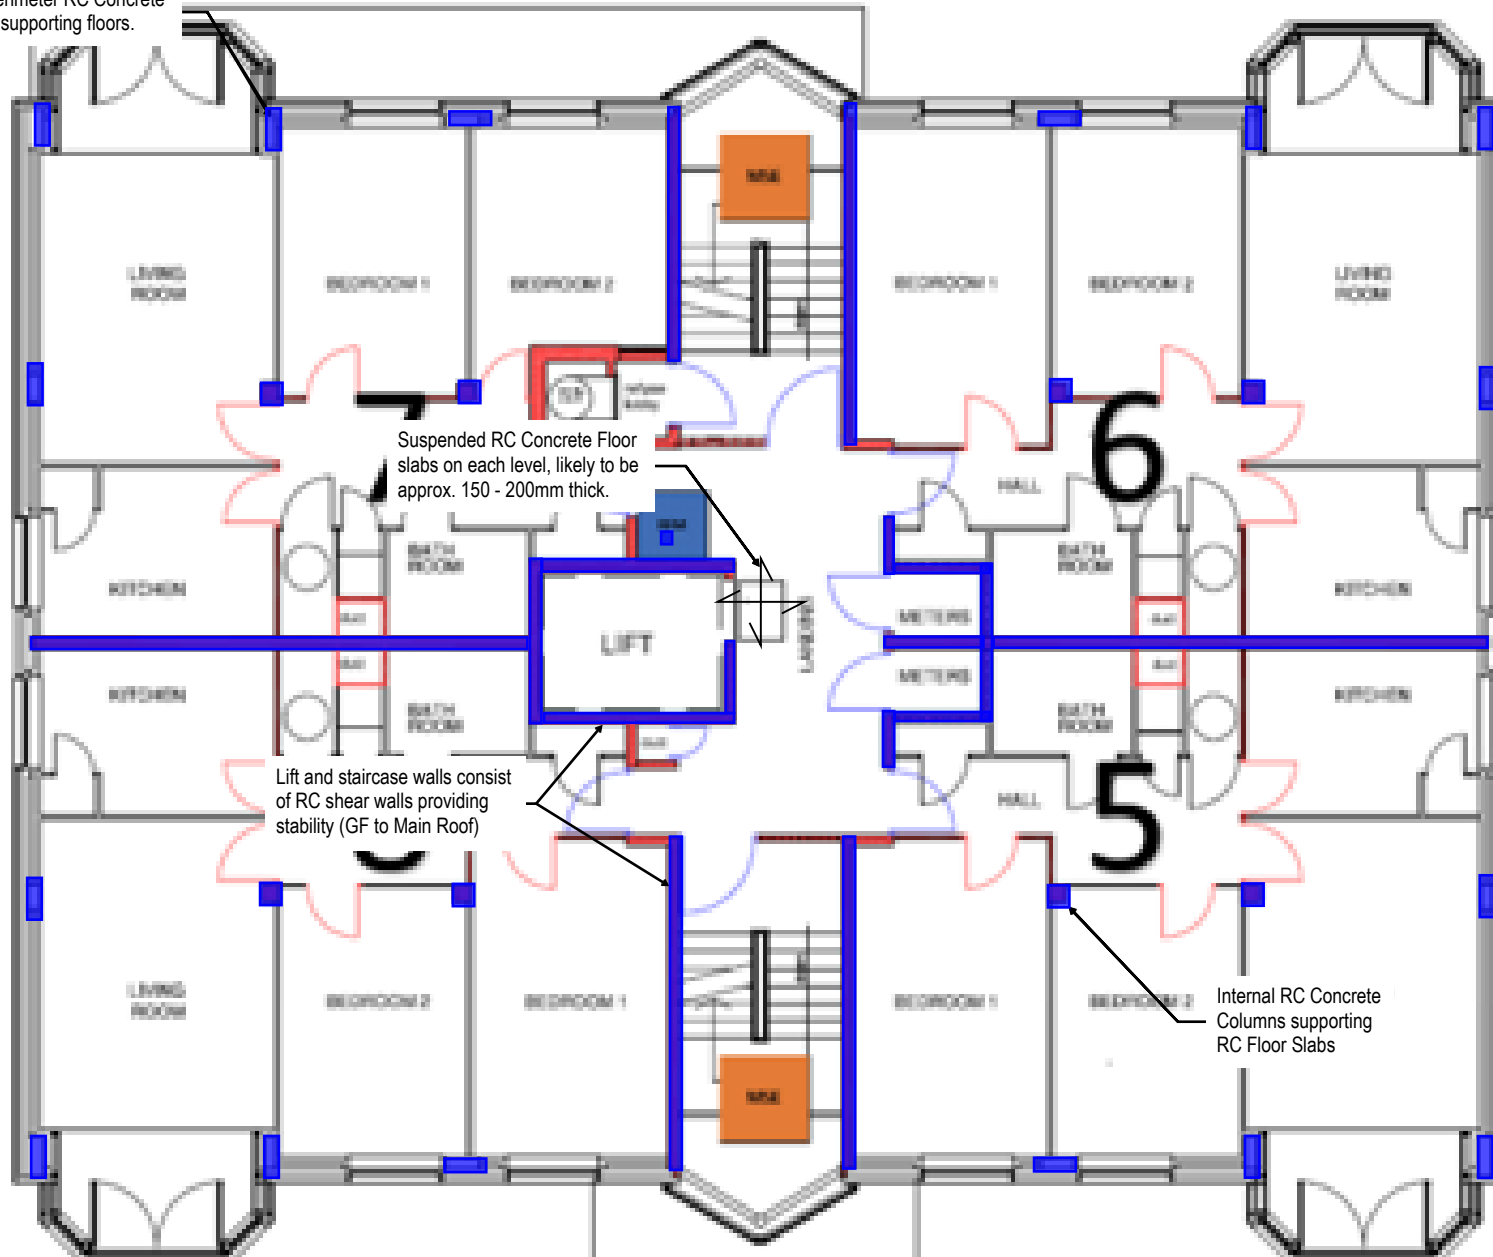
## ST CLEMENTS HOUSE TYPICAL FLOOR LAYOUT

RC Shear/Core Walls & Columns. Annotated on plan shown indicatively based on limited site observations and general floor plan arrangement. Likely other locations present where not shown on plan. All floors appear to align with minimum transfer structure present.
