VISUAL STRUCTURAL APPRAISAL

St Giles Court

Reservoir Road  
Rowley Regis  
B65 9PE

21<sup>st</sup> November 2024

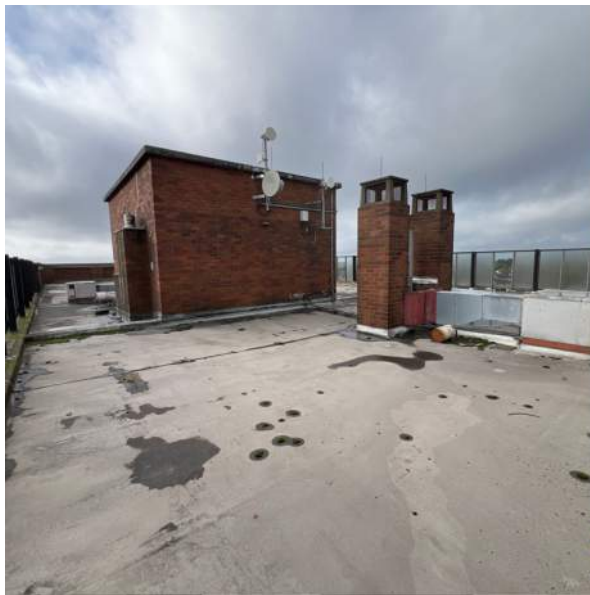
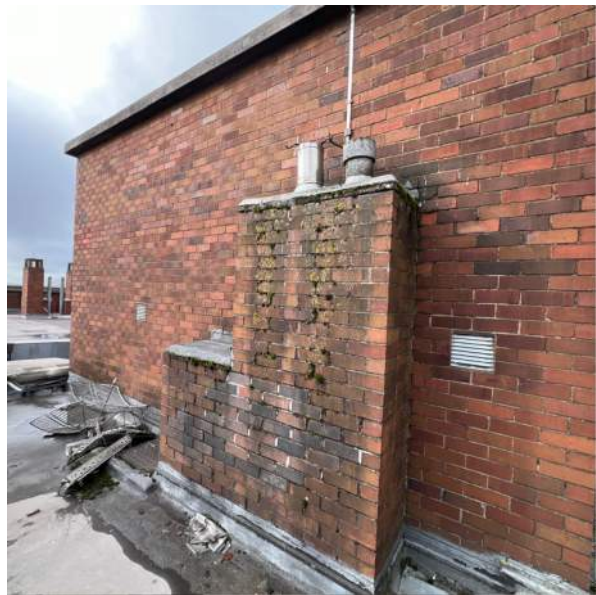
## Main Roof

Parapet walls noted to perimeter of roof.  
Insitu concrete roof slab. Masonry lift room located at roof level.

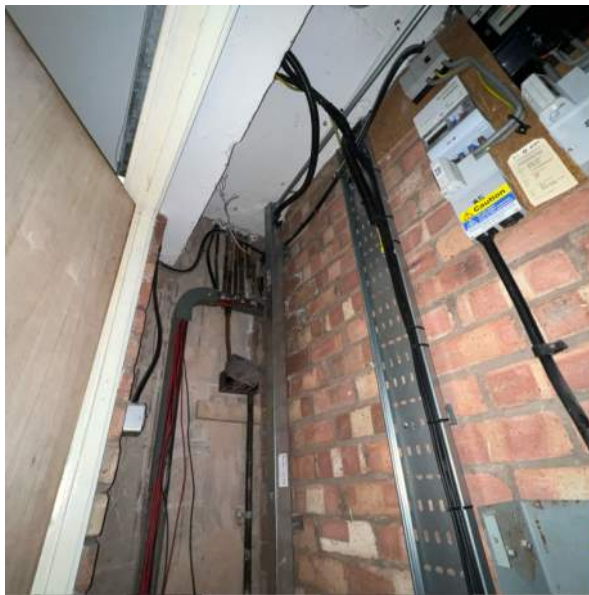
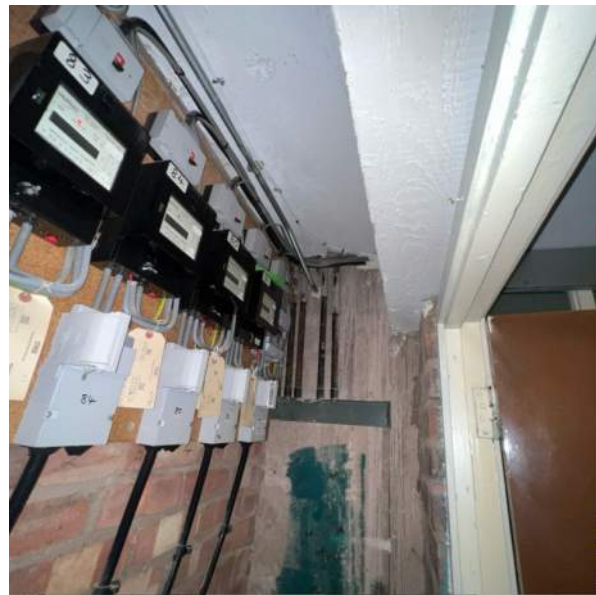
Comments: No jams or distortions noted to hallway doors to indicate any serviceability issues. Generally walls covered with finishes in hallway, likely to consist a mixture of concrete shear walls, embedded columns and block infill walls. Limited structure exposed. Partly visible concrete walls noted via electrical riser cupboards

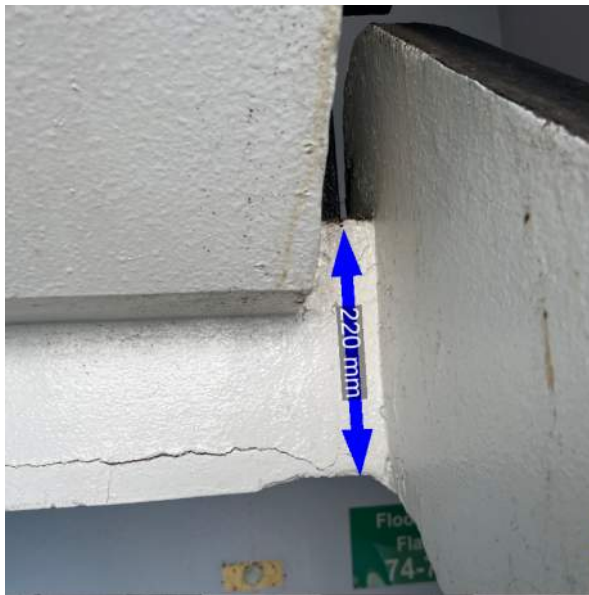
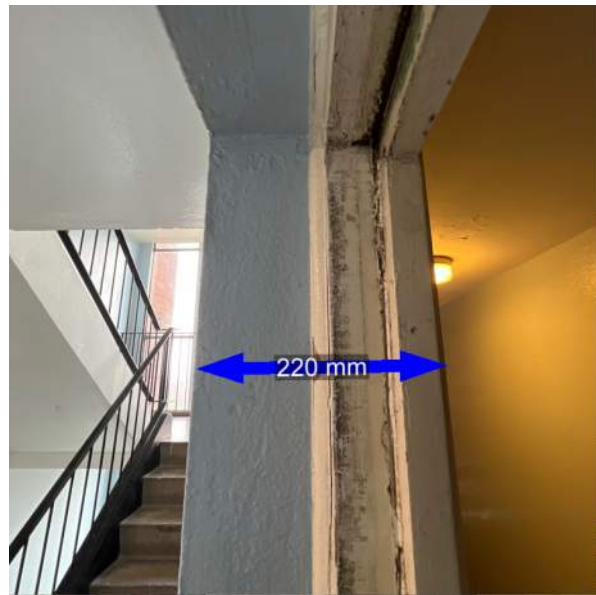
## 13th Floor Staircase

Insitu concrete stairs with steel hand railing fixed to stairs. Walls and floors appear to be fairly level.

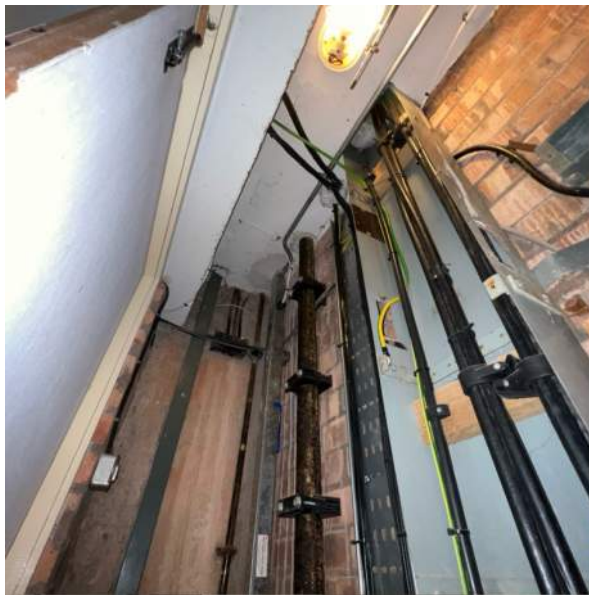
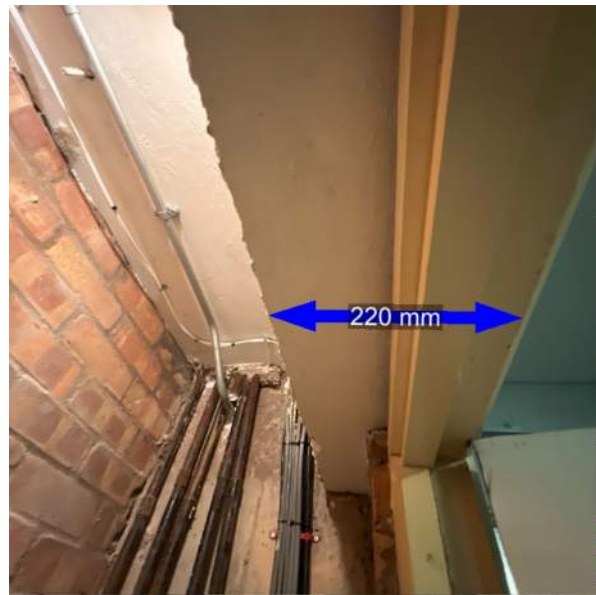
## 8th Floor Hallway

Comments: No jams or distortions noted to hallway doors to indicate any serviceability issues. Generally walls covered with finishes in hallway, likely to consist a mixture of concrete shear walls, embedded columns and block infill walls. Limited structure exposed. Partly visible concrete walls noted via electrical riser cupboards

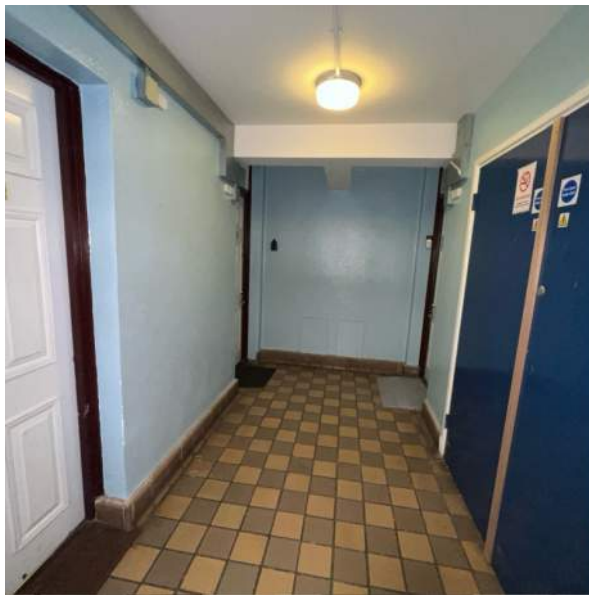
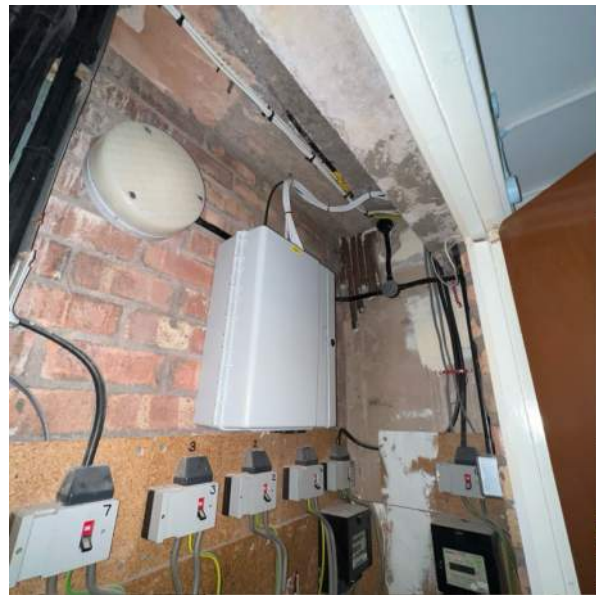
## Ground Floor Hallway

Comments: No jams or distortions noted to hallway doors to indicate any serviceability issues. Generally walls covered with finishes in hallway, likely to consist a mixture of concrete shear walls, embedded columns and block infill walls. Limited structure exposed. Partly visible concrete walls noted via electrical riser cupboards. RC Columns noted in hallway.

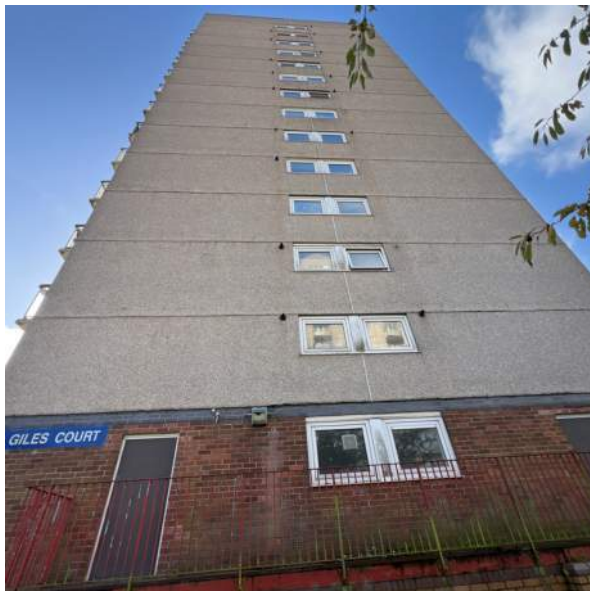
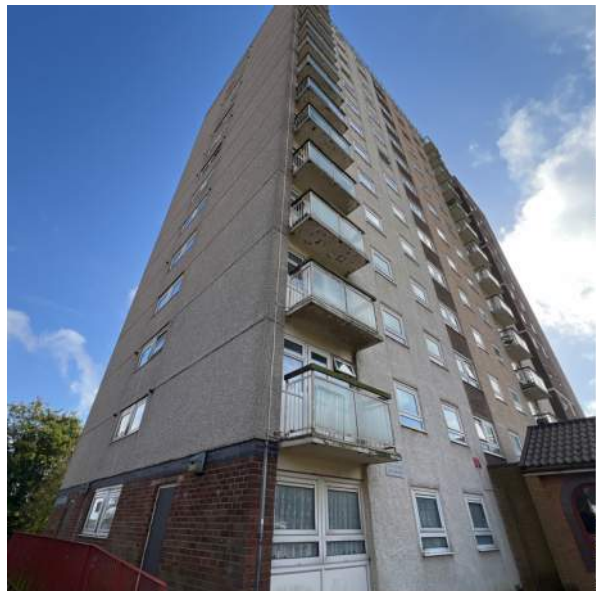
External facade consists of brickwork and render. Brickwork supported via floor slab at each level.
