VISUAL STRUCTURAL APPRAISAL

St Marys House

Summer Street  
West Bromwich  
B71 4HZ

31<sup>st</sup> July 2024

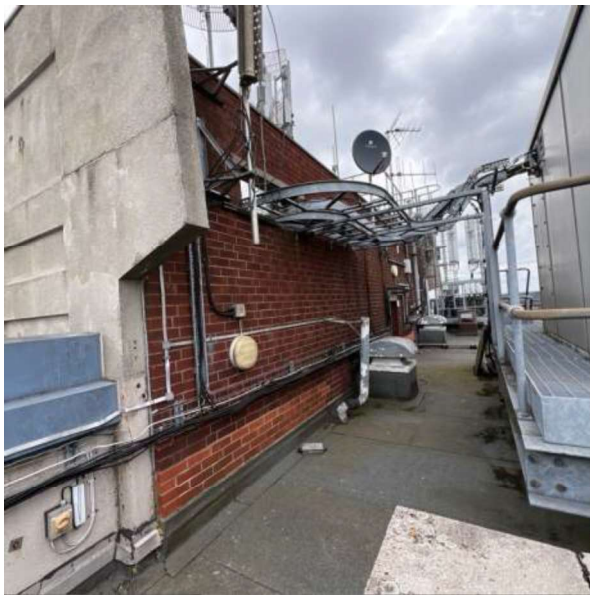
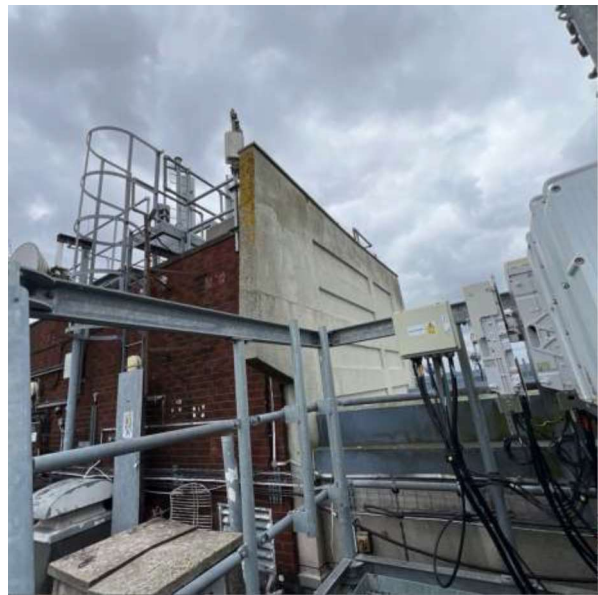
## Main Roof

Lift motor room located on roof formed of masonry walls.  
Parapet walls noted to perimeter of roof.  
Insitu concrete roof slab with insulated PIR Boad and felt roof coverings.

The roof has a felt finish. The exact build-up of the roof finishes were not accessible at the time of inspection. It is recommended an intrusive survey of the roof finishes is completed by a specialist surveyor to assess the condition of the roof covering.

There was moss growth and build-ups of debris noted which should be cleared as part of a normal maintenance regimen

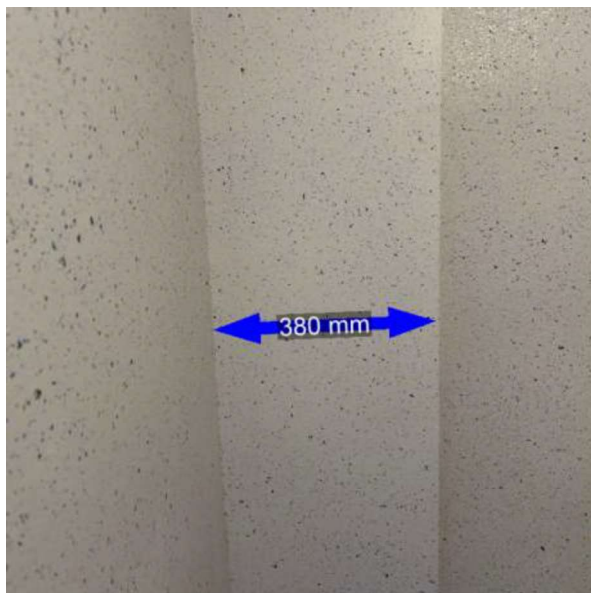
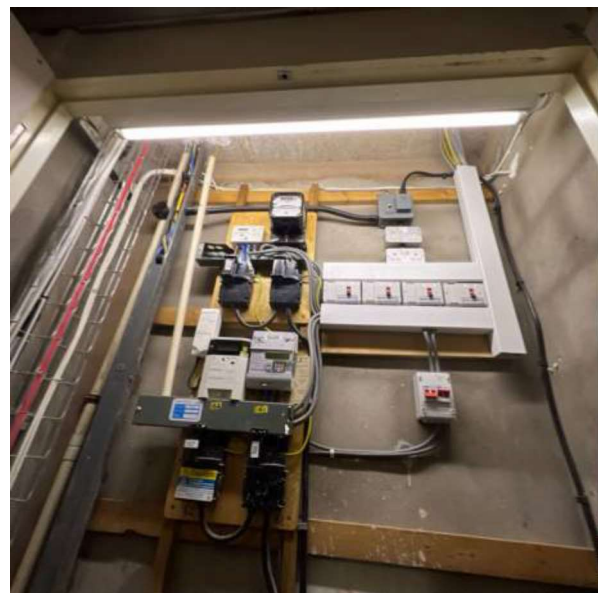
Comments: No jams or distortions noted to hallway doors to indicate any serviceability issues. Generally walls covered with finishes in hallway, likely to consist a mixture of concrete shear walls, embedded columns and block infill walls. Electrical cabinet shows infill blockwork with render on top. Dry riser cupboard shows some exposed concrete (likely forms part of the staircase shear wall).

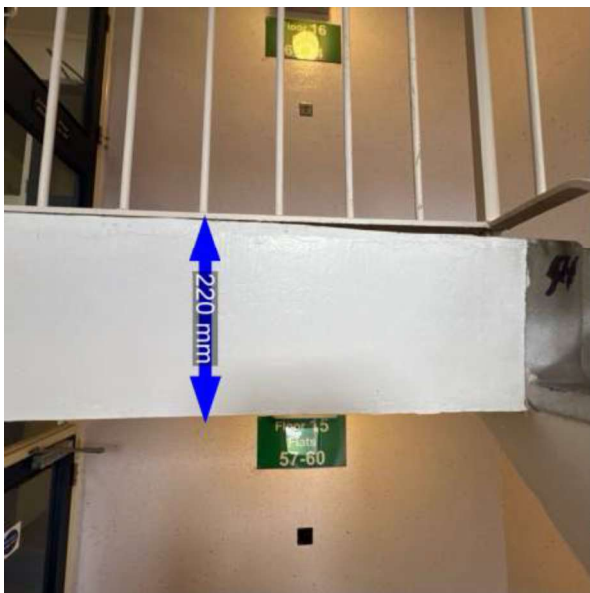
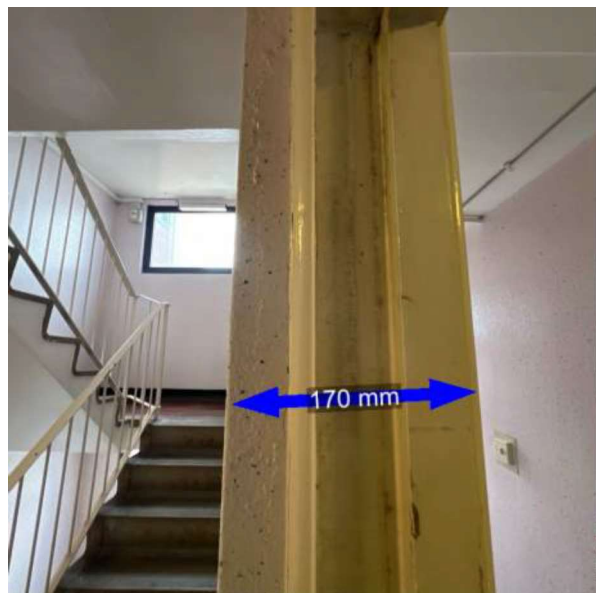
## 16th Floor Staircase

In situ concrete stairs with steel hand railing fixed to stairs. Walls and floors appear to be fairly level.

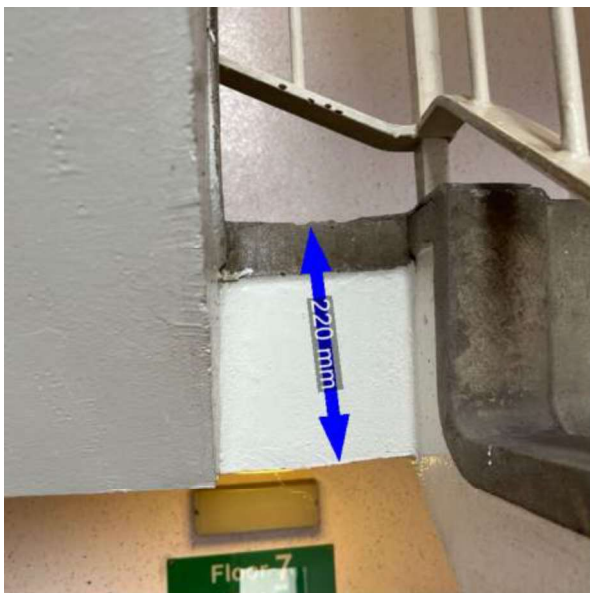
Insitu concrete stairs with steel hand railing fixed to stairs. Walls and floors appear to be fairly level.

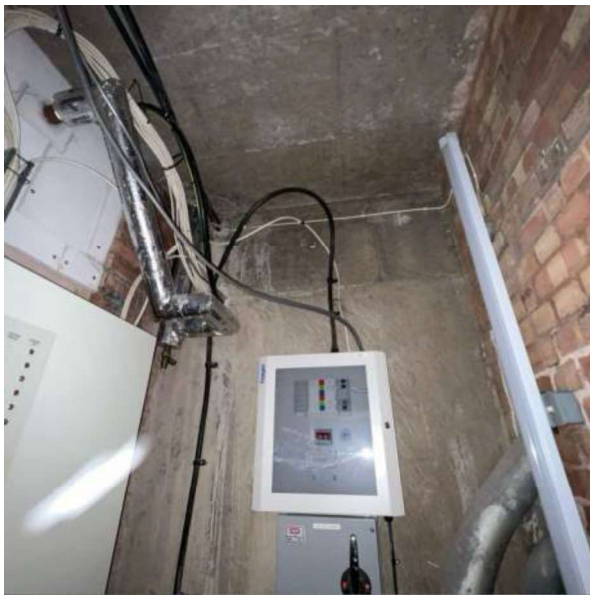
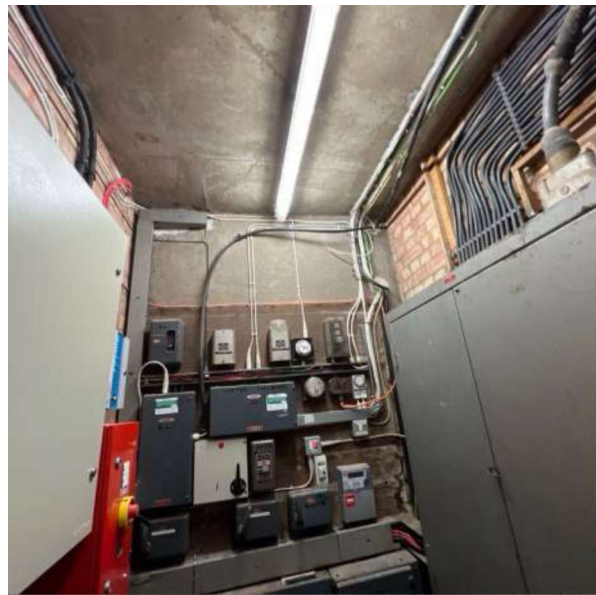
## Ground Floor Hallway

Comments: No jams or distortions noted to hallway doors to indicate any serviceability issues. Generally walls covered with finishes in hallway, likely to consist a mixture of concrete shear walls, embedded columns and block infill walls. RC Concrete Shear Core wall of lift visibly noted from riser cupboard and meterage room. Other internal main walls noted to solid concrete walls, these are likely to be shear core walls forming part of the primary structural elements.

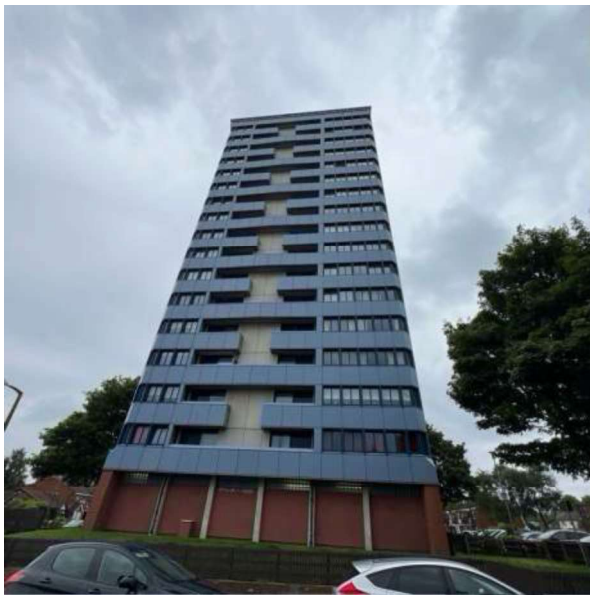
Two faces of exterior formed of brickwork facade whilst the other two faces have a cladded facade. Balconies inset to cladding.  
Concrete columns (300mm wide) noted to perimeter which form part of the primary structural elements of the building.  
Staircase exterior appears to have a concrete panel facade feature.
