VISUAL STRUCTURAL APPRAISAL

Stanton House

Beaconview Road  
West Bromwich  
B71 3PW

26<sup>th</sup> February 2025

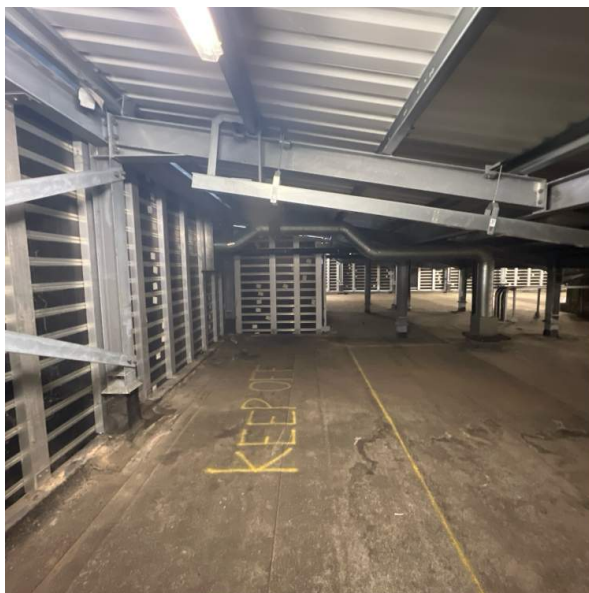
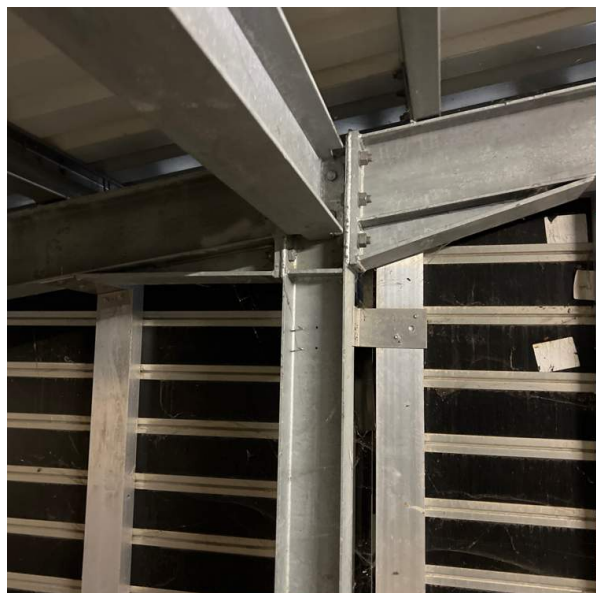
## Main Roof

Comments: A pitched roof constructed above existing original flat roof slab. Steel frame supporting purlins with aluminium standing / mineral wool core profiled panels.  
160mm thick RC core walls noted in motor room.

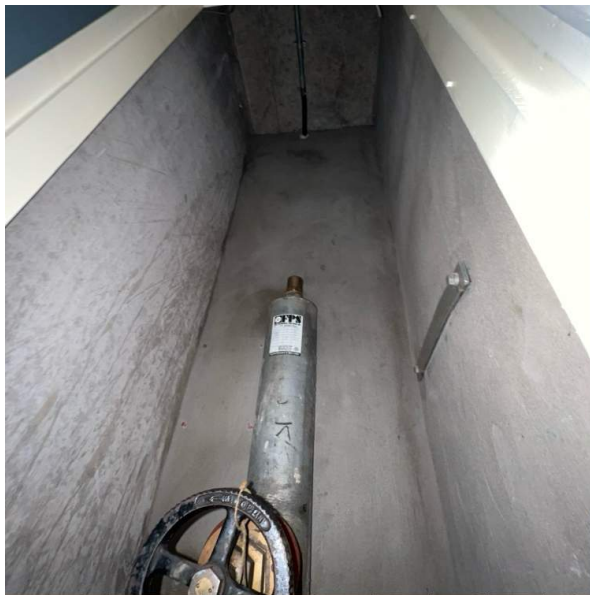
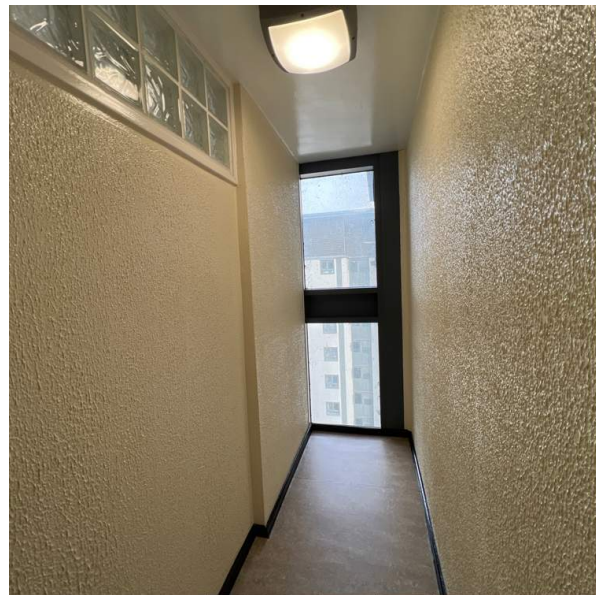
## 8th Floor Hallway

Comments: No jams or distortions noted to hallway doors to indicate any serviceability issues. Generally walls covered with finishes in hallway, likely to consist a mixture of concrete shear walls, embedded columns and masonry infill walls. Limited structure exposed. Concrete walls noted via dry riser cupboards. Electrical cupboard shows block infill walls with plaster.

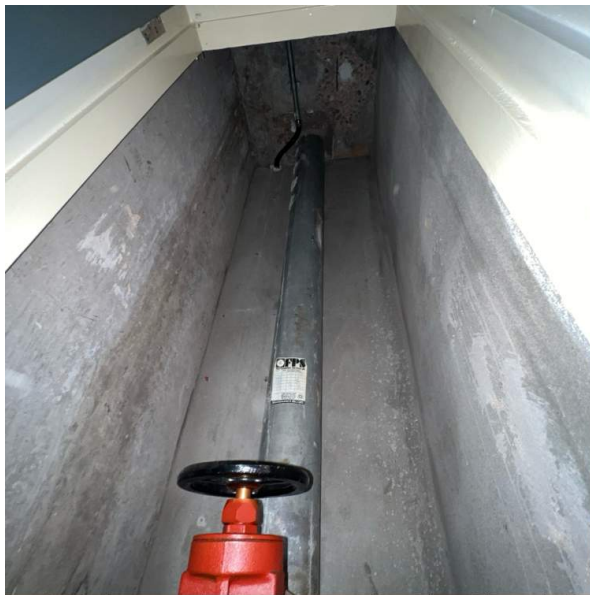
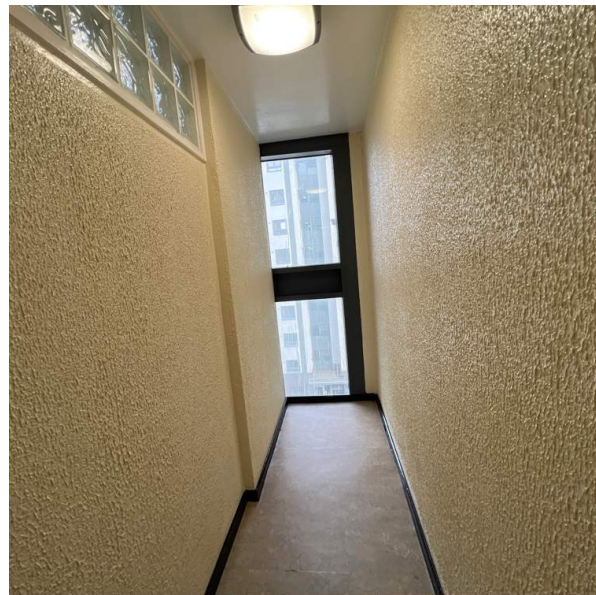
## 5th Floor Hallway

Comments: No jams or distortions noted to hallway doors to indicate any serviceability issues. Generally walls covered with finishes in hallway, likely to consist a mixture of concrete shear walls, embedded columns and masonry infill walls. Limited structure exposed. Concrete walls noted via dry riser cupboards. Electrical cupboard shows block infill walls with plaster.

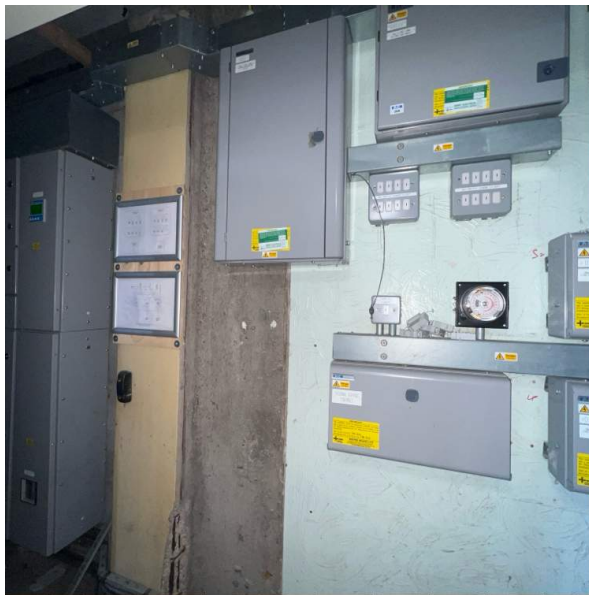
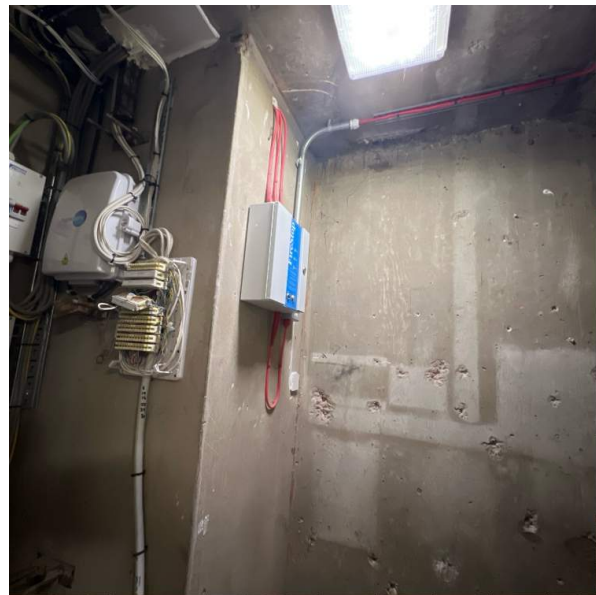
## Ground Floor Hallway

Comments: No jams or distortions noted to hallway doors to indicate any serviceability issues. Generally walls covered with finishes in hallway, likely to consist a mixture of concrete shear walls, embedded columns and block infill walls. Limited structure exposed. Partly visible concrete walls noted via riser cupboard and under stair case closet.

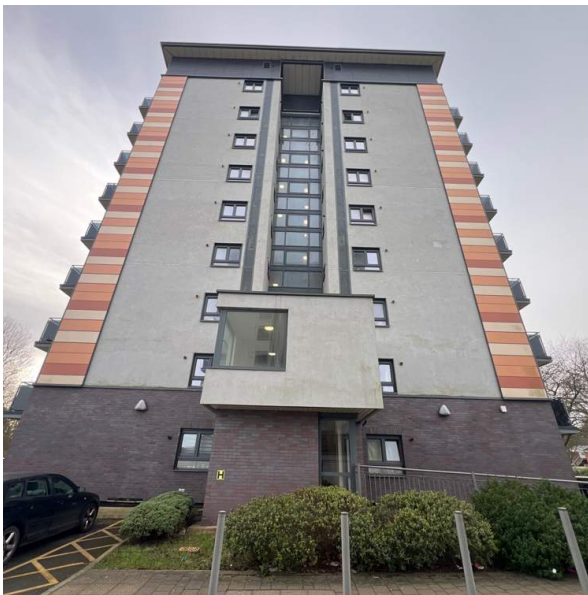
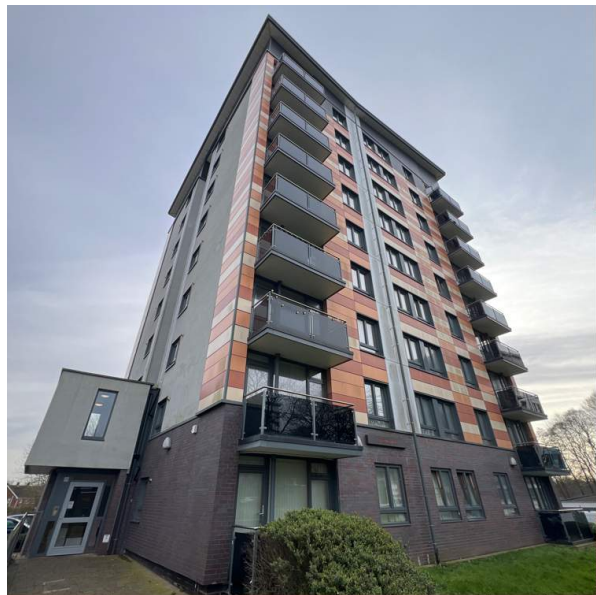
Ground floor level consists of brickwork. Remaining elevations consist of a mixture of rendered and cladded facade.
