VISUAL STRUCTURAL APPRAISAL

Thompson Gardens

1-89 Hales Lane  
Smethwick  
B67 6RX

29<sup>th</sup> November 2024

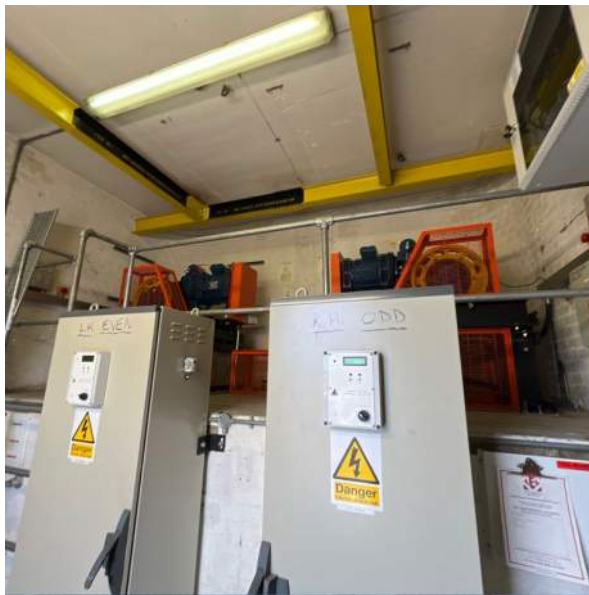
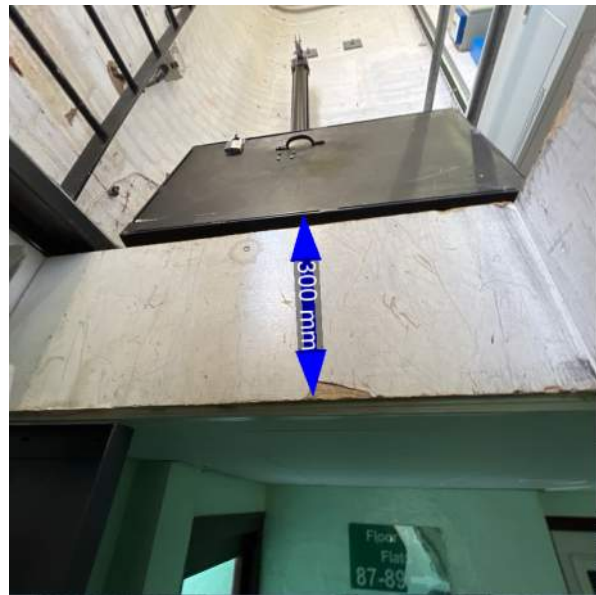
## Main Roof

Lift motor room located on roof formed of masonry walls.  
Telecomms building noted to roof supported of steel frame fixed to main roof.  
Insitu concrete roof slab with insulated PIR Boad and felt roof coverings.

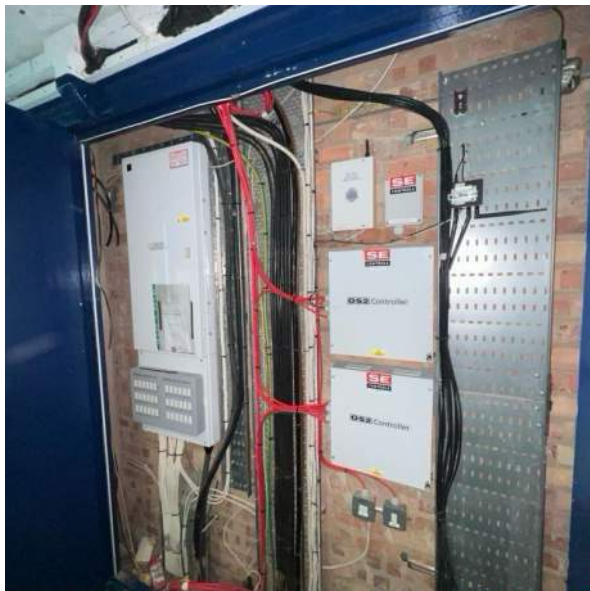
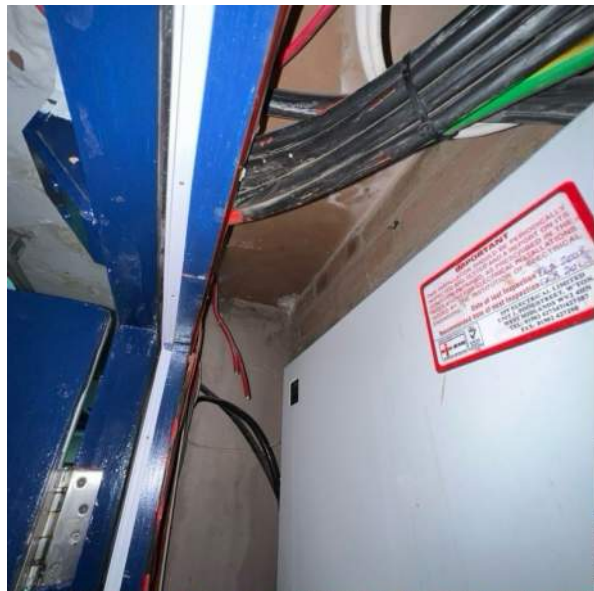
Comments: No jams or distortions noted to hallway doors to indicate any serviceability issues. Hallway walls generally formed of infill masonry (non-load bearing brickwork) with embedded structural columns and shear walls. Electrical dry riser cupboard shows infill masonry with partly exposed concrete column (rendered). Floors and walls were mainly level.

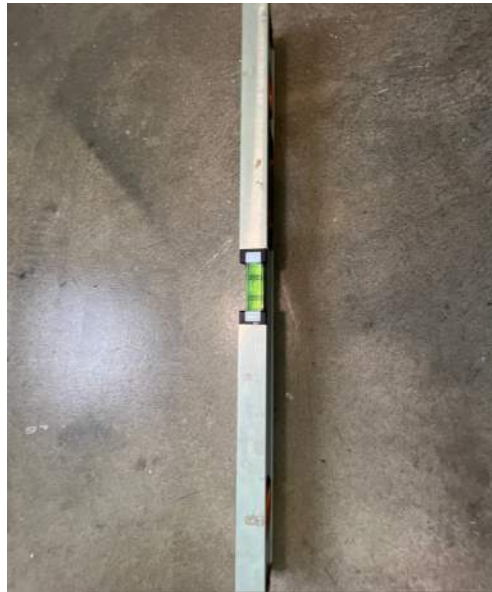
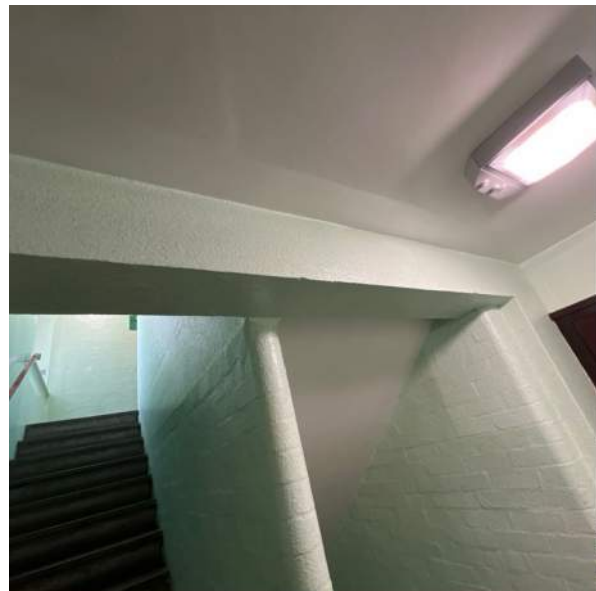
## 14th Floor Staircase

Insitu concrete stairs. Walls and floors appear to be fairly level.  
Stair walls predominantly formed of infill masonry walls (non-load bearing) and embedded RC Concrete beams and columns noted.  
Side wall of stair case appears to be formed of a concrete shear wall.

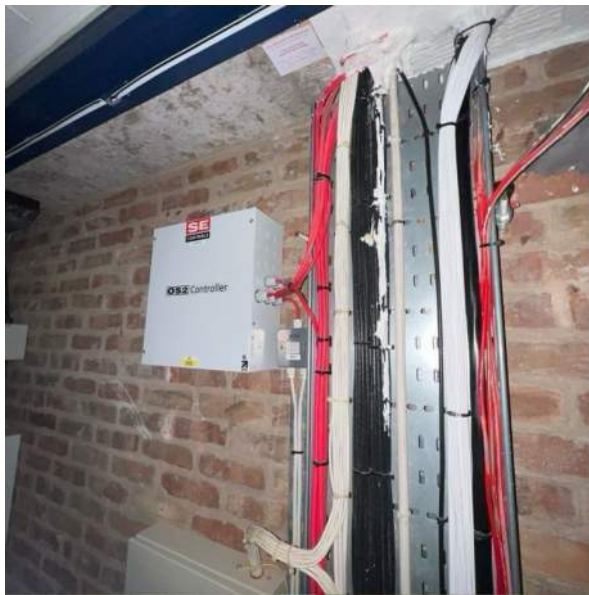
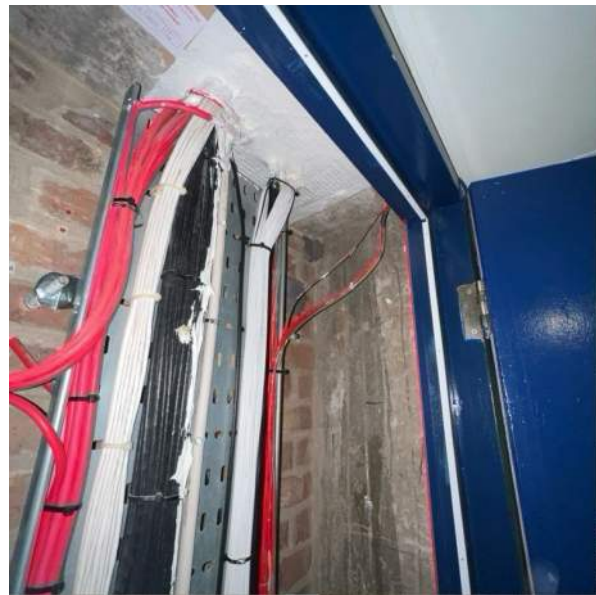
## 6th Floor Hallway

Comments: No jams or distortions noted to hallway doors to indicate any serviceability issues. Hallway walls generally formed of infill masonry (non-load bearing brickwork) with embedded structural columns and shear walls. Electrical dry riser cupboard shows infill masonry with partly exposed concrete columns.

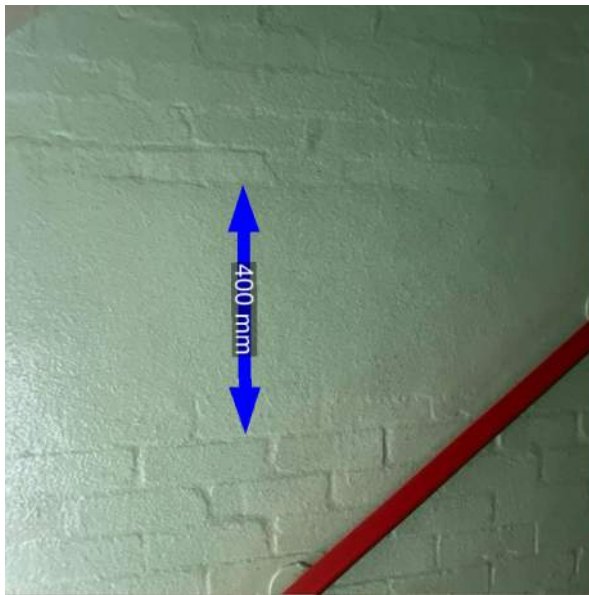
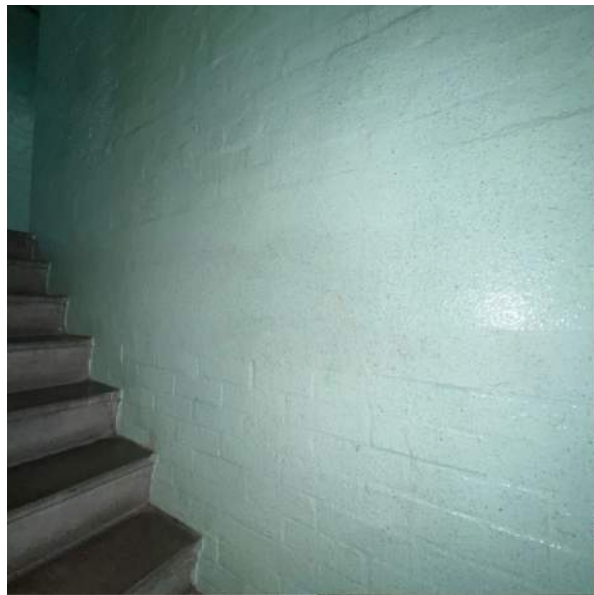
## 6th Floor Staircase

Insitu concrete stairs. Walls and floors appear to be fairly level.  
Stair walls predominantly formed of infill masonry walls (non-load bearing) and embedded RC Concrete beams and columns noted.  
Side wall of stair case appears to be formed of a concrete shear wall.

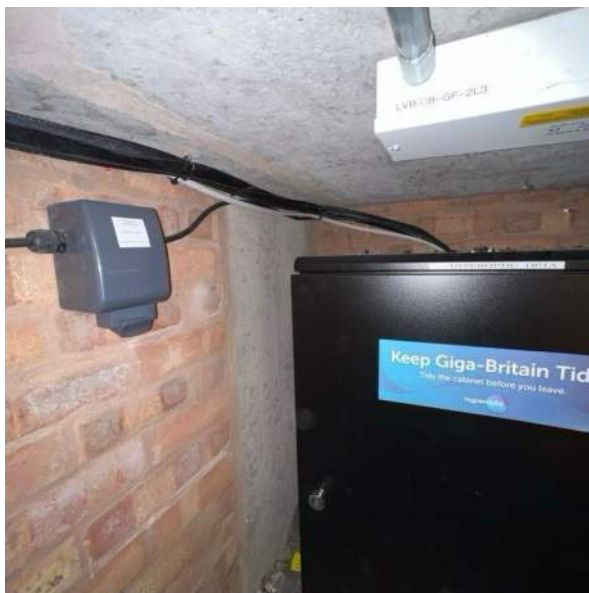
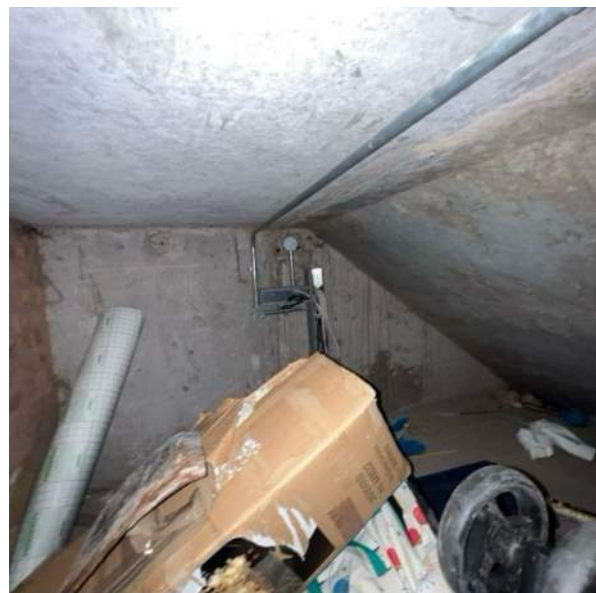
## Ground Floor Hallway

Comments: No jams or distortions noted to hallway doors to indicate any serviceability issues. Hallway walls generally formed of infill masonry (non-load bearing brickwork) with embedded structural columns and shear walls. Electrical dry riser cupboard shows infill masonry with partly exposed concrete columns. RC columns noted via pump room and janets cupboard.

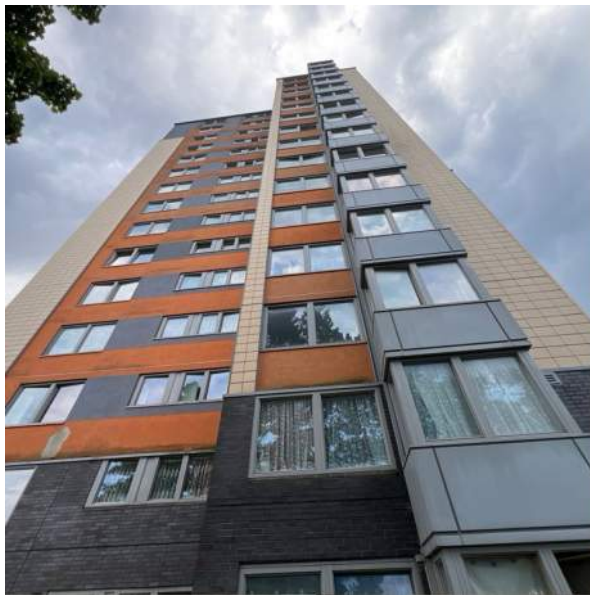
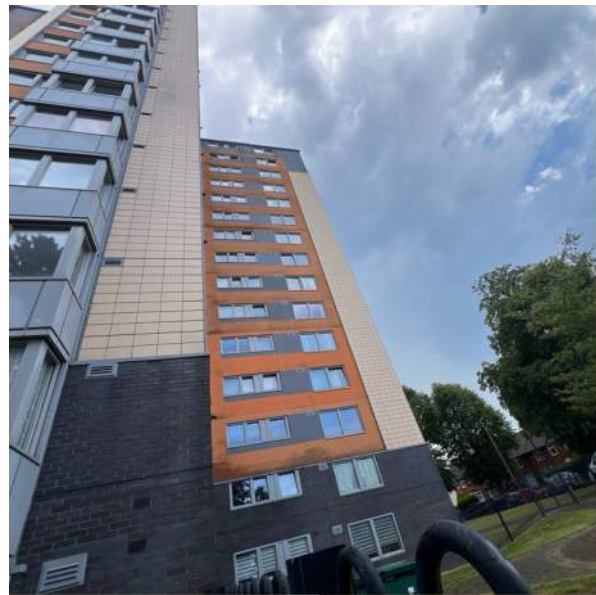
External ground and first level consists of brick work.  
Remaining floors noted to have a cladded facade to exterior.  
Some general maintenance/cleaning required to cladding.

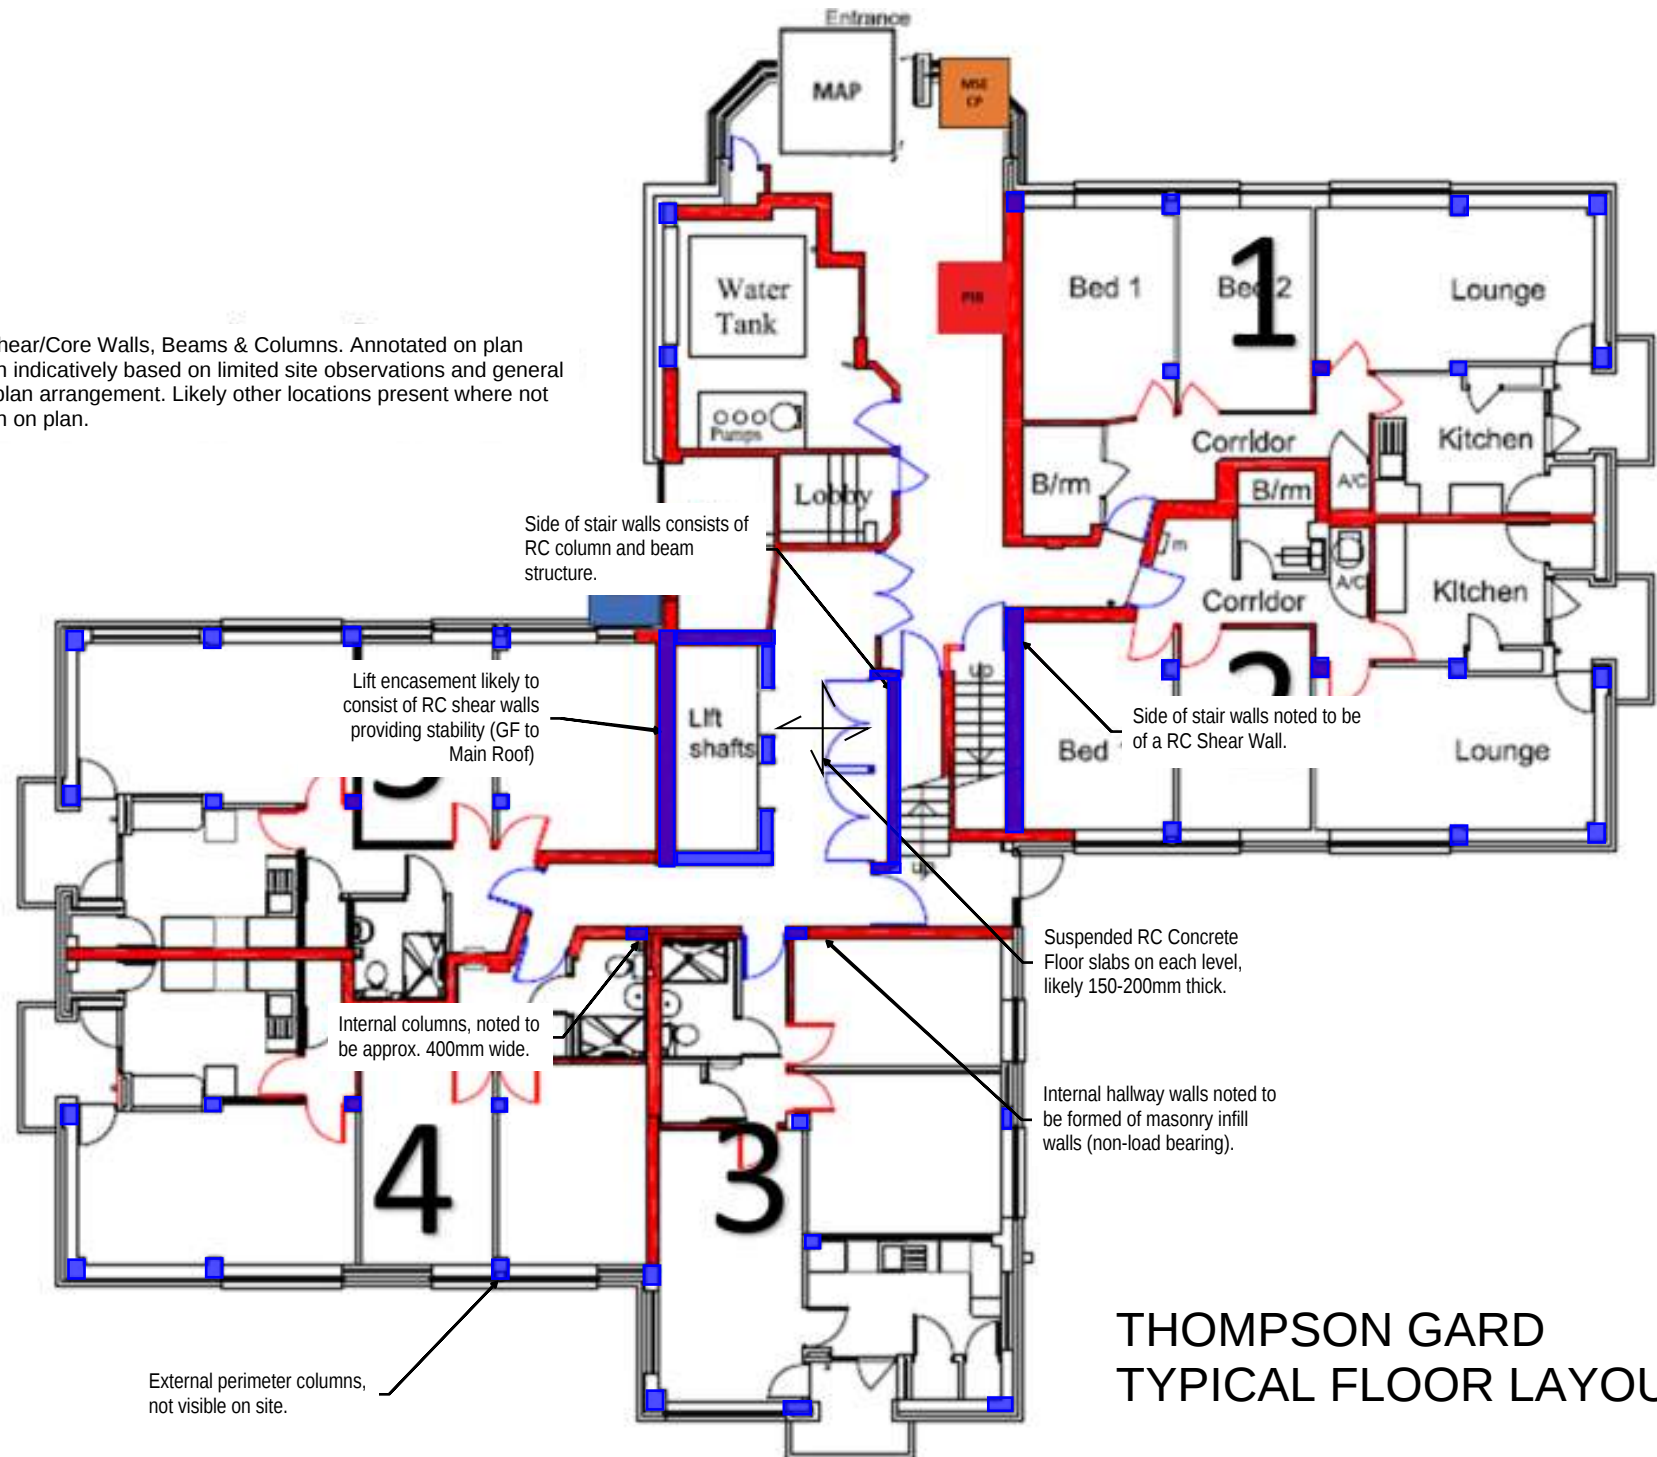
THOMPSON GARD  
TYPICAL FLOOR LAYOUT

RC Shear/Core Walls, Beams & Columns. Annotated on plan shown indicatively based on limited site observations and general floor plan arrangement. Likely other locations present where not shown on plan.
