VISUAL STRUCTURAL APPRAISAL

Wallace House

Badsey Rd  
Oldbury  
B69 1ER

12<sup>th</sup> November 2024

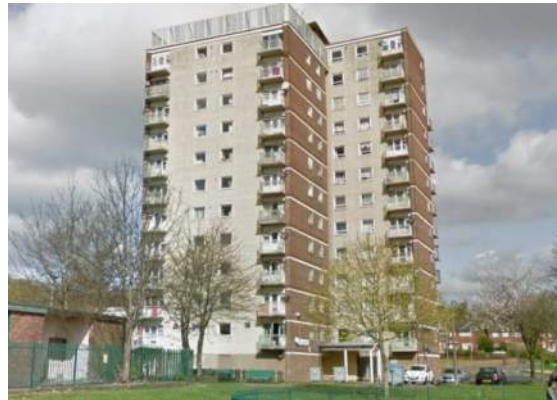
Figure 5. Online photograph of the building before the buildings underwent the refurbishment in 2018

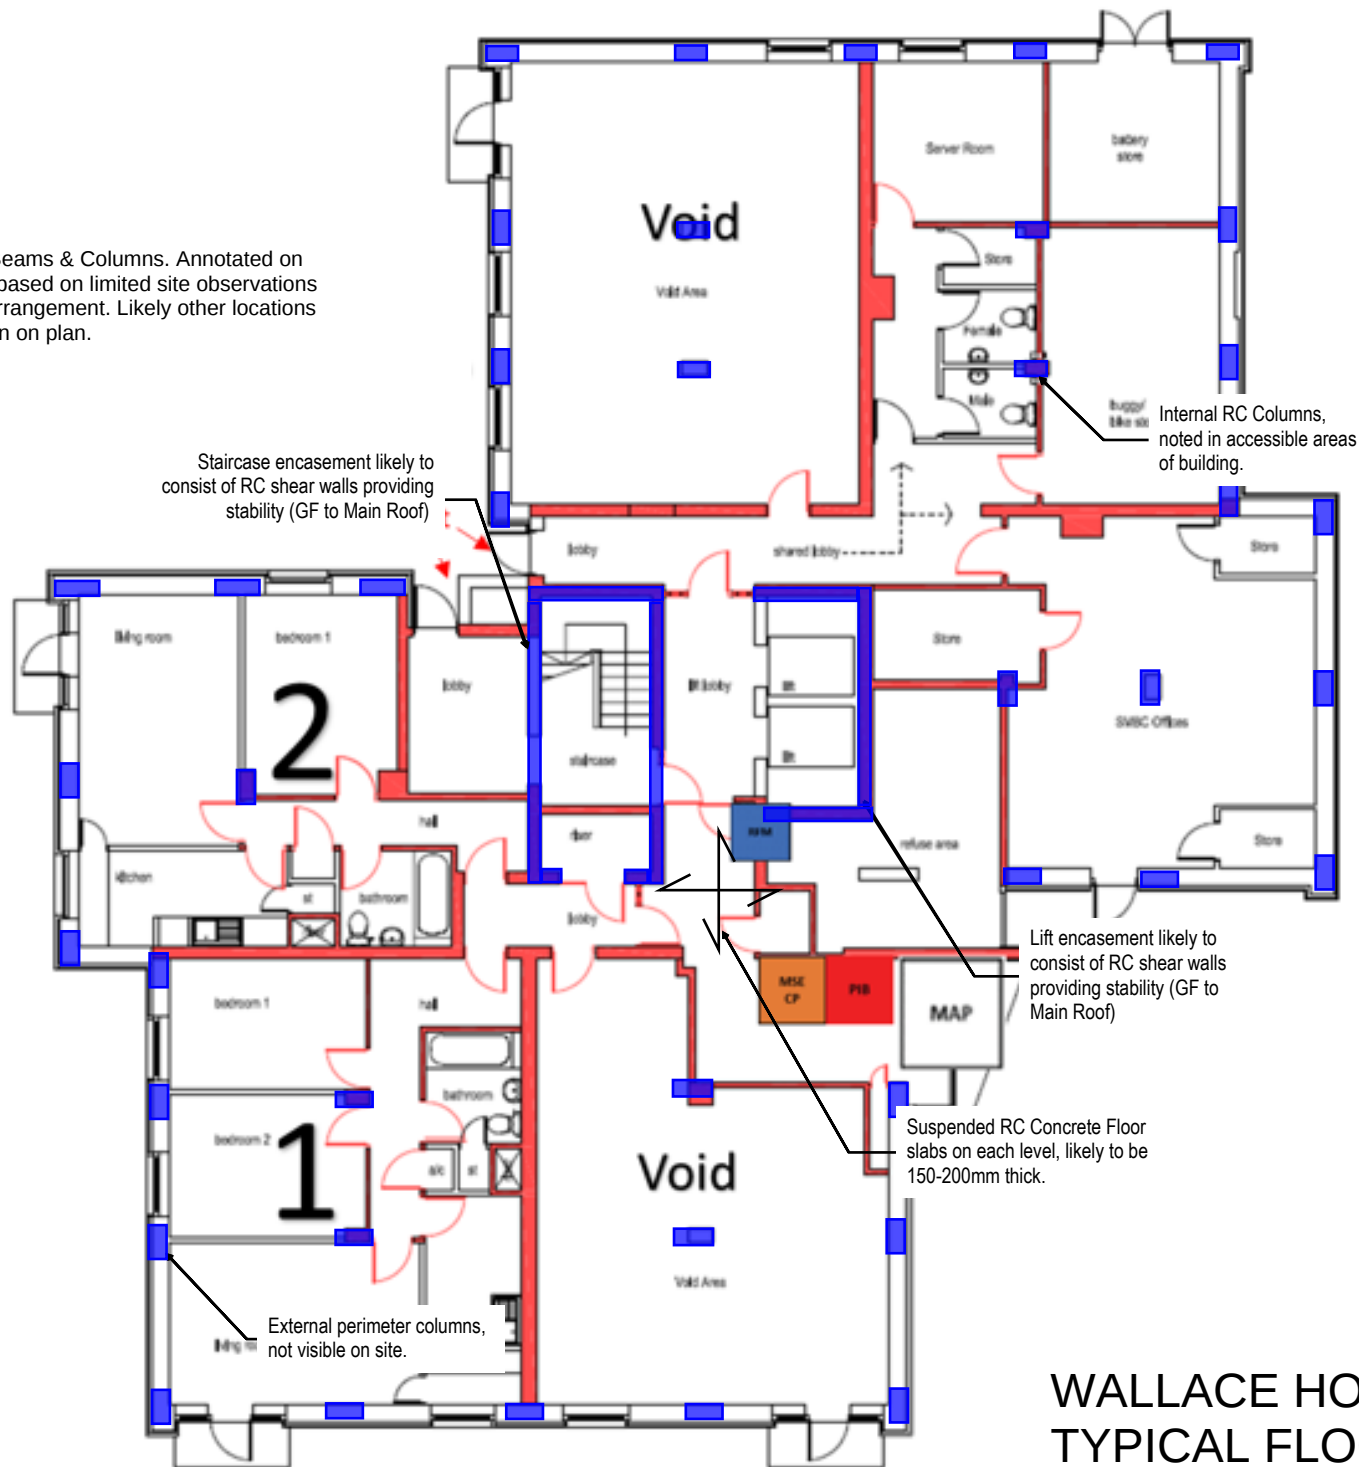
WALLACE HOUSE  
TYPICAL FLOOR LAYOUT

External ground floor level consists of brick work.  
Remaining floors noted to have a cladded facade to exterior. Balconies noted.  
Some staining noted to cladding.

RC Shear/Core Walls, Beams & Columns. Annotated on plan shown indicatively based on limited site observations and general floor plan arrangement. Likely other locations present where not shown on plan.
