VISUAL STRUCTURAL APPRAISAL

Wesley Court

Southbank Road  
Oldbury  
B64 6LQ

29<sup>th</sup> November 2024

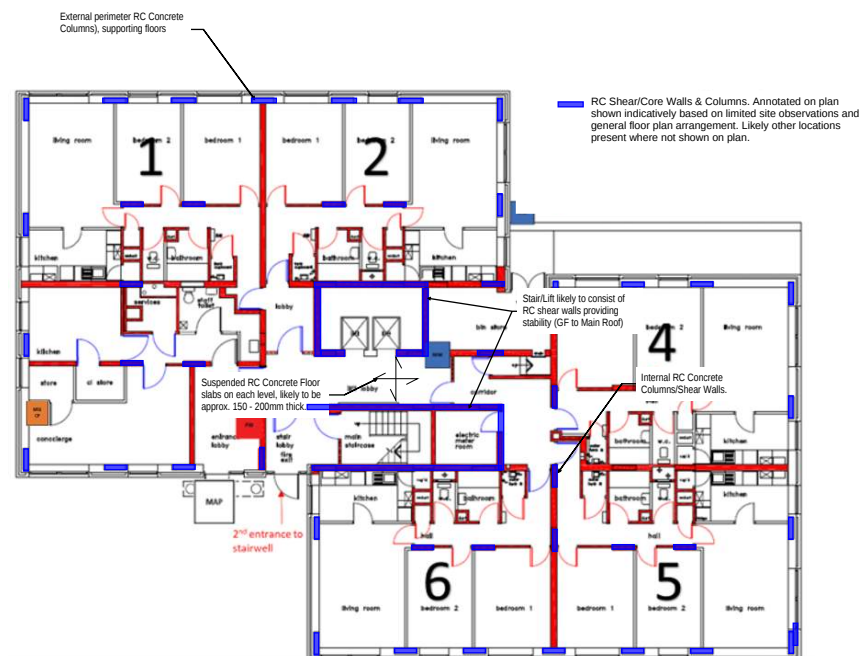
Figure 6: Diagram of typical floor plan

Figure 6 indicates the assumed structural layout for a typical upper floor level.

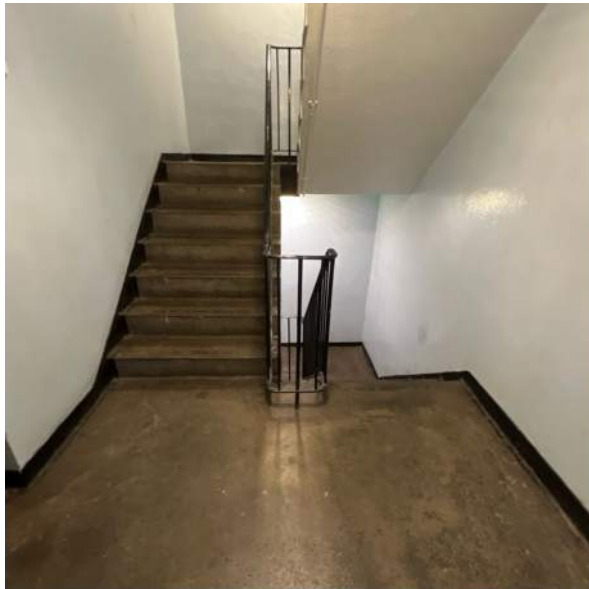
## 8th Floor Staircase

Comments: Insitu concrete stairs with steel hand railing fixed to stairs. Walls and floors appear to be fairly level.  
Stair walls covered with finishes however these would likely form the main concrete shear core walls. Stair walls approx. 200mm thick.
