**FIRNTEC**  
BUILDING COMPLIANCE

VISUAL STRUCTURAL APPRAISAL

Wimberger House

Hallam St  
West Bromwich  
B71 4HA

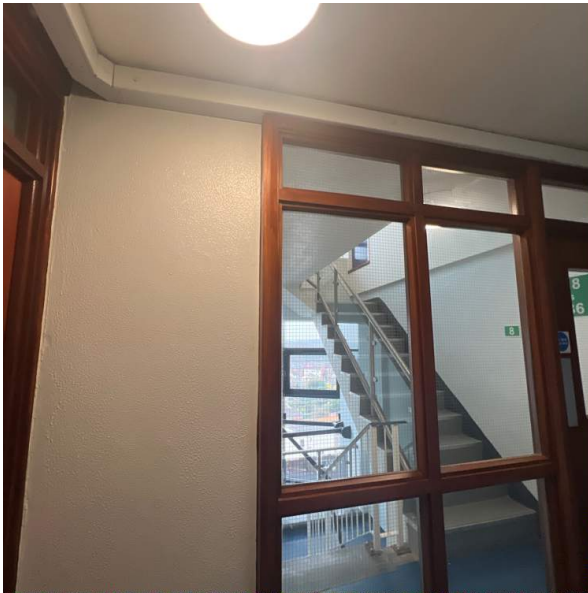
## 9th Floor Hallway

Comments: No jams or distortions noted to hallway doors to indicate any serviceability issues. Generally walls covered with finishes in hallway, likely to consist a mixture of concrete shear walls, embedded columns and masonry infill walls. Limited structure exposed. Concrete walls noted via riser cupboard and lift motor room.

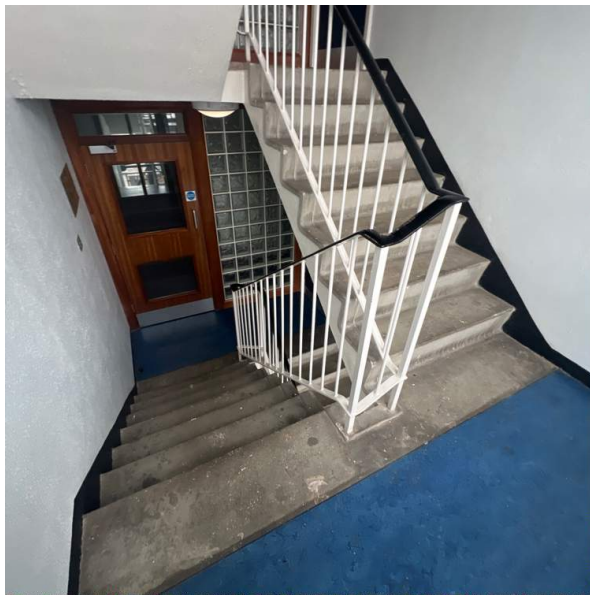
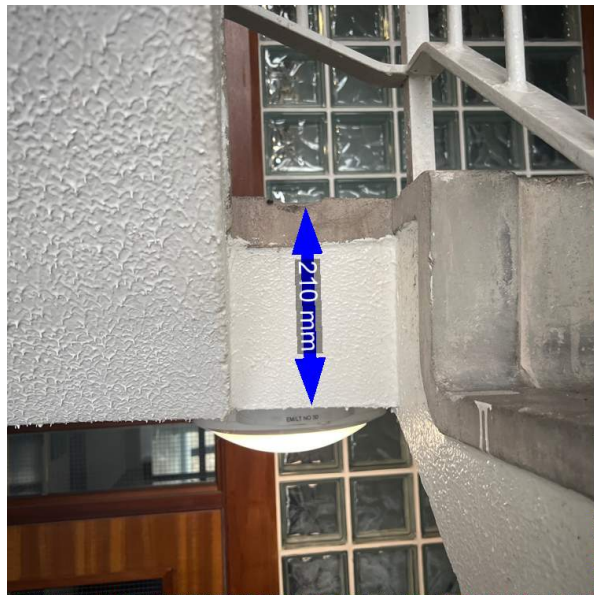
## 9th Floor Staircases

Comments: 2 sets of staircases present. Insitu concrete stairs with steel hand railing fixed to stairs. Walls and floors appear to be fairly level. Stair walls covered with finishes however these would likely form the main concrete shear core walls. A set of steel stairs also present leading to roof level.

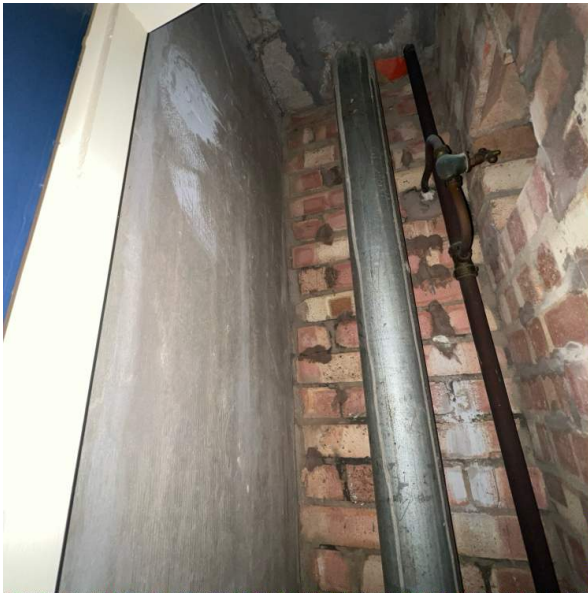
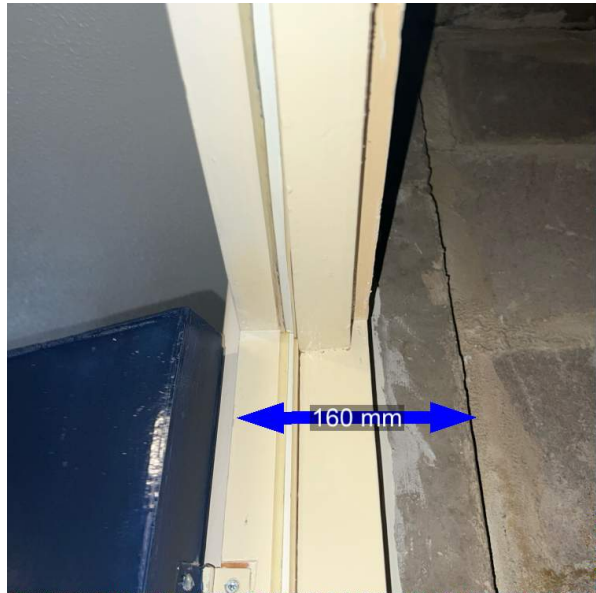
## 5th Floor Hallway

Comments: No jams or distortions noted to hallway doors to indicate any serviceability issues. Generally walls covered with finishes in hallway, likely to consist a mixture of concrete shear walls, embedded columns and masonry infill walls. Limited structure exposed. Concrete walls noted via riser cupboard. Lift walls appear to be solid concrete walls.

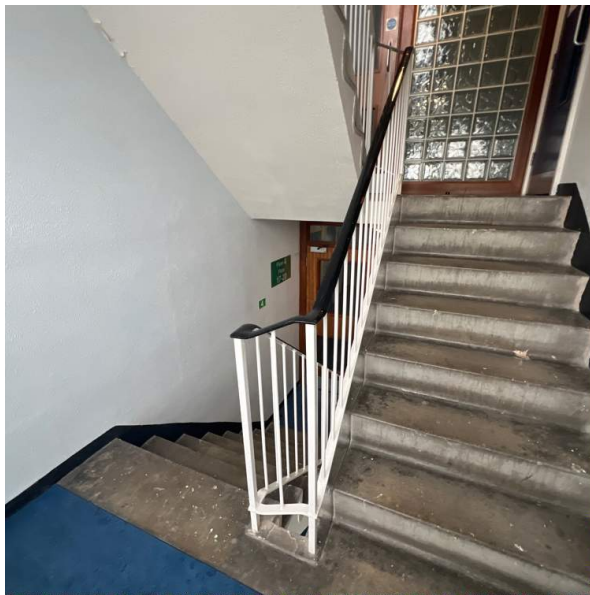
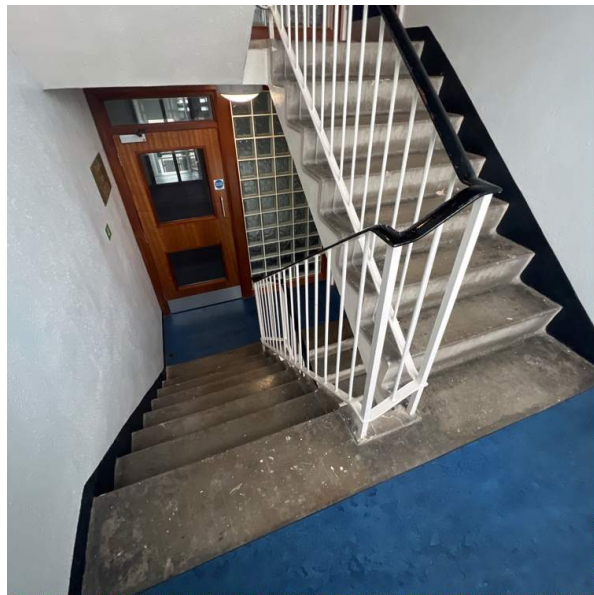
## 5th Floor Staircases

2 sets of staircases present. In situ concrete stairs with steel hand railing fixed to stairs. Walls and floors appear to be fairly level. Stair walls covered with finishes however these would likely form the main concrete shear core walls.

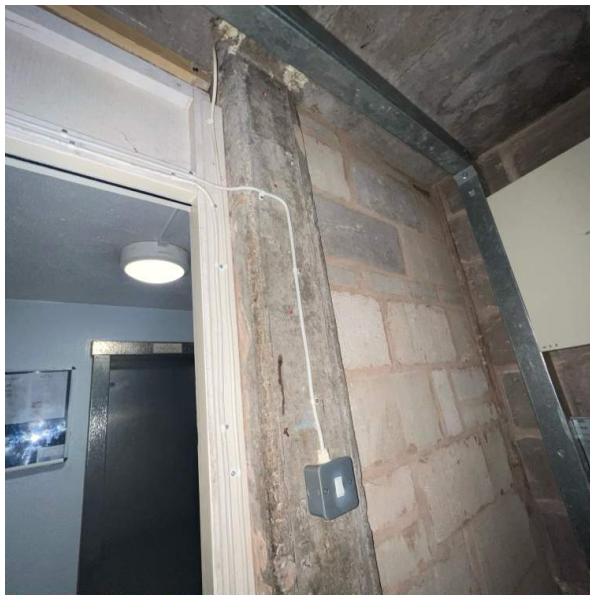
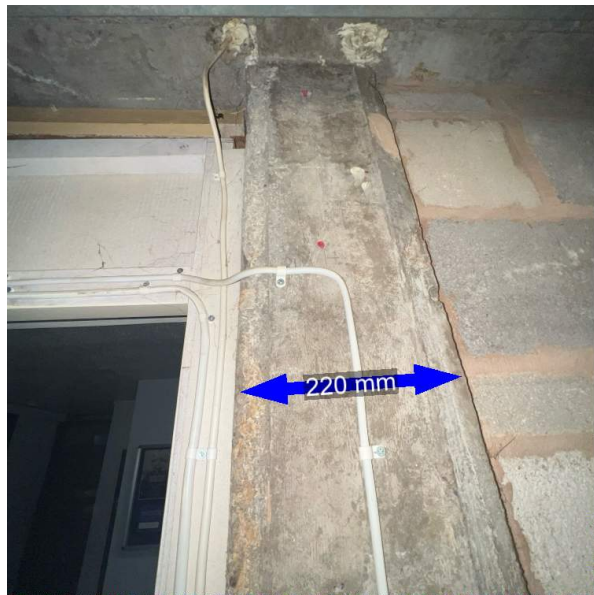
## Ground Floor Hallway

Comments: No jams or distortions noted to hallway doors to indicate any serviceability issues. Generally walls covered with finishes in hallway, likely to consist a mixture of concrete shear walls, embedded columns and block infill walls. Limited structure exposed. Partly visible concrete walls noted via electrical riser cupboard. RC columns noted in electric cupboard.

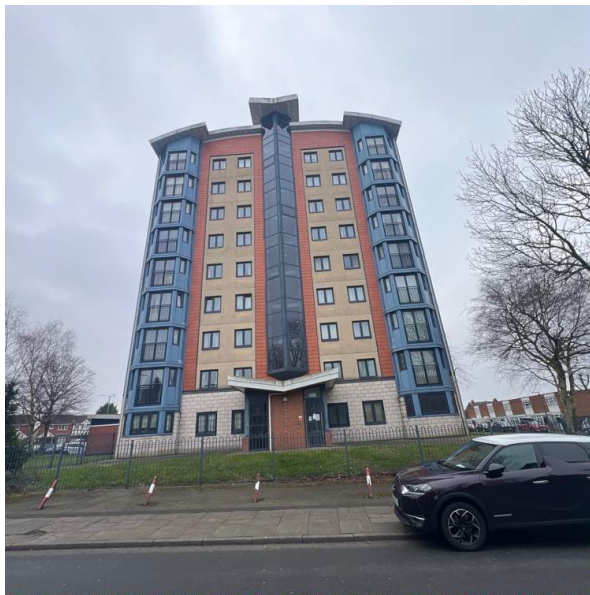
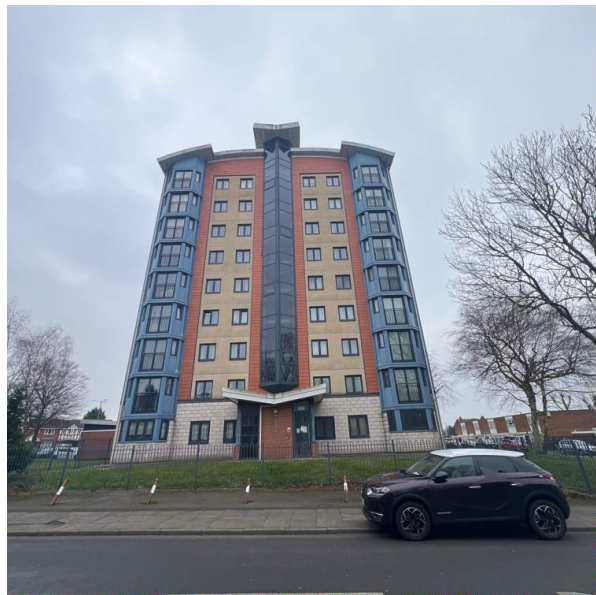
External facade consist of blockwork to the ground floor level. All other levels consist of a mixture of render, tiles and aluminium panel cladding and encased balconies.
