**FIRNTEC**  
BUILDING COMPLIANCE

VISUAL STRUCTURAL APPRAISAL

Wyndmill Crescent

26<sup>th</sup> February 2025

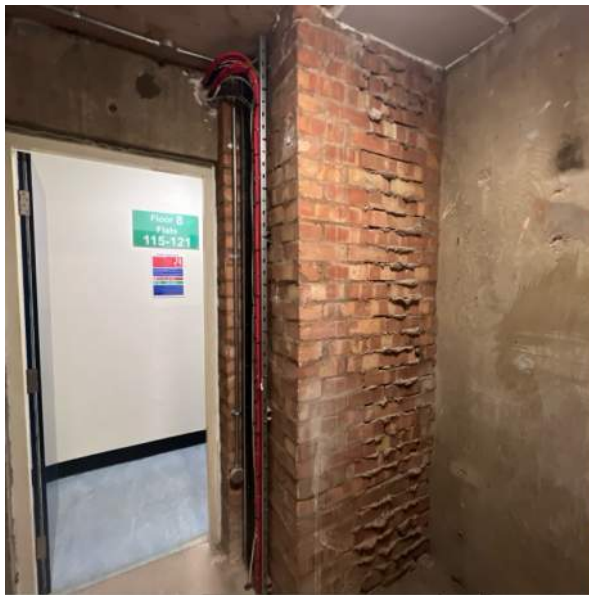
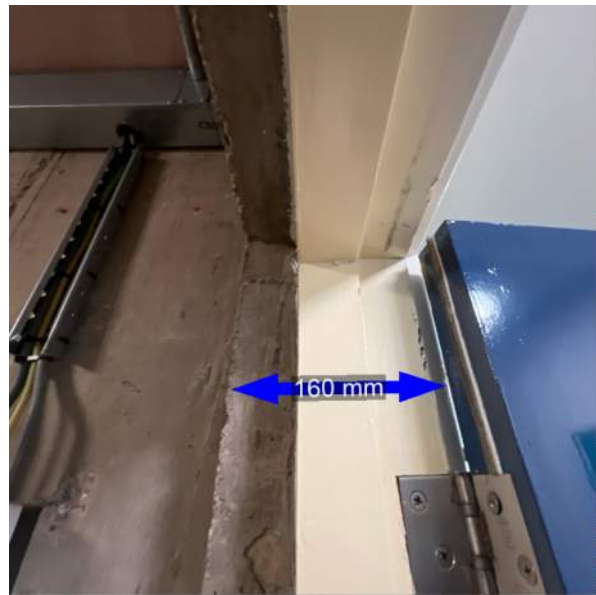
Comments: No jams or distortions noted to hallway doors to indicate any serviceability issues. Generally walls covered with finishes in hallway, likely to consist a mixture of concrete shear walls, embedded columns and masonry infill walls. Limited structure exposed. Concrete walls and infill masonry (non-load bearing) walls noted in riser cupboards.

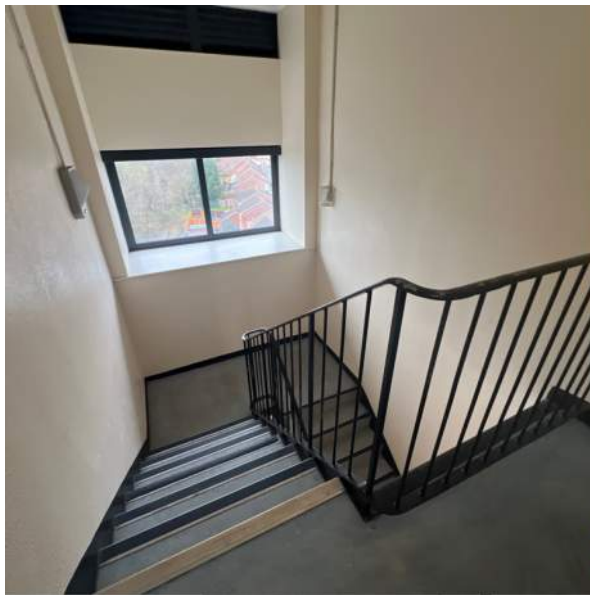
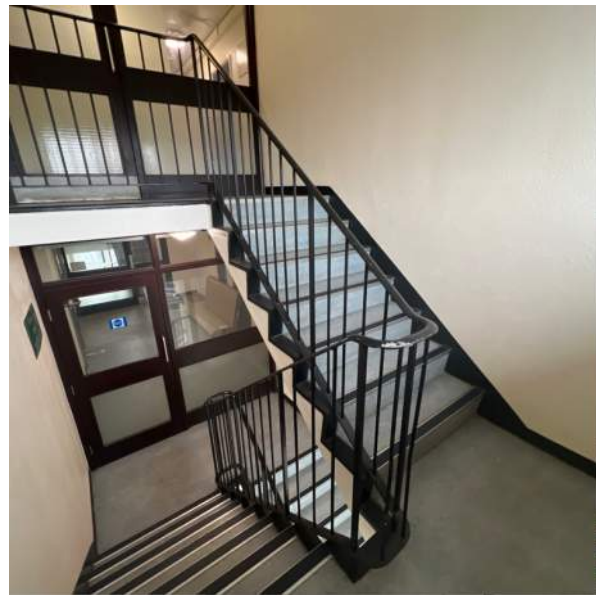
## 8th Floor Staircases

Comments: Insitu concrete stairs with steel hand railing fixed to stairs. Walls and floors appear to be fairly level.  
Stair walls covered with finishes however these would likely form the main concrete shear core walls.

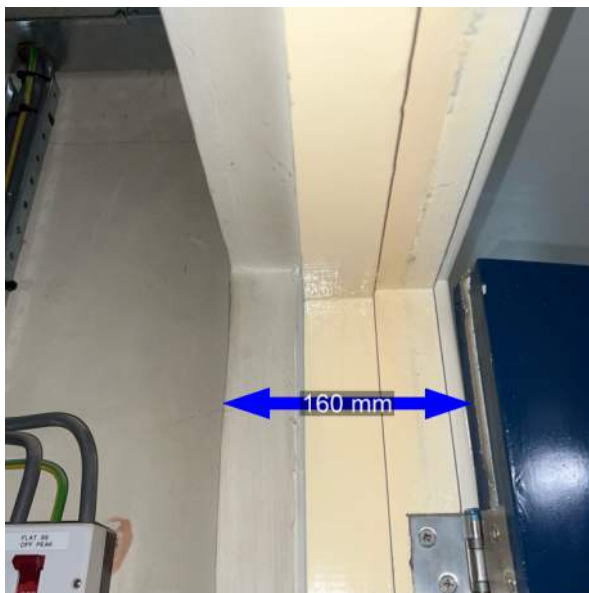
## 4th Floor Hallway

Comments: No jams or distortions noted to hallway doors to indicate any serviceability issues. Generally walls covered with finishes in hallway, likely to consist a mixture of concrete shear walls, embedded columns and masonry infill walls. Limited structure exposed. Concrete walls and infill masonry (non-load bearing) walls noted in riser cupboards.

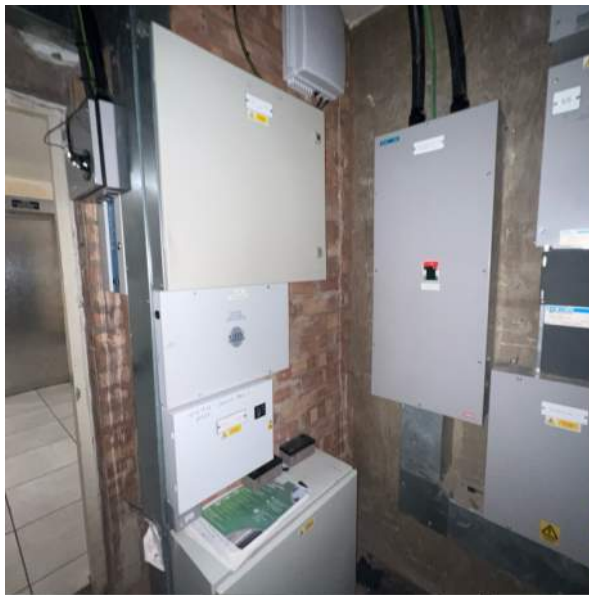
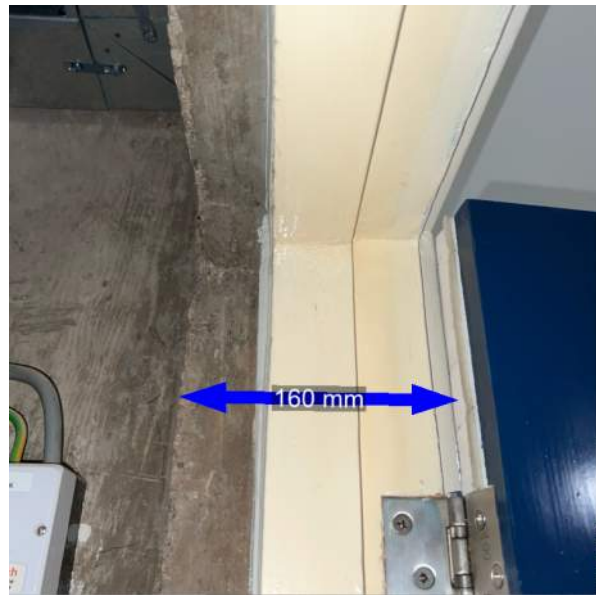
Comments: No jams or distortions noted to hallway doors to indicate any serviceability issues. Generally walls covered with finishes in hallway, likely to consist a mixture of concrete shear walls, embedded columns and masonry infill walls. Limited structure exposed. Concrete walls and infill masonry (non-load bearing) walls noted in riser cupboards.

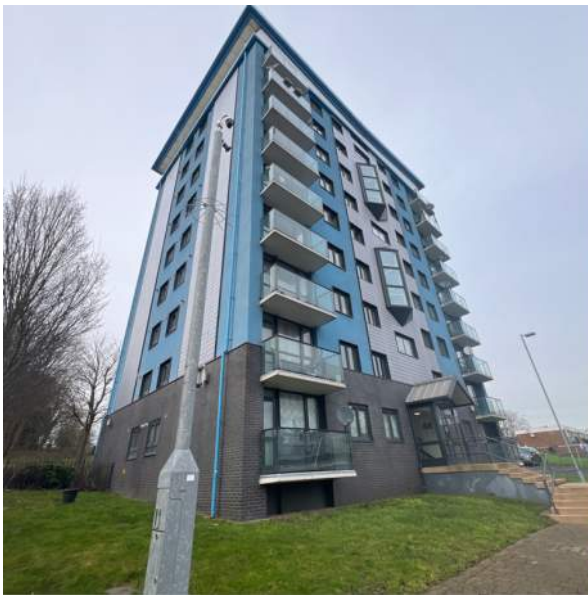
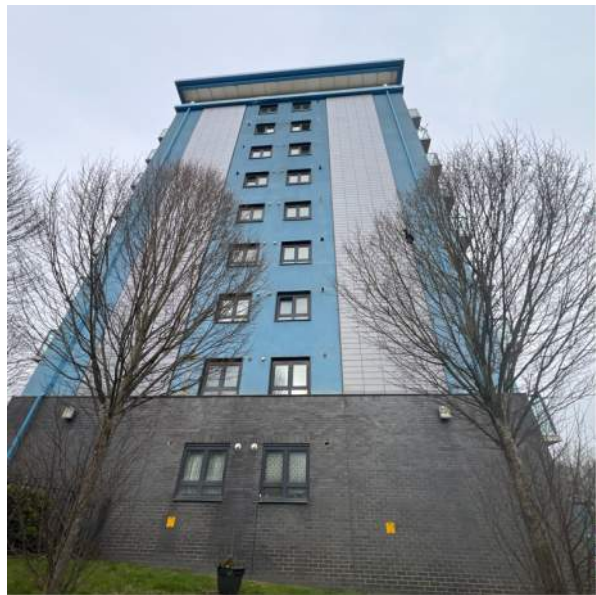
Ground floor level consists of brickwork. Remaining elevations consist of a mixture of rendered and cladded facade.
