**FIRNTEC**  
BUILDING COMPLIANCE

VISUAL STRUCTURAL APPRAISAL

Wyrley House  
Sedgeley Road East  
Tipton  
DY4 7TT

24<sup>th</sup> June 2025

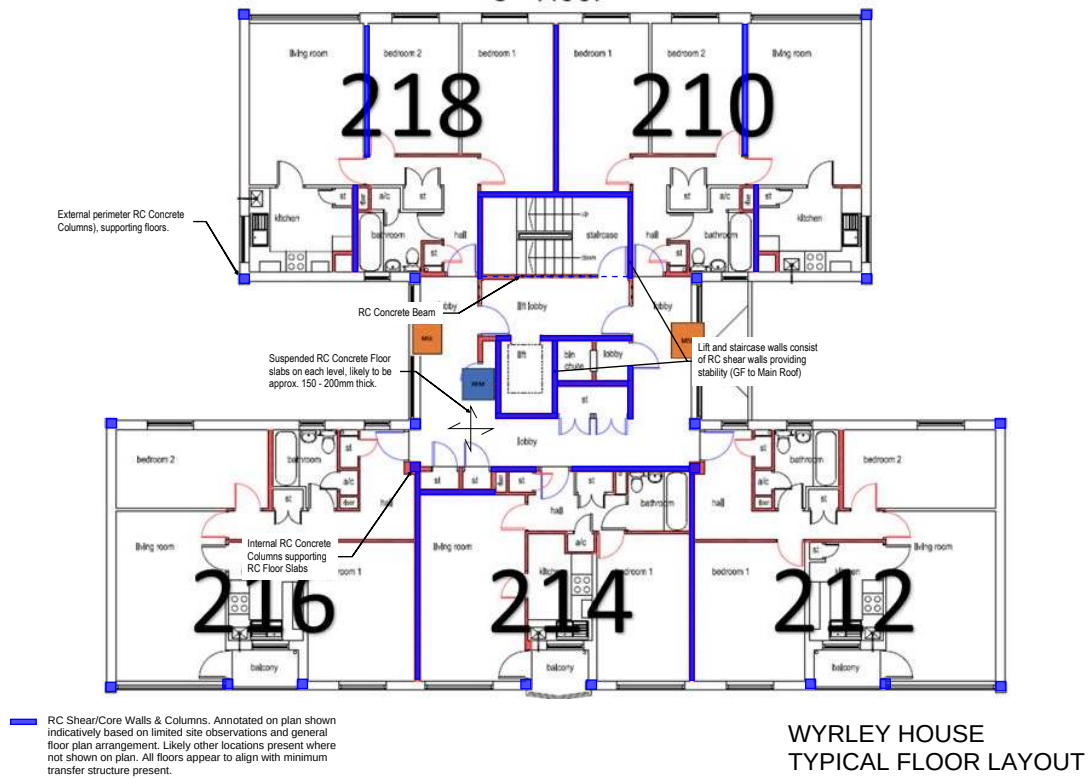
Figure 6: Diagram of typical floor plan

Figures 6 indicates the assumed structural layout for a typical upper floor level.

There were vertical concrete walls supporting the floor plates at every level. The elements visible matched the floor layout in Figure 6. The walls appear continuous from ground to roof with no transfer structure. The overall condition of the structure observed is good.
