# Fire Risk Assessment

**45-49**

**New Hope Road,  
Smethwick,  
B66 3TX**

**Date Completed: 10/07/2026**

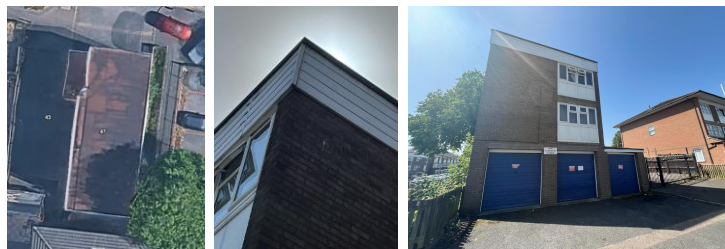
The low-rise three-storey block was built in 1968 using traditional brick cavity and concrete construction. The building has a flat bitumen-felt roof with uPVC fascia boards fitted around the roofline.

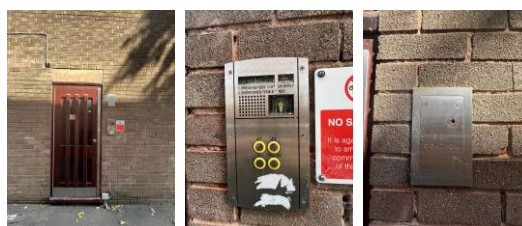
The building is a detached residential block positioned at the end of the row. Access is provided via New Hope Road. The entrance/exit door is of timber construction with glazed panel insets. Entrance access is controlled by a fob system, flat call button, and fire-service drop key.

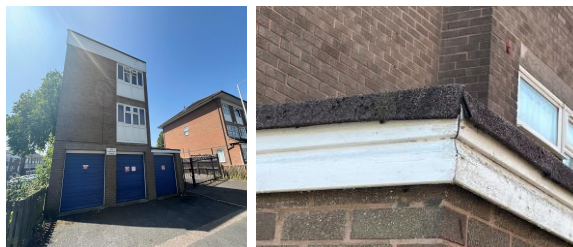
Located at the side of the premises are three garages, two of which are directly beneath the first and second floors. These were not accessible at the time of the FRA; therefore, I am unable to comment on the compartmentation or internal condition of these areas. The garage attached to the block has a flat roof with felt covering and timber fascia boards.

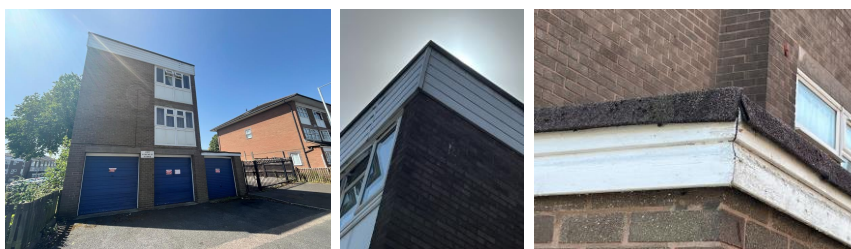
- 1) The external surface of the building is predominantly brick structure. The building has a flat bitumen-felt roof with uPVC fascia boards fitted around the roofline, timber fascia boards around the single garage.

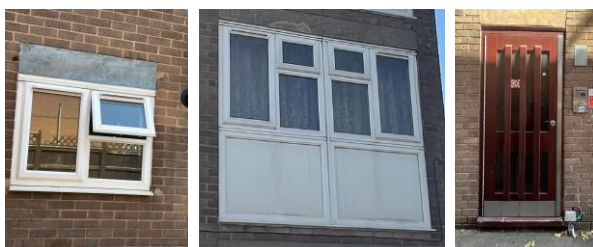
- 2) uPVC double-glazed units have been installed in each flat and within the communal stairway, most of the large units have spandrel panels fitted on the lower sections of the units. The entrance doors are a timber construction with glazed panels.

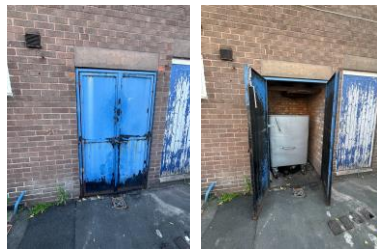
- 4) The blocks bin store is located at rear of the premises and built within the block. This is secured by double steel doors. Within this store is a commercial-grade metal wheelie bin, functioning as the receptacle for refuse discharged via the block's bin chute.

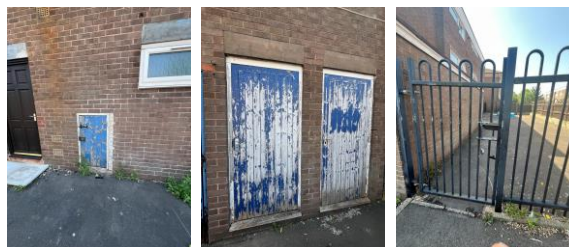
- 5) Adjacent to the bin storeroom, within the same wall, there are three individual storage rooms allocated to specific flats, accessible only by the respective residents. Also located within this wall is the entrance door to the ground-floor flat. This rear area forms part of a secure courtyard, enclosed with metal railings and gated access.

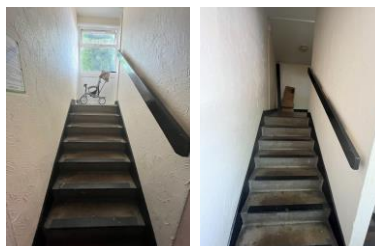
- 9) The flooring and stairway within this property are concrete construction.

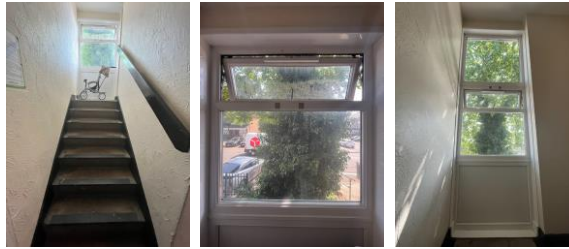
- 10) Automatic smoke ventilation is not employed. Windows fitted on the stairwell are fitted with manual openers; the windows will assist in additional lighting and any ventilation required.

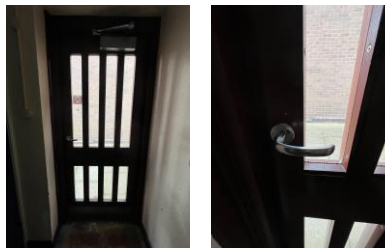
- 11) The final exit door is operated using a levered handle to egress the building and are also fitted with automatic closing devices that are checked on a regular basis by caretaking teams as part of their checks. Defective closing devices are replaced either by the Caretaking Team(s) or the in-house repairs team(s). The final exit doors have door entry systems installed. These systems are designed to fail safe i.e. door unlocked in the event of a power failure. This prevents residents being locked in or out of the building.

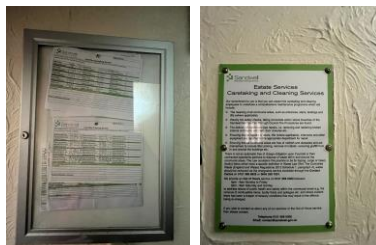
- 12) Communal areas are kept free of flammable items. The communal areas are checked on a regular basis by Caretaking / Cleaning teams 365 days per year and all items of rubbish are immediately removed. There is also an out of hour's service that allows combustible items of furniture / rubbish to be removed.

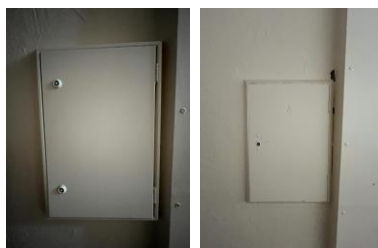
- 14) Adjacent to the flat entrance doors on the first and second floor, there are service over-cupboards. These were in working order and good condition.

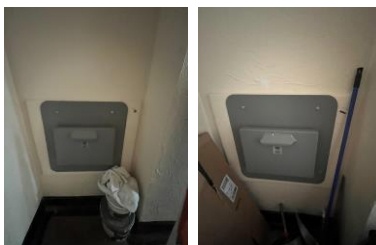
- 15) On the 1st and 2nd floors, a bin-chute hopper door is located adjacent to the flat entrances for residents to dispose of refuse bags.

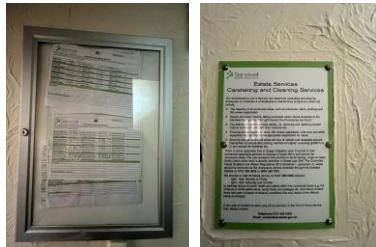
- 1) There is a regular Cleaning Service to the premises.

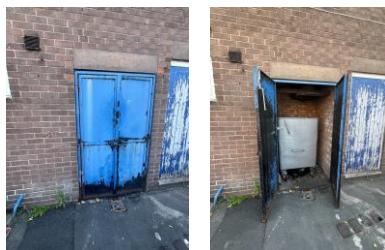
- 2) The refuse bins for 45-49 New Hope Road are stored at the rear of the premises within a designated internal bin-storage cupboard, which is built into the structure of the building. This area also serves as the bin-chute room, with hopper doors located on the first and second floors for residents to dispose of waste. The bins are emptied as part of the routine waste-collection service. This storage area is secured by double steel doors.

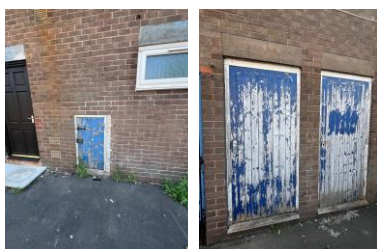
- 3) Residents should not store flammable liquids or gas cylinders on site.
- 4) No Flammable liquids stored on site by Caretakers / Cleaners.
- 5) There are three individual storage rooms allocated to specific flats, accessible only by the respective residents. Also located within this wall is the entrance door to the ground-floor flat. This rear area forms part of a secure courtyard, enclosed by metal railings with gated access.
