# Fire Risk Assessment

## New Hope Road 54 - 58

**Smethwick**  
**B66 3TX.**

**Date Completed:** 13<sup>th</sup> July 2026

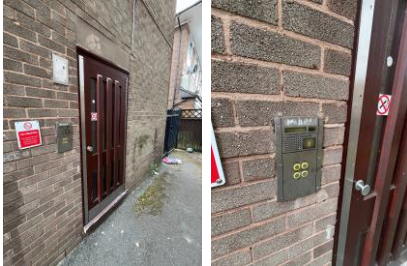
emergency access there is a firefighter manual override switch located above the door intercom panel.

Entrance with door access control to the block

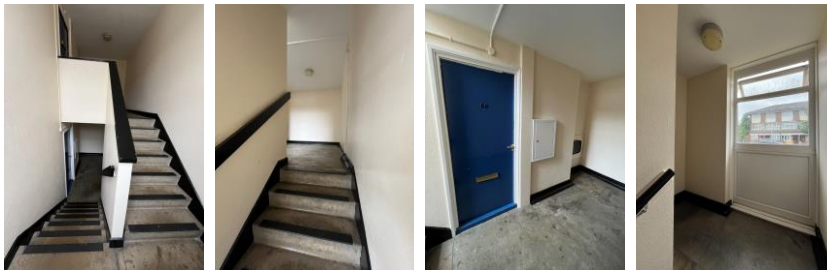
- 3) **On the second-floor landing outside Flat 54, numerous items are stored within the escape route and in front of the refuse hopper. The landing is actively being used for storage, compromising the means of escape.**

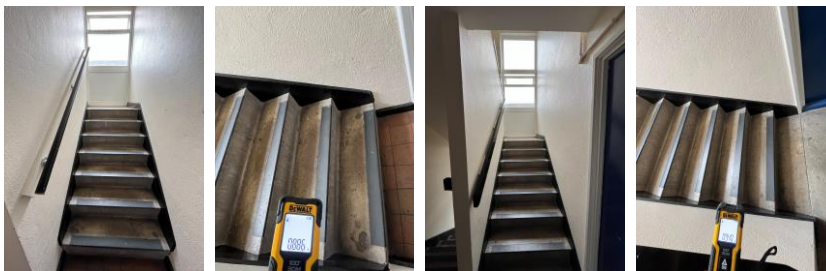
Ground to 1<sup>st</sup> and 2<sup>nd</sup> floor

- 6) 54 -58 New Hope Road consists of a single staircase that provides sufficient means of escape, this is located as you enter the block. The width of the staircases has been measured from handrail to wall at a measurement of 886 and 940mm. The stairs and landings are kept clear to maintain safe means of escape.

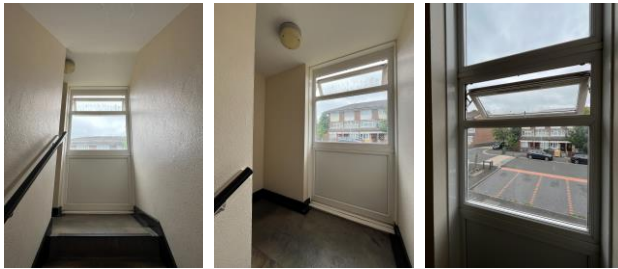
1st and 2<sup>nd</sup> floor landing

- 7) UPVC windows units have been installed on the staircase landing and within the corridors to the flats, these windows can be opened without the use of a key to allow sufficient airflow into the corridor and stairwell. There is no automatic smoke ventilation system installed in this premises.

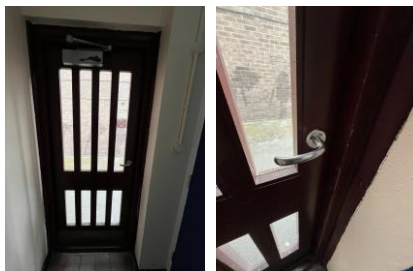
- 11) There is a clear and safe exit out of the building via the single-ground floor exit. The front final exit door is accessed using a levered handle allowing easy exit out of the building.

Final exit door and levered handle

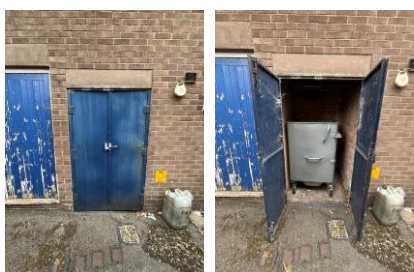
- 2) Refuse bins are stored in secured bin rooms that are located at the front of the building. This is kept secure by a means of a sliding bolt and padlock. Bins Are regularly emptied by site services.

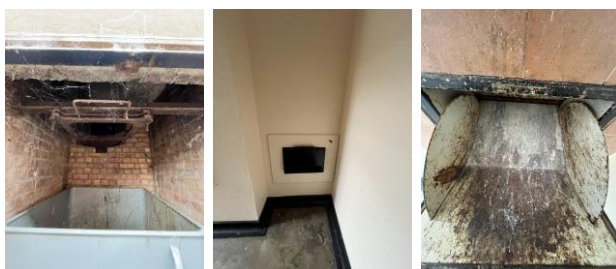
- 3) Refuse storage cupboard has a manual bin closure plate to mitigate any potential fire risk, both 1<sup>st</sup> floor internal refuse chutes are clear of any rubbish.

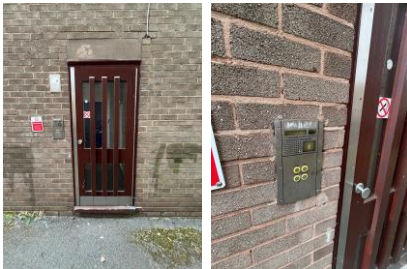
- 1) Regular checks are undertaken by Caretakers / Cleaning Team(s) 365 days per year which helps reduce the risk of arson.
- 2) 54 - 58 New hope Road has restricted access, this is via door access control, each resident has their own fob to gain access. There is an intercom system that can allow visitors and contractors in.

Entrance door access systems.

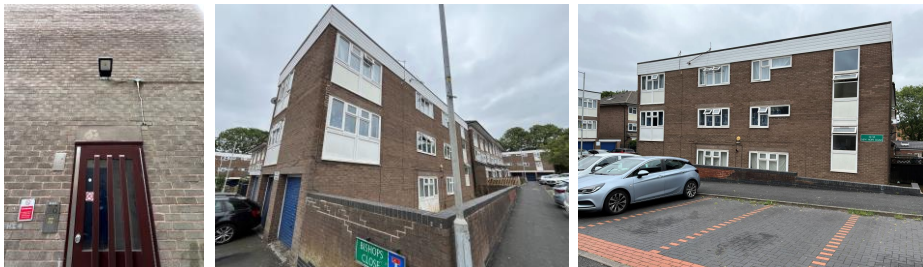
- 3) There is no current evidence of arson.
- 4) The perimeter of the premises is well illuminated. The building has external lighting unit installed over the front entrance alongside illumination from the nearby streetlamps provide sufficient lighting.
