# Fire Risk Assessment

**New Hope Road 60-68**

**Smethwick  
B66 3TX.**

**Date Completed: 3<sup>rd</sup> July 2026**

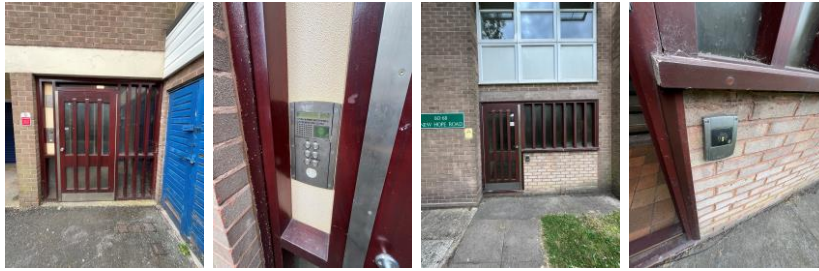
Both entrance with door access control to the block

Firefighter's switches at only the front entrance

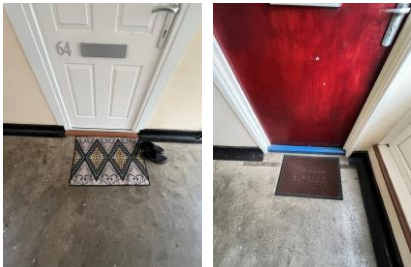
- 1) Each flat is equipped with, as a minimum LD3 fire detection to facilitate means of escape and provide sufficient response time.
- 2) Flat entrances have door mats placed within communal corridors, the fire rating is not known, however the condition and the size of these mats are acceptable

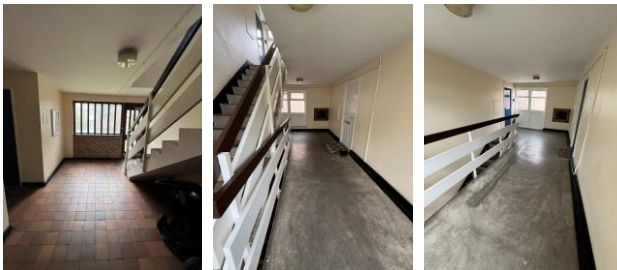
- 3) All corridors, landing and staircase are of adequate width and are kept clear to promote & maintain safe exit in an event of fire.

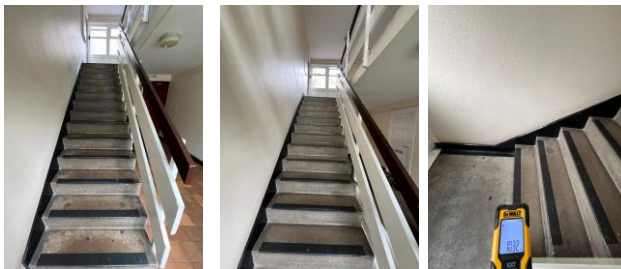
Ground to 1<sup>st</sup> and 2<sup>nd</sup> floor

- 5) 60-68 New Hope Road consists of a single staircase that provides sufficient means of escape, this is located as you enter the block from side entrance. The width of the staircases has been measured from handrail to wall at a measurement of 1032mm. The stairs and landings are kept clear to maintain safe means of escape.

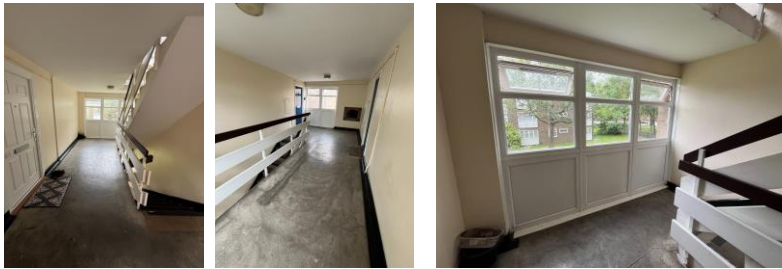
1st and 2<sup>nd</sup> floor landing

- 7) UPVC windows units have been installed on the staircase landing and within the corridors to the flats, these windows can be opened without the use of a key to allow sufficient airflow into the corridor and stairwell. There is no automatic smoke ventilation system installed in this premises.

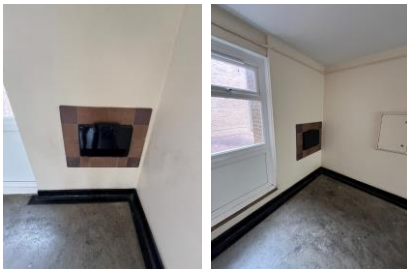
- 8) On both 1<sup>st</sup> floor and 2<sup>nd</sup> floor landings, there are bin chute hoppers within the means of escape, they do not present any obstruction in the event of safe evacuation.

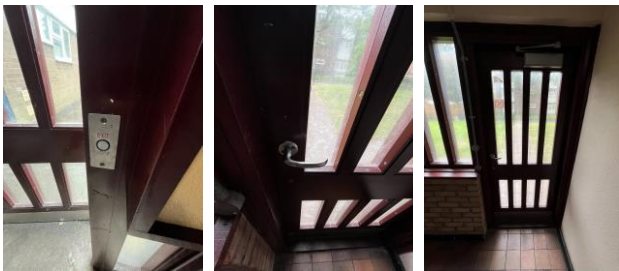
- 11) There is a clear and safe exit out of the building via the two-ground floor exits. The front final exit door is accessed using a push button, this will fail safe in an emergency, the rear final exit door accessed by a levered handle.

Final exit doors and doors exits buttons

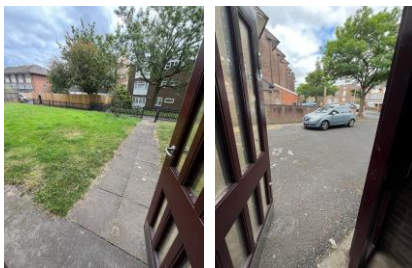
- 12) The route out the block to ultimate safety is clear from both final exit doors.

Front and rear final exit routes

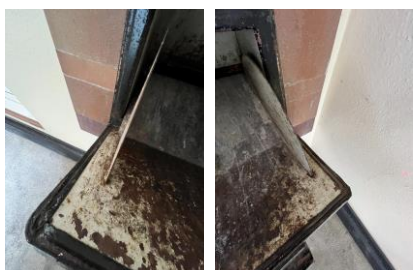
- 9)Intumescent seals have been installed within the chute hoppers on the 1<sup>st</sup> and 2<sup>nd</sup> landing

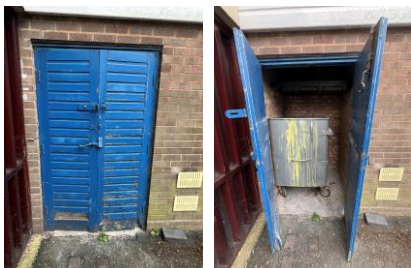
- 2) Refuse bins are stored in secured bin rooms that are located at the front of the building. This is kept secure by a means of a sliding bolt and padlock. Bins Are regularly emptied by site services.

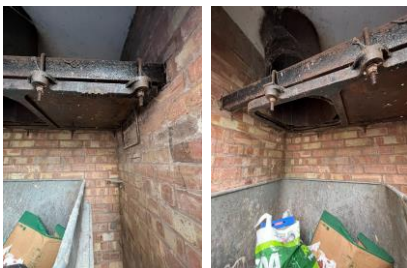
- 3) Refuse storage cupboard has a manual bin closure plate to mitigate any potential fire risk, both 1<sup>st</sup> floor internal refuse chutes are clear of any rubbish.

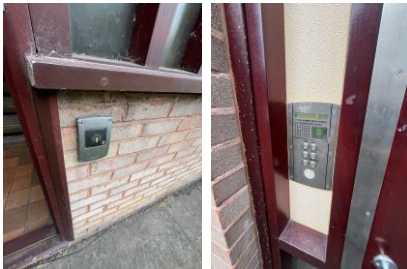
- 1) Regular checks are undertaken by Caretakers / Cleaning Team(s) 365 days per year which helps reduce the risk of arson.
- 2) 60-68 New hope Road has restricted access, this is via door access control, each resident has their own fob to gain access. There is an intercom system that can allow visitors and contractors in.

Both entrance door access systems.

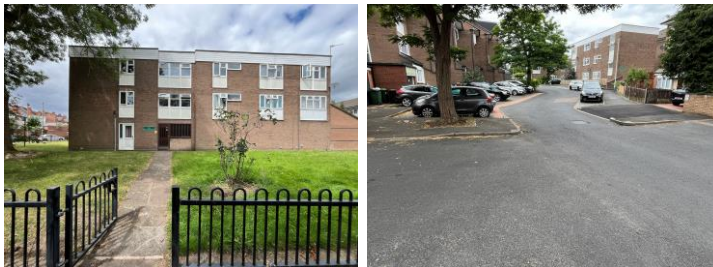
- 3) There is no current evidence of arson.
- 4) The perimeter of the premises is well illuminated. The building has no external lighting units installed, however illumination from the nearby streetlamps provide sufficient lighting
