# **Fire Risk Assessment**

## **Moorlands Court**

**Reservoir Road,  
Rowley Regis B65 9PB**

**Date Completed: 02/07/2026**

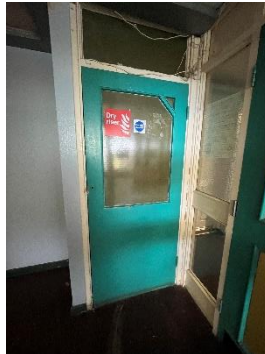
The dry riser outlets are in cupboards adjacent the chute rooms at the lift end of the communal corridor on each floor. Each cupboard is secured with a budget lock.

- 2) The dry riser riser outlets are in cupboards adjacent the chute rooms at the lift end of the communal corridor on each floor. Each cupboard is secured with a budget lock. It was evident that telecommunication cabling within the riser cupboards does hang loose and is generally untidy. The cabling does not restrict the use of the riser outlets and will be made good as part of the significant building refurbishment works that are planned.

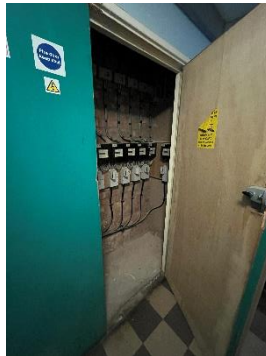
The electrical services to the flats are contained within the electrical riser cupboards, behind modified notional FD30s doors on each floor.

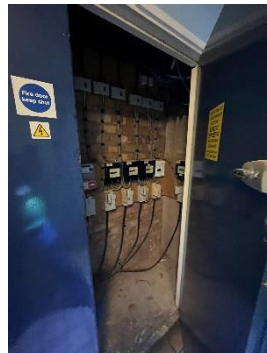
- 15) Electrical service cupboards have notional FD30 rated doors, secured with a suited cylinder lock. Residents have been provided with a key for access to their electricity meters. It is recommended that all service cupboard doors are uprated to FD30s during future building refurbishment works.

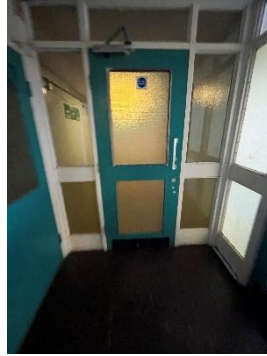
- 5) All communal doors are fitted with automatic closing devices that are checked on a regular basis by Caretaking Teams as part of their checks. Defective closing devices are replaced either by the Caretaking Team(s) or the in-house repairs team(s). It is recommended that all service communal doors are uprated to modern FD30s during future building refurbishment works.

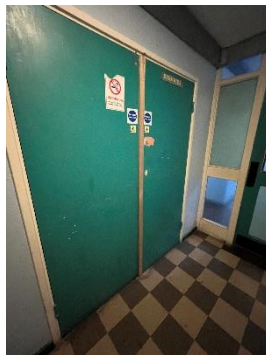
- 6) Service cupboards have FD30 rated doors, secured with a suited cylinder lock. Residents have been provided with a key for access to their electricity meters. It is recommended that all service cupboard doors are uprated to FD30s during future building refurbishment works.

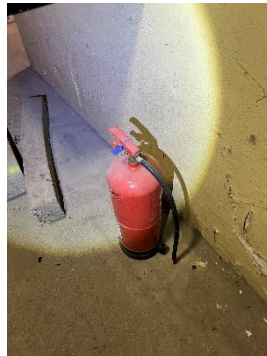
- 5) **Two out of date fire extinguishers in the lower ground floor are required to be removed. See action 11/5.**

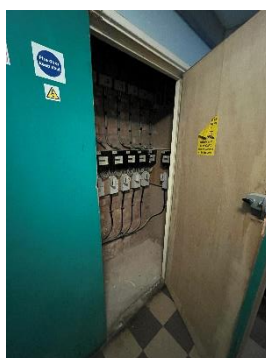
- 3) Hot works are not usually conducted. If essential maintenance requires the use of hot work processes, then corporate policies and procedures are to be followed.
- 4) **The electrical installation shall be tested every 5 years. No satisfactory EICR was available. See action 14/4.**
- 5) Electrical equipment used as part of the Caretaking / Cleaning regime is subject to annual PAT Testing. The Estate Services Manager holds this information.
- 6) The electrical service cupboards have FD30 rated doors, secured with a suited cylinder lock. Residents have been provided with a key for access to their electricity meters. It is recommended that all service cupboard doors are uprated to FD30s during future building refurbishment works.
