# Fire Risk Assessment

**2-6**

**New Hope Road,  
Smethwick,  
B66 3TX**

**Date Completed: 16/07/2026**

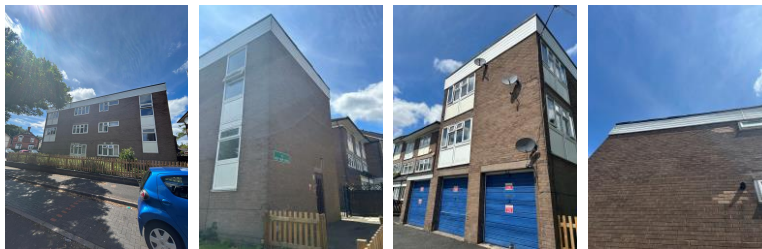
- 1) The external surface of the building is predominantly brick structure. The building has a flat bitumen-felt roof with uPVC fascia boards fitted around the roofline

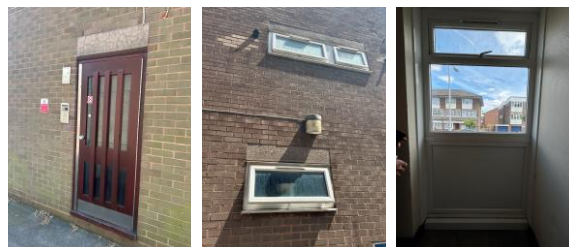
- 2) uPVC double-glazed units have been installed in each flat and within the communal stairway, most of the large units have spandrel panels fitted on the lower sections of the units. The entrance doors are a timber construction with glazed panels.

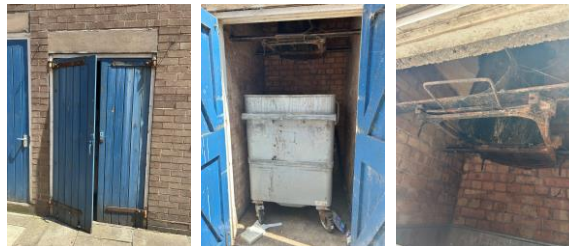
- 4) The blocks bin store is located at the rear of the building beneath the first and second floor. See section 15

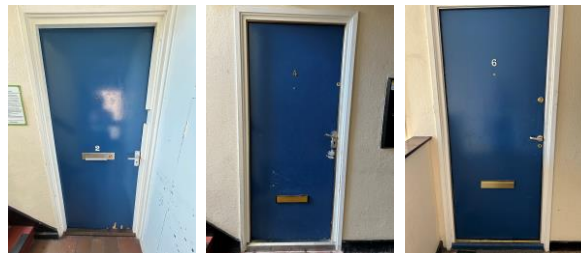
- 1) Each property is fitted with a minimum of an LD3 detection system within the flat. See Section 8
- 2) All corridors are of adequate width (at least 1050mm) and will be maintained clear to that width as a minimum
- 3) None of the corridors that form part of the means of escape are dead ends.
- 4) Flats within the block are fitted with timber notional doors

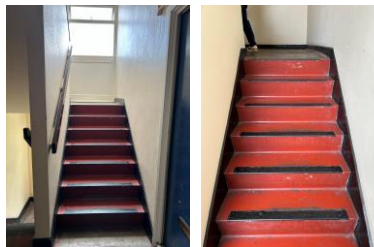
- 7) The flooring and stairway within this property are concrete construction.

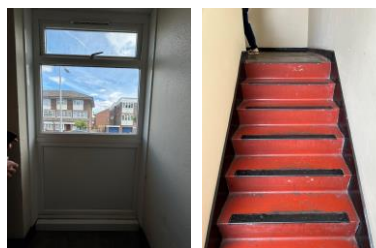
- 8) Automatic smoke ventilation is not employed. Windows fitted on the stairwell are fitted with manual openers; the windows will assist in additional lighting and any ventilation required.

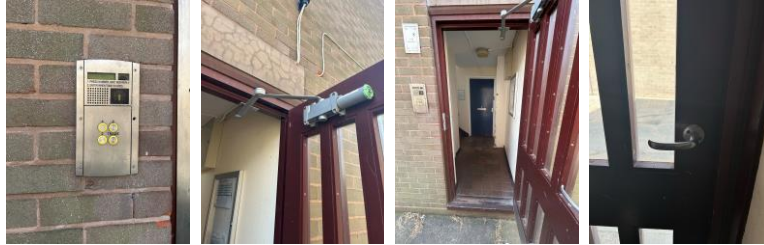
- 9) The final exit doors are operated using a levered handle to egress the building and are also fitted with automatic closing devices that are checked on a regular basis by caretaking teams as part of their checks. Defective closing devices are replaced either by the Caretaking Team(s) or the in-house repairs team(s).

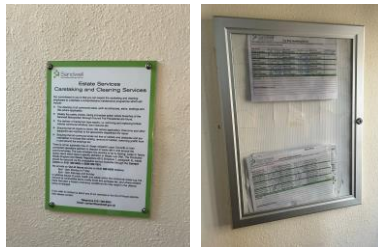
- 10) Communal areas are kept free of flammable items. The communal areas are checked on a regular basis by Caretaking / Cleaning teams 365 days per year, and all items of rubbish are immediately removed. There is also an out of hour's service that allows combustible items of furniture / rubbish to be removed.

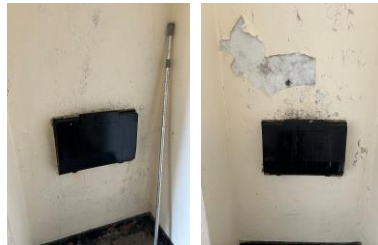
- 13) On the 1st and 2nd floors, a bin-chute hopper door is located adjacent to the flat entrances for residents to dispose of refuse bags.

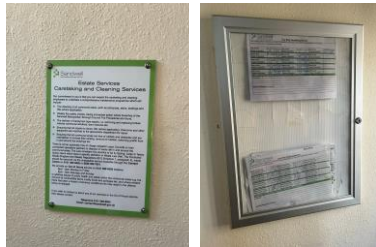
1) There is a regular Cleaning Service to the premises.

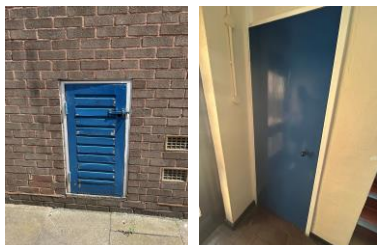
- 1) Residents instructed not to bring L.P.G cylinders into block.
- 2) The tenancy conditions, Section 7 – Condition 5.6 stipulates “If you live in a flat or maisonette, you, people living with you and any visitors to your property must not keep or use paraffin oil, petrol, bottled gas appliances or any other explosive, FLAMMABLE or dangerous material in the property. This restriction also applies to any storage facility situated in or attached to the block, which has been provided for your use.”
- 3) Residents should not store flammable liquids or gas cylinders on site.
- 4) No Flammable liquids stored on site by Caretakers / Cleaners.
- 5) There is a storage cupboard for each flat upon the ground floor and is locked by a tenant only key.
