# Fire Risk Assessment

**9-14**

**Newmans Close,  
Smethwick,  
B66 4SW.**

**Date of Inspection: 6<sup>th</sup> August 2026**

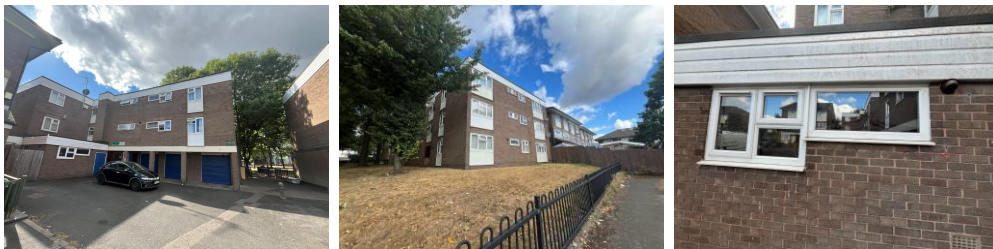
- 1) The external surface of the building is predominantly brick structure. The building has a flat bitumen-felt roof with uPVC fascia boards fitted around the roofline

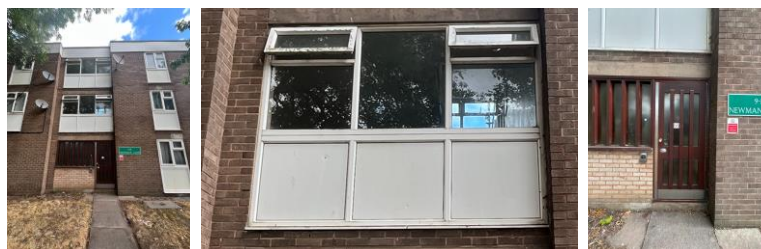
- 2) uPVC double-glazed units have been installed in each flat and within the communal stairway, most of the large units have spandrel panels fitted on the lower sections of the units. The entrance doors are a timber construction with glazed panels.

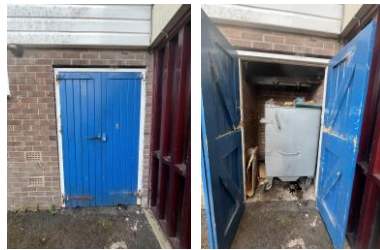
- 4) Adjacent to the front entrance of the block is a secure bin store. The store houses a large, galvanised steel bin which serves the building's bin chute system. Access to the bin store is restricted to authorised users to ensure appropriate control of waste and reduce fire loading in this area.

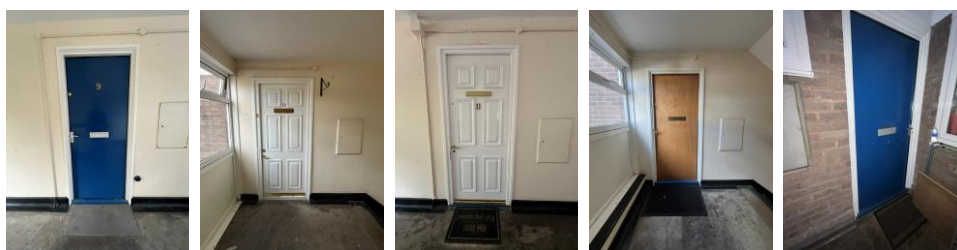
- 1) Each property is fitted with a minimum of an LD3 detection system within the flat.  
See Section 8
- 2) All corridors are of adequate width (at least 1050mm) and will be maintained clear to that width as a minimum
- 3) None of the corridors that form part of the means of escape are dead ends.
- 4) Majority of the flats within the block are fitted with timber notional doors, with two flats having composite FD30s door fitted.

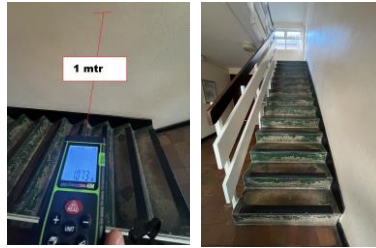
- 6) Within the block each floor is accessed via a single staircase that provides a means of escape for the flats on the 1<sup>st</sup> and 2<sup>nd</sup> floors, the width of the staircase is 1.073m handrail to wall.

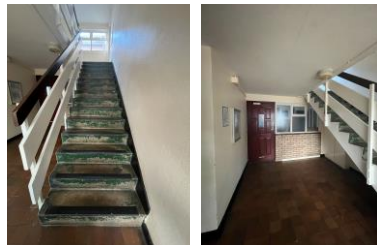
- 8) The flooring and stairway within this property are concrete construction.

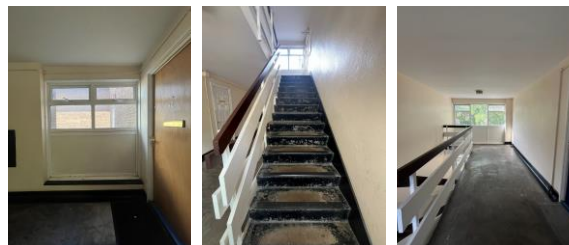
- 9) Automatic smoke ventilation is not employed. Windows fitted on the stairwell are fitted with manual openers; the windows will assist in additional lighting and any ventilation required.

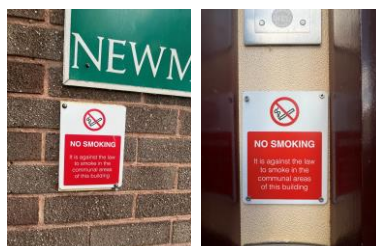
2) Smoking is prohibited within any communal parts of the building in line with Smoke Free England legislation. Signage is installed to notify residents and visitors of this.

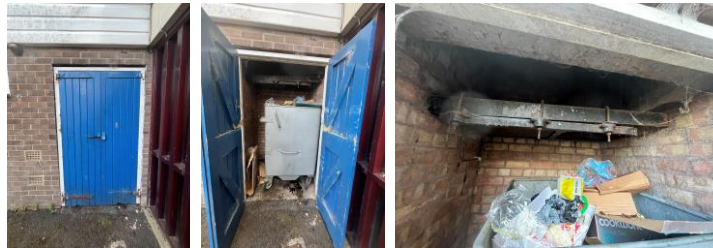
- 2) Refuse bins for Newmans Close 9-14 are stored within a designated storage cupboard. This area also functions as the bin-chute room, with hopper doors located on the 1st and 2nd floors for residents to dispose of refuse. The bins are emptied as part of the routine waste collection service.
