# Fire Risk Assessment

**15-19**

**Newmans Close,  
Smethwick,  
B66 4SW.**

**Date of Inspection: 11<sup>th</sup> August 2026**

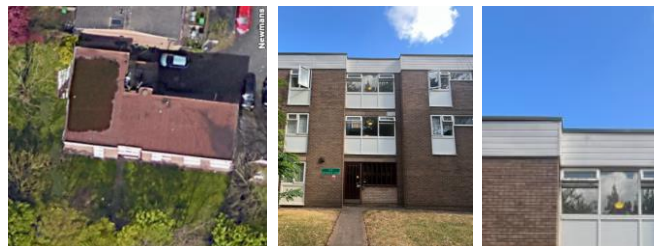
The low-rise three-storey block was built in 1968 using traditional brick cavity and concrete construction. The building has a flat bitumen-felt roof with uPVC fascia boards fitted around the roofline.

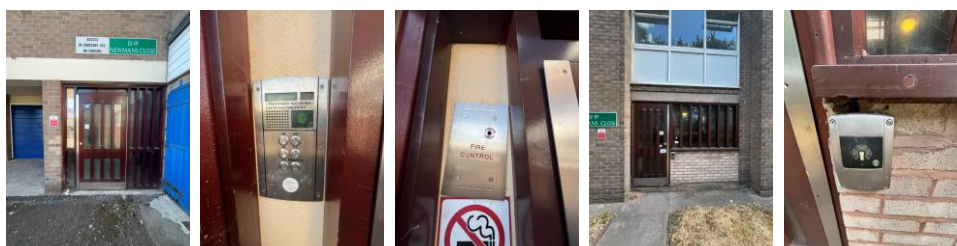
The building is a detached residential block positioned at the end of the close. Access is provided from the front via Bishops Close and from the rear via the A457 Grove Lane. The entrance and exit doors are of timber construction with glazed panel insets. Front-entrance access is controlled by a fob system, flat call button, and fire-service drop key, while the rear entrance is fob-controlled only.

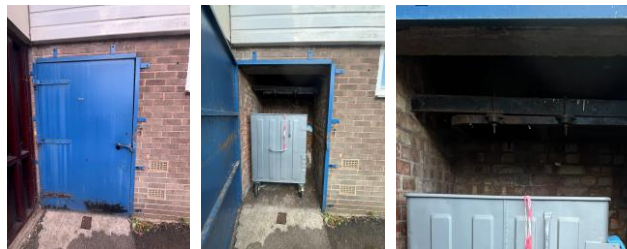
The blocks bin store is located adjacent to the front door. This is secured by a steel door. Within this store is a commercial-grade metal wheelie bin, functioning as the receptacle for refuse discharged via the block's bin chute.

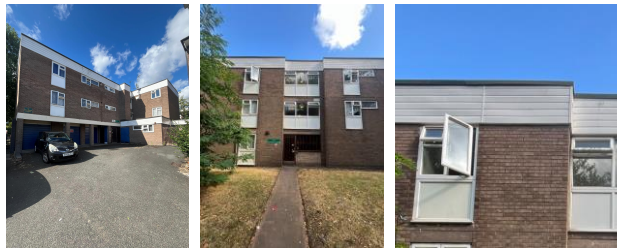
- 1) The external surface of the building is predominantly brick structure. The building has a flat bitumen-felt roof with uPVC fascia boards fitted around the roofline

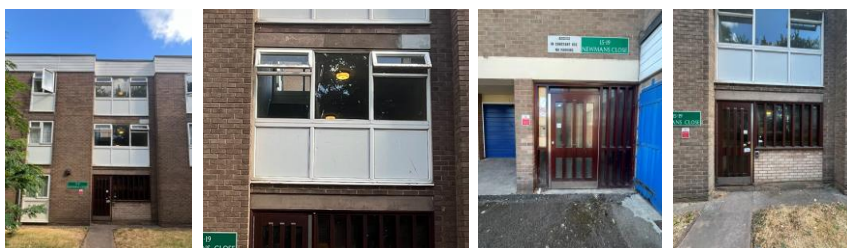
- 2) uPVC double-glazed units have been installed in each flat and within the communal stairway, most of the large units have spandrel panels fitted on the lower sections of the units. The entrance doors are a timber construction with glazed panels.

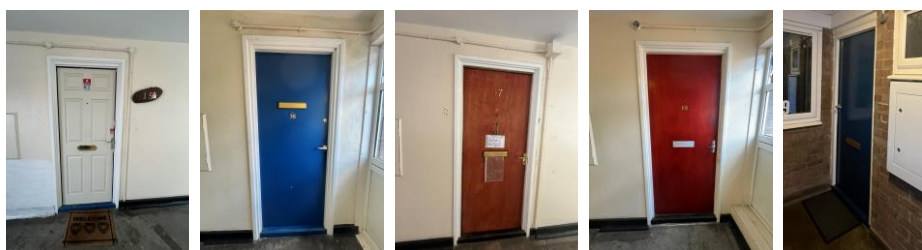
- 1) Each property is fitted with a minimum of an LD3 detection system within the flat.  
See Section 8
- 2) All corridors are of adequate width (at least 1050mm) and will be maintained clear to that width as a minimum
- 3) None of the corridors that form part of the means of escape are dead ends.
- 4) Majority of the flats within the block are fitted with timber notional doors, with two flats having composite FD30s door fitted.

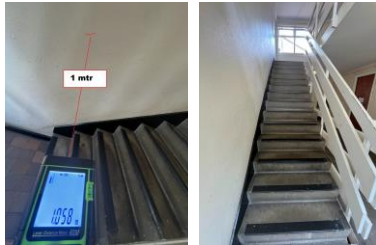
- 7) Within the block each floor is accessed via a single staircase that provides a means of escape for the flats on the 1<sup>st</sup> and 2<sup>nd</sup> floors, the width of the staircase is 1.073m handrail to wall.

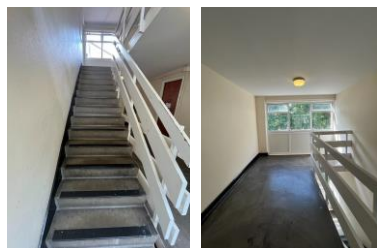
- 9) The flooring and stairway within this property are concrete construction.

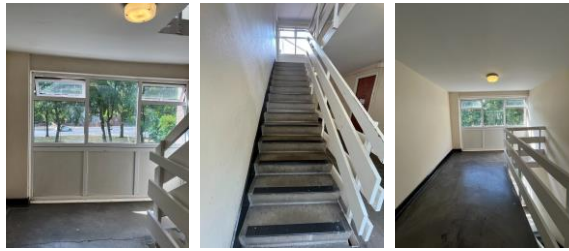
- 10) Automatic smoke ventilation is not employed. Windows fitted on the stairwell are fitted with manual openers; the windows will assist in additional lighting and any ventilation required.

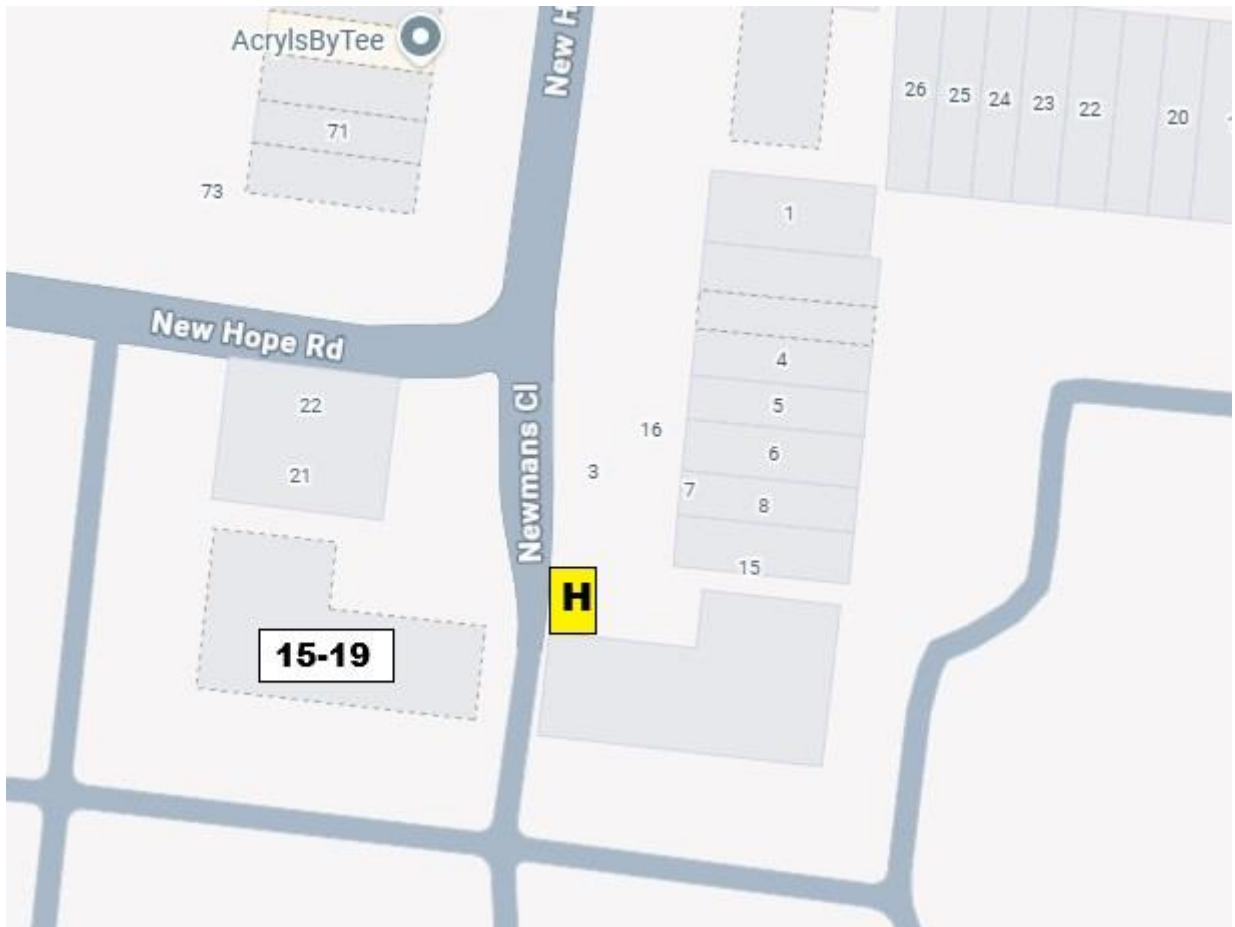
- 1) There is no firefighting equipment on this premises.
- 2) Nearest fire hydrant is indicated within the attached plan.

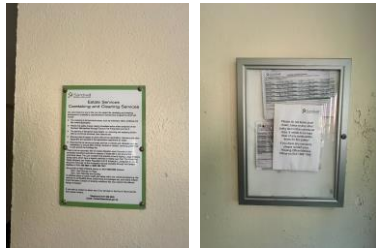
- 1) There is a regular Cleaning Service to the premises.

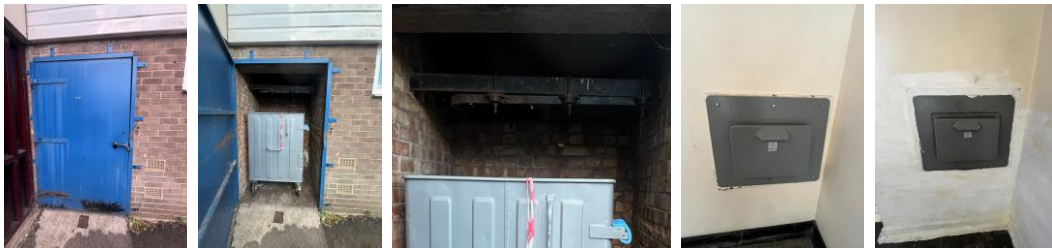
- 2) Refuse bins for Newmans Close 15-19 are stored within a designated storage cupboard. This area also functions as the bin-chute room, with hopper doors located on the 1st and 2nd floors for residents to dispose of refuse. The bins are emptied as part of the routine waste collection service.
