# Fire Risk Assessment

## Bearwood Road 200 - 238

**Date of Inspection:** 3<sup>rd</sup> August 2026

**Current Risk Rating = Tolerable**

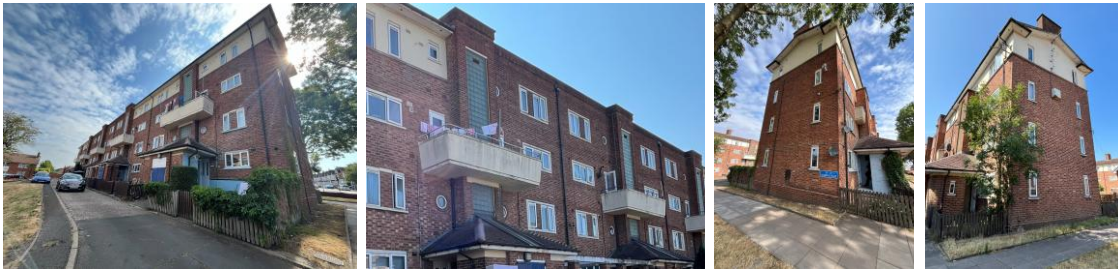
2) Communal stairwells feature glass panes, while individual residential units are fitted with UPVC double-glazed windows. The buildings is constructed with traditional tiled or slated pitched roofs. Ground-floor flats feature front and rear garden areas, with select boundaries partitioned by timber fencing. Upper-floor flats feature external concrete balconies, which require monitoring to ensure they remain clear of combustible materials and storage items.

Glass panes in communal stairwell with concrete balconies, UPVC window units and pitched roof

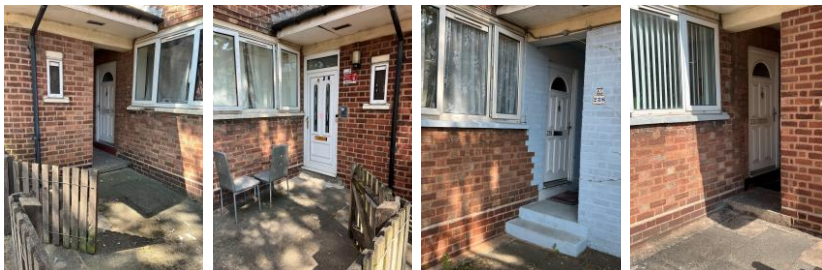
Examples of ground floor flats open to fresh air.

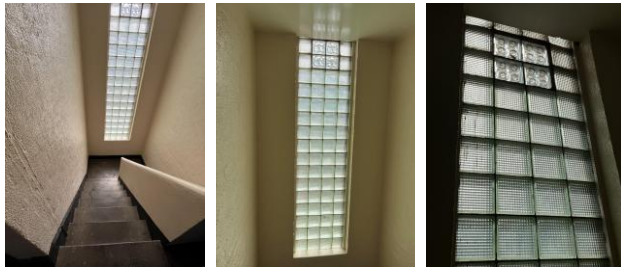
- 7) While there are no openable communal windows, natural ventilation is provided via dedicated vents integrated into the glass panes at the head of the communal staircase. This will reduce any smoke logging in the communal stairwell in an event of a fire.

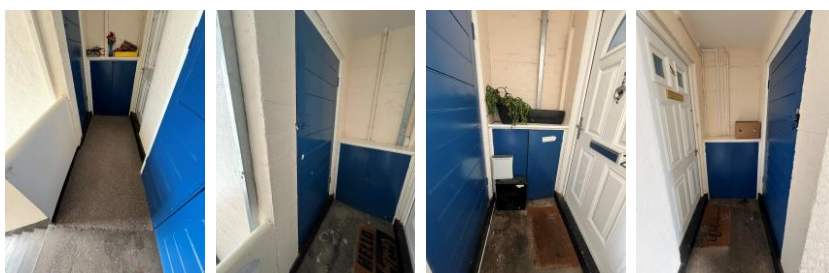
- 9) Service cupboards containing resident's meters are located on landings next to flat entrance doors.

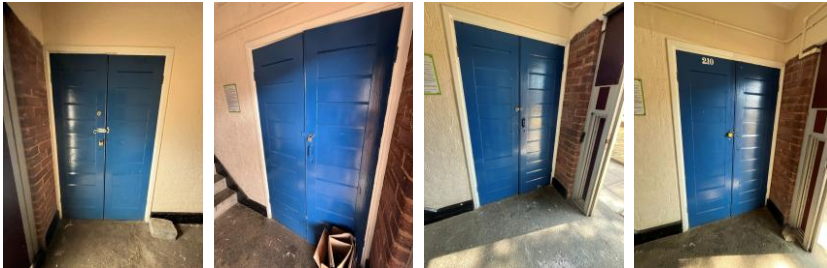
- 10) Residents are allocated storage cupboards, these can be found on the ground floor communal entrance to each block, there are further storage cupboards on the 2<sup>nd</sup> floor adjacent to each flat on this floor. These could not be accessed on the day of conducting FRA.

Samples of ground floor storage cupboards.

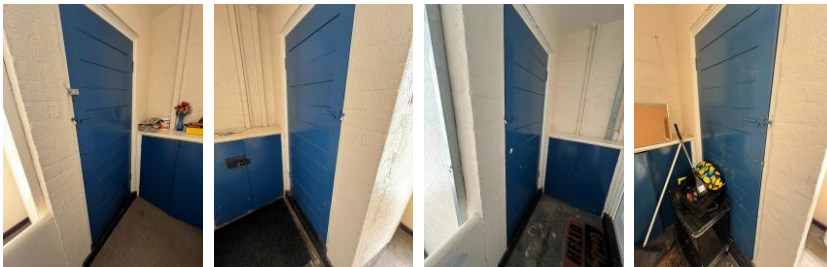
Samples of 2<sup>nd</sup> floor storage cupboards adjacent to flats

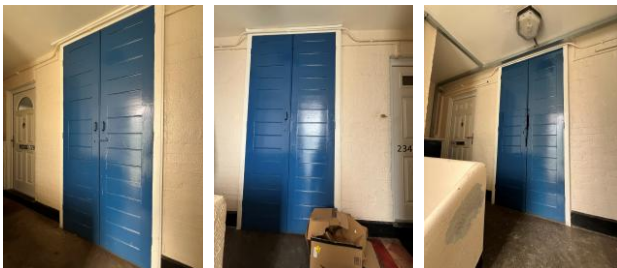
- 11) There are cupboards in between the 2 flats on the 2<sup>nd</sup> floor to each block, these are secured and not in use.

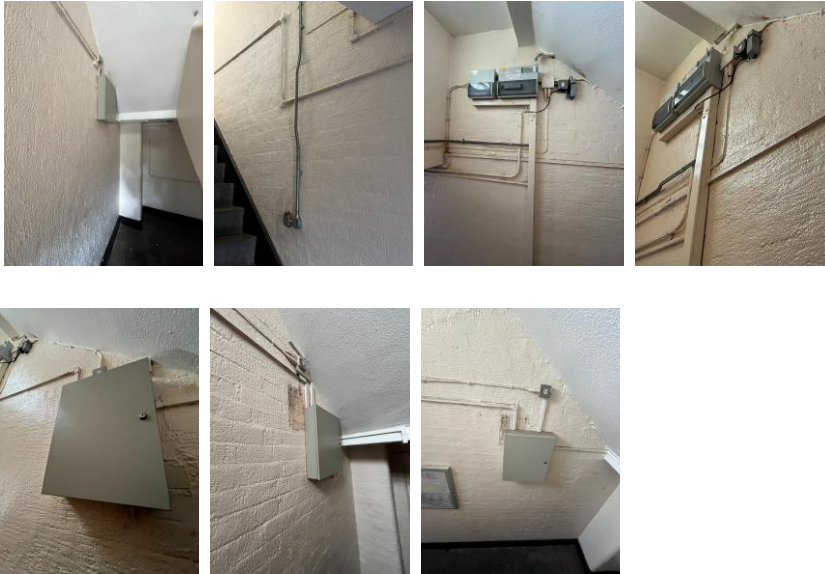
- 16) All electrical cabling within the communal corridors and protected escape routes is securely enclosed within metal trunking and metal conduits to prevent premature collapse in a fire. Additionally, the surface-mounted electrical distribution board on block serving flats 218 & 220 is positioned clear of the exit route and does not encroach on the required escape width or present a significant obstruction to means of escape. Door access control units in all blocks are installed clear from escape routes.**
-

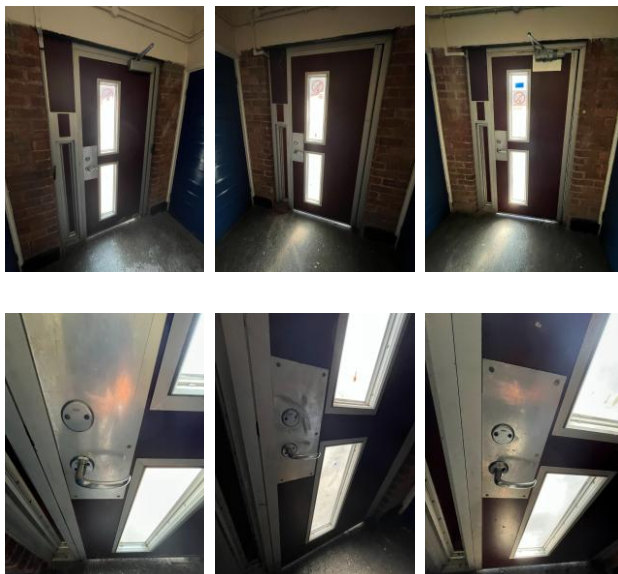
- 18) There is a clear and safe exit out of the building via the ground floor exits. The final front exit doors are accessed using levered handles.**

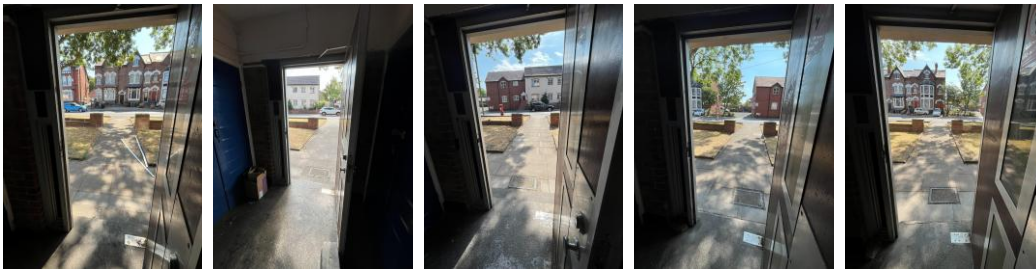
- 20) The route out the block to ultimate safety is clear from single final exit door.

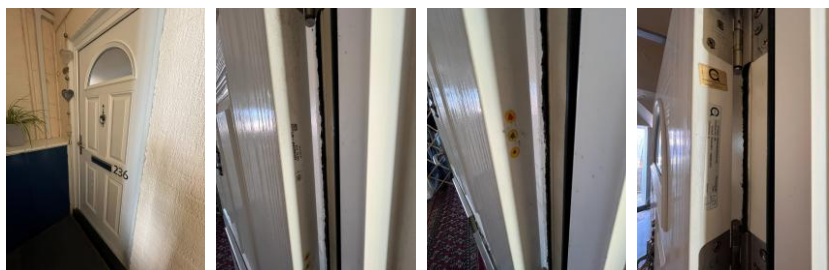
- 9) Individual flat doors are composite FD30s fire rated door sets with intumescent strips, cold smoke seals and self-closing devices.

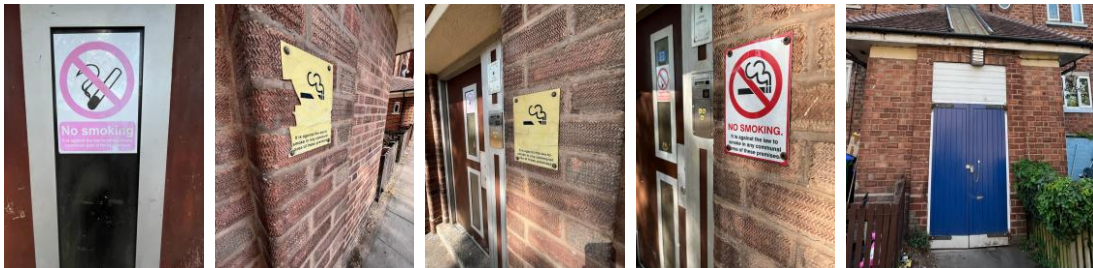
- 1) There is no fire doors installed within the premise therefore Fire Door signage is not currently required.
- 2) Smoking is prohibited within any communal parts of the building in line with Smoke Free England legislation. Signage is not displayed in the external refuse cupboard located next to the entrance doors

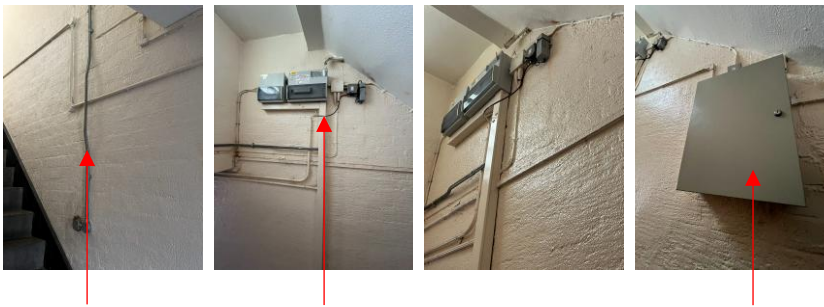
Metal conduit, metal enclosed D.B, metal Door access control power supply.

- 8) There is a run of Extra Low Voltage data cables that are fed from the door access control unit in the communal hallway to the door, these cable are housed in plastic trunking, at present the risk is low, but it is recommended that any refurbishment of the block that these cable be housed in metal trunking separate to any low voltage cables.

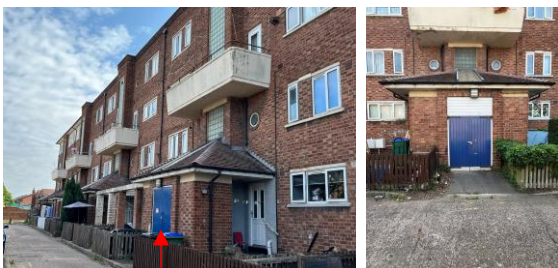
- 3) Bins are located externally within a secure brick compound to the rear of the block, the compound is secured by timber doors and padlocked, access is only available for refuse collection staff and residents.

Bin Storage compound

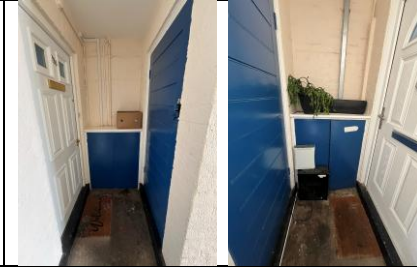
- 17) Resident electrical cupboards located adjacent to flat entrances on the 2<sup>nd</sup> floor on each block are secured by a timber door. *Recommended that these doors be upgraded to certified fire doors on any future works program for the building.*

All resident electrical cupboards to be upgraded to FD30s fire rated enclosures and appropriate signage to be attached regarding Fire Door Keep Locked on any future works program.
