Fire Risk Assessment Severn House (1-7)

Queensway, Oldbury B68 0HP.

Date Completed: 23.04.25 Review Period: 3 years. Officer: A. Froggatt Building Safety Manager Checked By: A. Jones Building Safety Manager

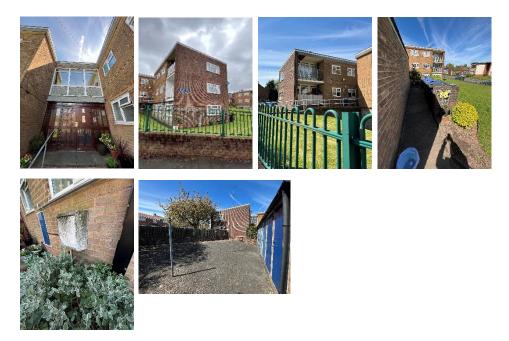
High/Low Rise	Low Rise
Number of Floors	3 (including lower ground)
Date of Construction	1965.
Construction Type	Solid Brick Construction
Last Refurbished	Unknown
External Cladding	Small amount of spandrel panels.
Number of Lifts	None
Number of Staircases	1
Automatic Smoke Ventilation to	None
communal area	
Fire Alarm System	None in common area
Refuse Chute	None
Access to Roof	Externally only
Equipment on roof (e.g. mobile	None
phone station etc)
