Fire Risk Assessment Minster Close

Flats 2 - 13 Minster Close. Rowley Regis B65 0RS.

Date Completed: 30/04/2025.

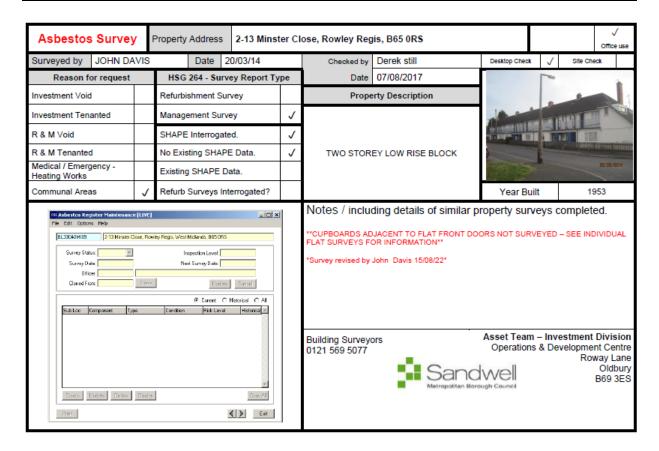
Hazard	Information/Comments
Asbestos	An asbestos survey has been undertaken of the communal areas. Survey held by Sandwell Housing (Derek Still Tel:- 0121 569 5077).

Sample Locations		Property Address 2-13 Minster Close, Rowley Regis, B65 0RS											
LOCATION		MATI	MATERIAL		r	SURFACE TREATMENT	SAMPLE REF	R	RESULT HSE		(papelled)		TION TAKEN ON CONTRACT
IF DURING THE COURSE OF WORK	SUSP	ECTED A	M'S ARI	E IDENTIF	IEC	THAT ARE NO	CONTAINED	WITH	IN THIS REP	ORT ST	OP W	ORK & S	SEEK ADVICE
MAIN ROOF COVERING		BITUMIN	OUS FELT	-		SEALED	TE 1340		NO ASBESTOS NO DETECTED NO		NO		
D.P.C.		BITUMEN		-		SEALED	-	NO	NOT SAMPLED PI			PLEASE REQUEST SAMPLE IF TO BE DISTURBED	
DECK ACCESS WALKWAY FLOOR SURFACE	E	ASPHALT		-		SEALED	-	NO	NOT SAMPLED		-	PLEASE REQUEST SAMPLE IF TO BE DISTURBED	
TEXTURED COATING TO EXTERNAL BRICKWO	ORK	TEXTURE	TEXTURED COATING			PAINT SEALED	JD 325 / 001	NON	ONE DETECTED NO		NO		
ITEMS SHOWN BELOW	ITEMS SHOWN BELOW HAVE BEEN ASSESSED ON SITE BY THE ASBESTOS SURVEYOR & ARE CONFIRMED NOT TO BE ACM'S.												
LOCATION DESCRIPTION	MAT	MATERIAL LOC		CATION DESCRIPTION		CRIPTION	MATERIAL	L LOCATIO		N DESCRIPTION			MATERIAL
