Fire Risk Assessment 33-64 Horton St

Tipton, DY4 7JW

Date Completed: 08/10/2025

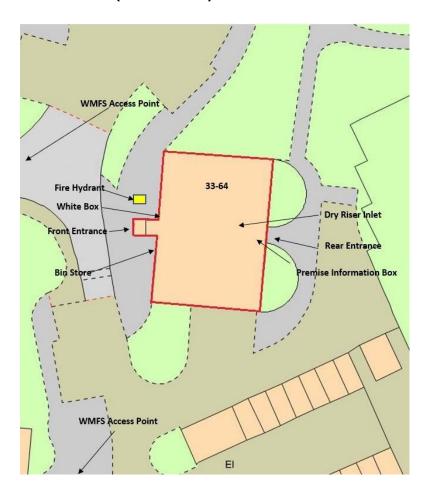
On arrival Information (for WMFS)

There is a firefighter's white box externally to the left-hand side of the main entrance to the front of the building. The box contains keys for the building and is secured with a bridge-door padlock. All keys are the same for the neighbouring three blocks, each block has its own set within its own firefighter's white box.

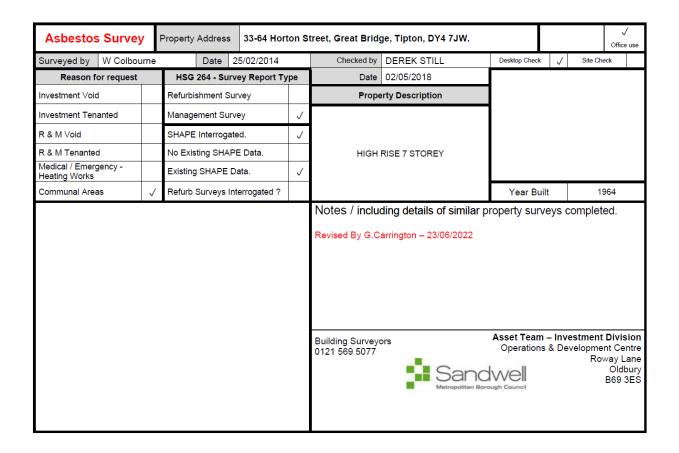
Hazard	Information/Comments
Asbestos	An asbestos survey has been undertaken of the communal areas. Survey held by Sandwell Housing (Derek Still Tel:- 0121 569 5077). Include survey

Sample Locations		Prope Addre		33-64 Hor	ton Street, Gr	eat Bridge, T	pton, DY4 7JW	<i>I</i> .		
LOCATION		MAT	ERIAL	QTY	SURFACE TREATMENT	SAMPLE REF	RESULT	HSE NOTIF Y	Labelled ?	ACTION TAKEN ON CONTRACT
IF DURING THE COURSE OF WOR	K SUSP	PECTED A	CM'S ARE	IDENTIFIE	D THAT ARE NO	T CONTAINED	WITHIN THIS REP	ORT ST	OP W	ORK & SEEK ADVICE
FLOORS 1-7 WALLS		TEXTUR	RED COAT	100m2+	SEALED	BB3338	NONASBESTOS	NO	NO	
FLOORS 1-7 CEILING		TEXTUR	RED COAT	100m2+	SEALED	BB3338	NONASBESTOS	NO	NO	
GROUND FLOOR WALLS		TEXTUR	RED COAT	60m2	SEALED	BB3338	NONASBESTOS	NO	NO	
LIFT MOTOR ROOM				•		NO ACMS F	OUND			1
ALL BALCONIES - RAIN WATER PIPE		CEI	MENT	-	SEALED	PRESUMED	CHRYSOTILE	NO	-	-
FLAT ROOF MINERAL FELT TO LIFT MOTOR-FRONT AND REAR ENTRANCES		BITUN	MINOUS	-	-	-	-	-	-	REQUEST SAMPLE IF TO BE DISTURBED
ITEMS SHOWN BELOW HAVE BEEN ASSESSED ON SITE BY THE ASBESTOS SURVEYOR & ARE CONFIRMED NOT TO BE ACM'S.
