Fire Risk Assessment 65-96 Horton St

Tipton, DY4 7JW

Date Completed: 02/10/2025

Current Risk Rating = Tolerable

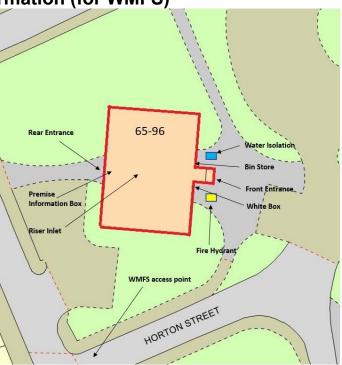
On arrival Information (for WMFS)

There is a firefighter's white box externally to the left-hand side of the main entrance to the front of the building. The box contains keys for the building and is secured with a bridge-door padlock.

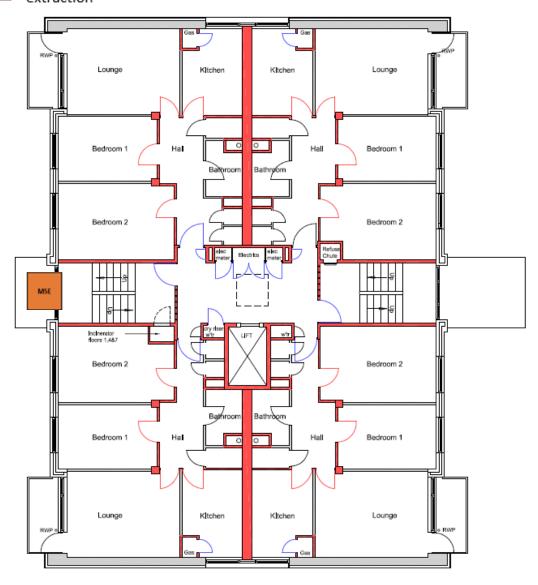
Floor 7

mechanical smoke extraction

11) There is a master reset / activation switch located on the 7th floor rear staircase landing. The switch is operated by a key which can be found in the firefighter's white box.

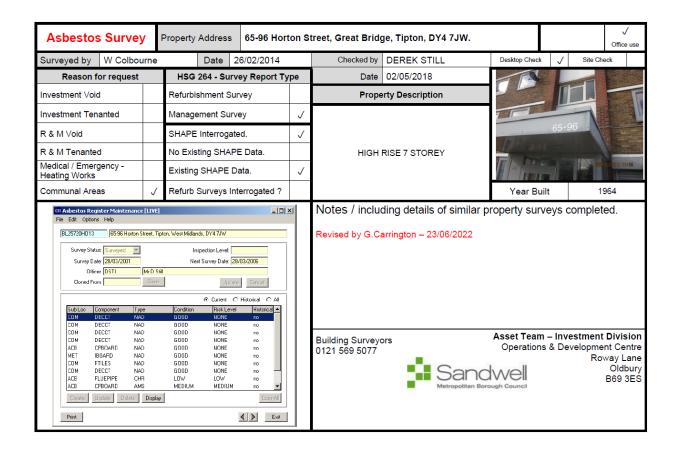
Hazard	Information/Comments
Asbestos	An asbestos survey has been undertaken of the communal areas. Survey held by Sandwell Housing (Derek Still Tel:- 0121 569 5077). Include survey

LIFT MOTOR ROOM CEILING	PLASTE	ERBOARD	D							
FLOOR 7 DRY RISER CEILING	PLASTE	ERBOARD								
ALL LANDING DUCT COVERS UNLESS STATED ABOVE		SUPALUX PLYWOOD								
GROUND FLOOR TRANSOM PANEL OVER INNER DOOR		PALUX WOOD								
GROUND FLOOR HIGH LEVEL BOXING TO TRUNKING NEXT TO FRONT ENTRACE DOOR
