# Fire Risk Assessment Horton St.

1 – 32, Horton Street Tipton, DY4 7JN

**Date Completed:** 08/10/2025. **Review Period:** 12 months.

**Current Risk Rating = Tolerable**

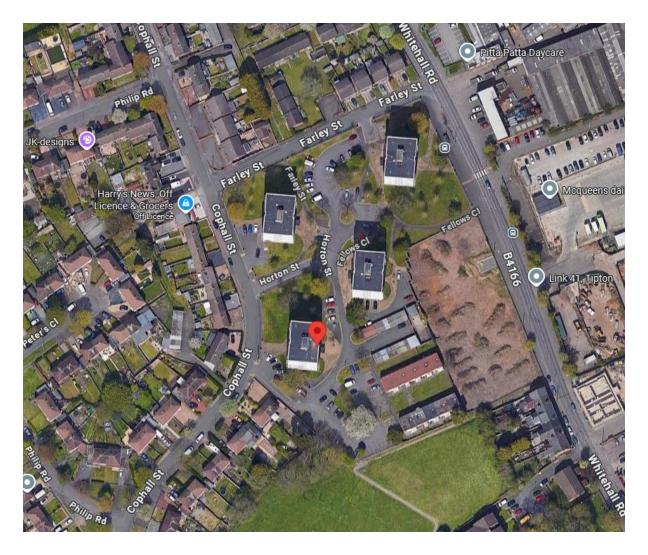
Aerial View – Block 1; 1-32 Horton Street.

A typical floor layout showing horizontal lines of compartmentation, lift shafts, dry riser installation and AOVs etc.
