## Fire Risk Assessment Meadow Avenue (Aspen)

Charlemont Farm, West Bromwich, B71 3EF.

**Date Completed:** 04/02/2025

**Current Risk Rating = Trivial**

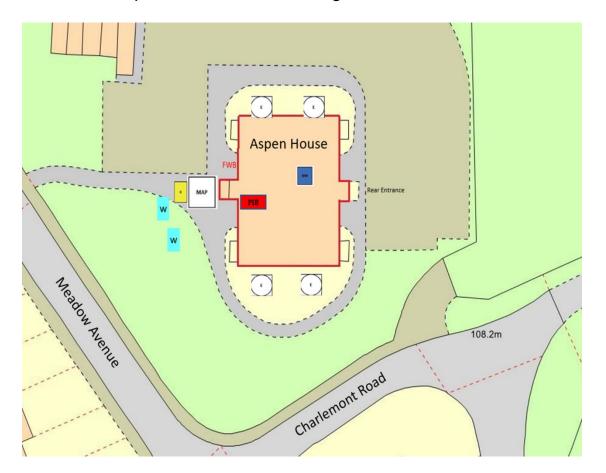
### **Orientation Plan**

The location of service isolation points for gas, electricity and water are detailed on a plan located in the fire fighter's white box.

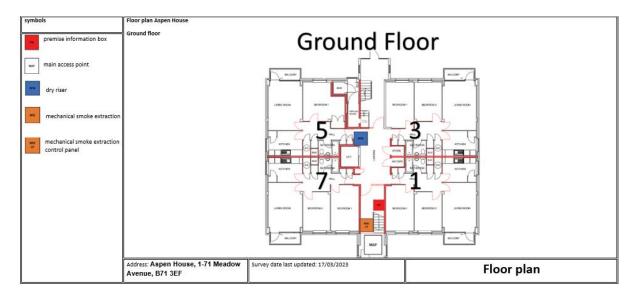
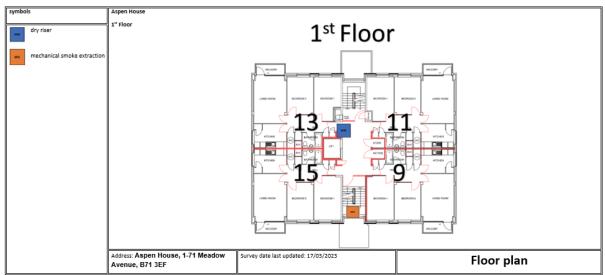
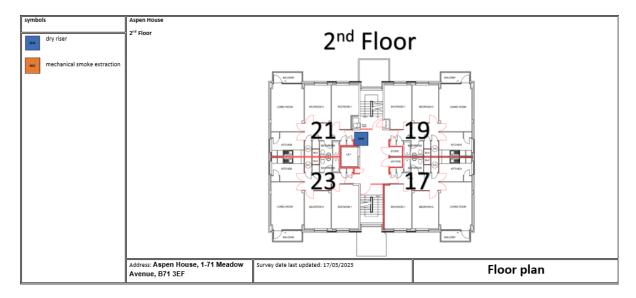
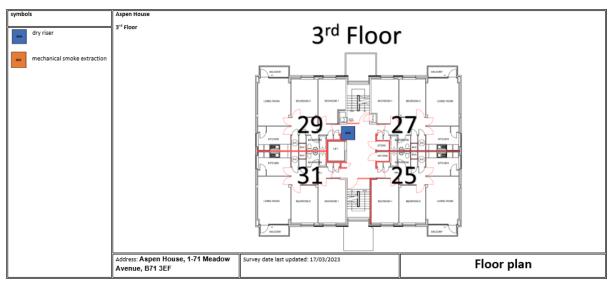
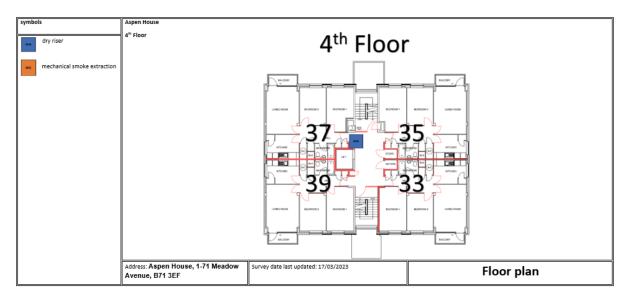
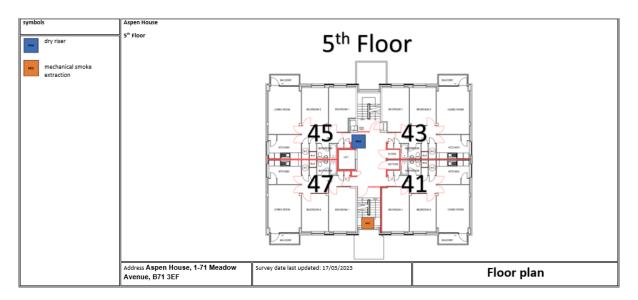
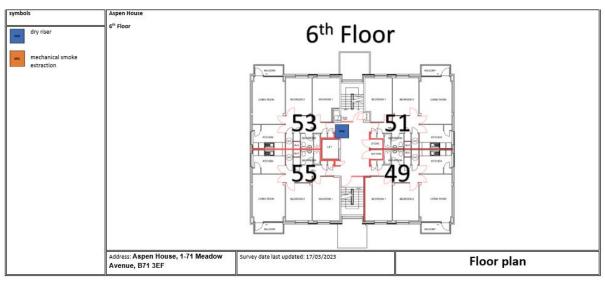
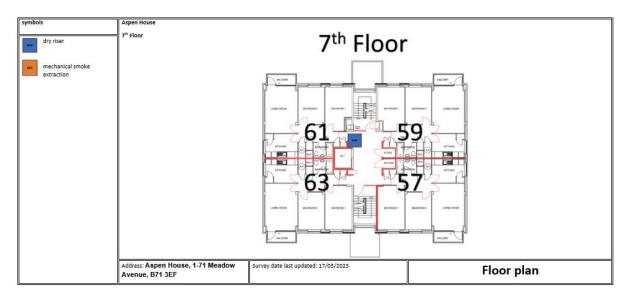
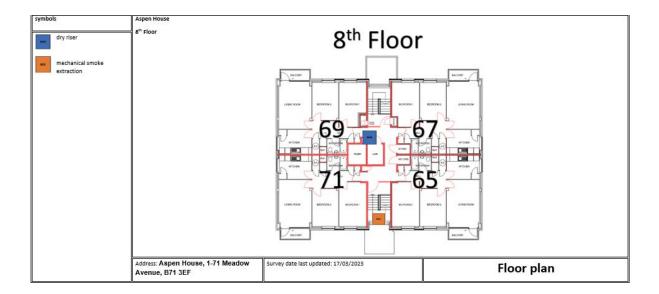
A typical floor layout showing horizontal lines of compartmentation, emergency lighting, fire detection is attached and AOVs etc.

The plans have been shared with WMFS electronically via their portal.

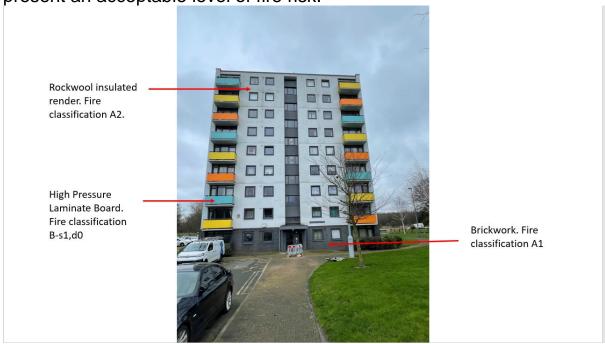
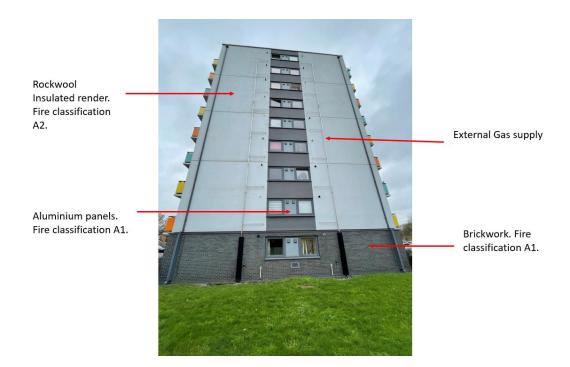
Below is a breakdown of the materials used within the external envelope and, as part of the external wall system of Aspen House. It is deemed that the combination and application of these materials present an acceptable level of fire risk.

Section number	Section Area	Individual Risk Level
Section 6	External Envelope	Trivial
	Brickwork from ground to 1 <sup>ST</sup> floor. Fire classification A1.	
	Wetherby EW1 render system 1 <sup>st</sup> to 8th floor. Fire classification A2	
	Trespa HPL panels to balconies. Fire classification B-s1, d0.	
	Aluminium panels. Fire classification A1.

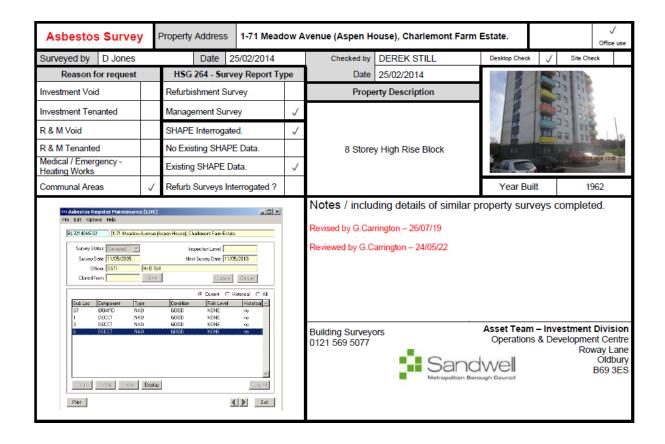
Hazard	Information/Comments
Asbestos	An asbestos survey has been undertaken of the communal areas. Survey held by Sandwell Housing (Derek Still Tel:- 0121 569 5077).  Include survey

Sample Locations		Prope Addre		1-71 Mea	dow Avenue (	Aspen House	), Charlemont	Farm E	ACTION TAKEN ON CONTRACT  T STOP WORK & SEEK ADVICE  O NO			
LOCATION		MAT	ERIAL	QTY	SURFACE		RESULT	HSE NOTIF Y	Labelled ?			
IF DURING THE COURSE OF WOR	K SUSF	ECTED A	CM'S ARE	E IDENTIFIE	ED THAT ARE N	OT CONTAINED	WITHIN THIS REF	ORT ST	OP W	ORK & SEEK ADVICE		
F LOORS TO ALL COMMUNAL LANDINGS	3	THERM	OPLASTIC	-	SEALED	PRESUMED	CHRYSOTILE	NO	NO			
ALL COMMUNAL LANDING WALLS		TEXTURE	D COATING	3 -	SEALED	DJ309/001	NO ASBESTOS DETECTED	-	-	-		
ELECTRICAL FUSE FLASH PADS		R	OPE	-	UNSEALED	PRESUMED	CHRYSOTILE	YES	-			
ITEMS SHOWN BELOW HAVE BEEN ASSESSED ON SITE BY THE ASBESTOS SURV						OS SURVEYOR	& ARE CONFIRM	ED NOT	то ве	ACM's.		
LOCATION DESCRIPTION MA		TERIAL	LOC	CATION DE	SCRIPTION	MATERIAL	LOCATIO	N DESC	DESCRIPTION MATERIAL			
		AL FIBRE DARD										
MAIN EXTERNAL ROOF MINE		RAL FELT										
8 <sup>™</sup> FLOOR CUPBOARD ADJ. FLAT 71 CEILING SU		PALUX
