Fire Risk Assessment Farley Street

97 – 128, Farley Street Tipton, DY4 7LA.

Date Completed: 02/10/2025

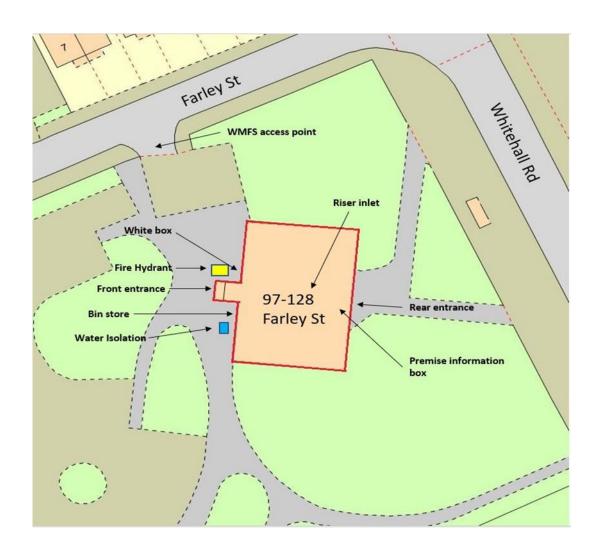
On arrival Information (for WMFS)

Address: Block 97-128 Farley Street DY4 7LA	Survey date: 18/09/2024	ON ARRIVAL INFORMATION	
BUILDING LAYOUT			
Building height	21.6 metres		
Construction	Wates, concrete brick		
Number of floors	8 including ground floor		
Layout	The block consists of 8 storeys (inclusive of the gro	ound floor). Each of the floors contains 4 number dwellings,	
	Lift granting access up to the 7 th floor, aluminium I to the lift motor room via a trap door. A full height	ladders stored in the 7 th floor storage cupboard grants access t door then grants access to the main roof.	
	2 sets of staircases granting access to all 8 floors of	f the block located at the front and rear of the block.	
	Corridors and stairs are protected by FD30s doors.		
	2 sets of ingress / egress points to the block with t MAP (main access point)	he override switch, FWB and fire hydrant located nearest the	
Lifts	1		
Types of entrance doors	FD30s	ruction. Communal doors within the block are notional timber

Rubbish chutes/ bin rooms	Yes		
Common voids	No		
Access to roof/ service rooms	Aluminium ladder (stored in dry riser 7 th floor cupboard) gives access into motor room through a trap (top floor landing). A full height door then allows access onto the main roof.		
Occupants	Approx. 68 based on an average of 2 occupants per flats (32 flats)		
Evacuation strategy	Stay Put Unless-The escape strategy is 'Stay Put Unless'. This means in the event of a fire in your flat you should evacuate. If there is a fire elsewhere in the building you should stay put unless you are affected by fire or smoke		
Fire alarm/ evacuation alarm	Early warning is limited to hard wired or battery smoke alarms within each of the resident's flats.		
Caretaker/ concierge	Caretaking/cleaning service that conducts regular checks of the building		
FIREFIGHTING SYSTEM	S		
Water supplies	Fire hydrant is located at the entrance of the build the orientation plan, there is a dry riser that serve	ling, fire hydrant location/ water isolation points located on s the building outlets located on the floor plans.
