# Fire Risk Assessment 13-20 Salop Drive

# Salop Drive, Oldbury, B68 9AG

Date Completed: 27.05.25.

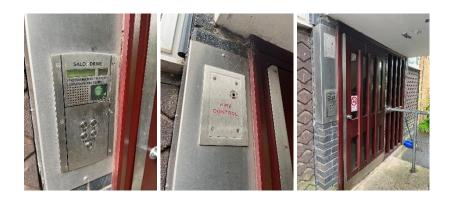
The block has a front entrance, for each core, that has a door entry system, with a fob reader installed. Local authority employees and the fire & rescue service can use a drop latch key to gain access.

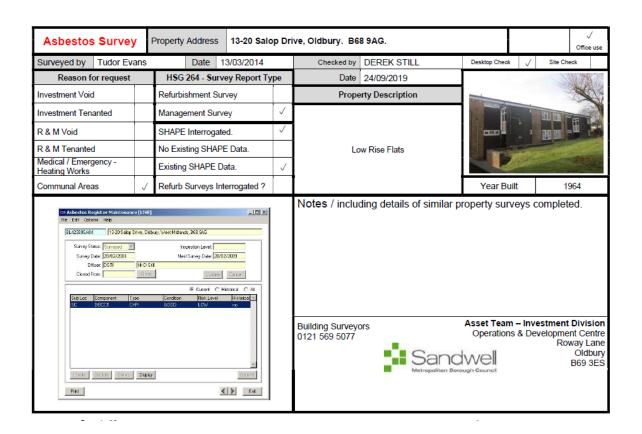
Hazard	Information/Comments
Asbestos	An asbestos survey has been undertaken of the communal areas. Survey held by Sandwell Housing (Derek Still Tel:- 0121 569 5077).

Sample Locations		Prope Addre		3-20 Salo	p Drive, Oldb	ury. B68 9A0	€.			
LOCATION		MAT	ERIAL	QTY	SURFACE TREATMENT	SAMPLE REF	RESULT	HSE NOTIF Y	Labelled ?	ACTION TAKEN ON CONTRACT
IF DURING THE COURSE OF WOR	K SUSF	ECTED A	M'S ARE	IDENTIFIE	D THAT ARE NO	T CONTAINED	WITHIN THIS REP	ORT ST	OP W	ORK & SEEK ADVICE
INTERNAL STAIRWELL WALLS AND CEILIN	GS	TEXTURED COATING		-	SEALED-PAINT	TE 479	NO ASBESTOS DETECTED	NO	NO	-
ELECTRIC CUPBOARD REAR WALL		TEXTURED PAINT		-	SEALED-PAINT	TE 480	NO ASBESTOS DETECTED	NO	NO	-
DAMP PROOF COURSE		BITUMINOUS		-	-	-	-	-	-	REQUEST SAMPLE IF TO BE DISTURBED
				_						
				_
