# Fire Risk Assessment 33-44 Salop Drive

### Salop Drive, Oldbury, B68 9AG

This type 1 fire risk assessment covers Salop Drive flats 33-44.

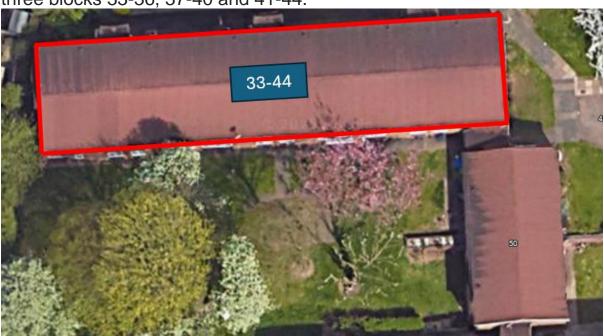
The premise consists of a 2-storey link-detached building, sub-divided into three blocks 33-36, 37-40 and 41-44.

Each block has a single entry point, single open plan staircase and contains two ground floor and two 1<sup>st</sup> floor flats, 12 in total.

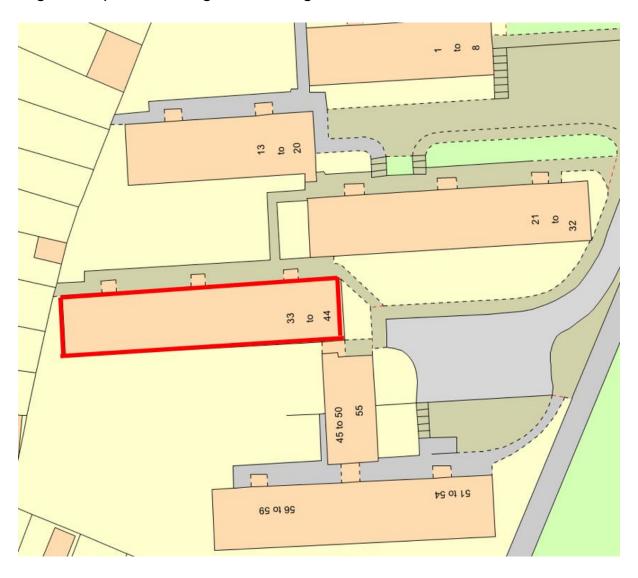
### **Building Plan**

A general plan showing the building location.

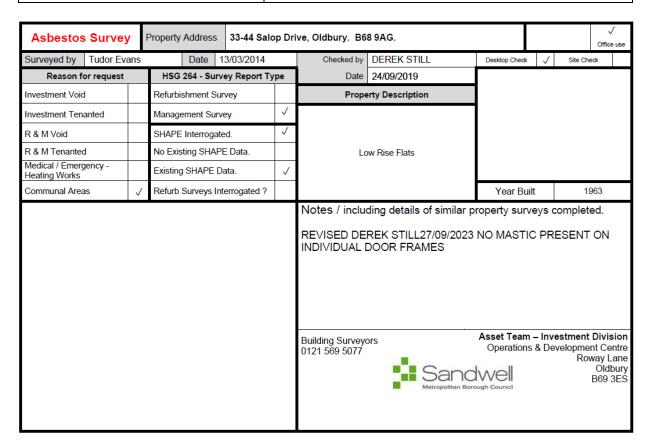
Hazard	Information/Comments
Asbestos	An asbestos survey has been undertaken of the communal areas. Survey held by Sandwell Housing (Derek Still Tel:- 0121 569 5077).

Sample Locations		Prope Addre		33-44 Salo	p Drive, Oldi	oury. B68 9A	G.			
LOCATION		MAT	ERIAL	QTY	SURFACE TREATMEN		RESULT	HSE NOTIF Y	Labelled?	ACTION TAKEN ON CONTRACT
IF DURING THE COURSE OF WOR	K SUSF	PECTED A	CM'S ARE	IDENTIFIE	D THAT ARE NO	OT CONTAINED	WITHIN THIS REP	ORT ST	OP W	ORK & SEEK ADVICE
INTERNAL STAIRWELL WALLS AND CEILIN	GS	TEXTURED COATING		-	SEALED-PAINT	TE 482	NO ASBESTOS DETECTED	NO	NO	-
ELECTRIC CUPBOARD REAR WALL		TEXTURED PAINT		-	SEALED-PAINT	TE 480	NO ASBESTOS DETECTED	NO	NO	-
DAMP PROOF COURSE		BITUMINOUS		-	-	-	-	-	-	REQUEST SAMPLE IF TO BE DISTURBED
ITEMS SHOWN BELOW HAVE BEEN ASSESSED ON SITE BY THE ASBESTOS SURVEYOR & ARE CONFIRMED NOT TO BE ACM'S.										
LOCATION DESCRIPTION	MAT	TERIAL	LOC	ATION DES	CRIPTION	MATERIAL	LOCATIO	N DESC	RIPTI	ON MATERIAL
ELECTRIC CUPBOARD INNER FRONT WAQLL LINING	SU	PALUX								
MAIN ROOF MINE		RAL FELT								
MAIN ROOF SOFFIT		PVC
