# Fire Risk Assessment

Flats 46 - 59 Salop Drive

# Salop Drive, Oldbury, B68 9AG

**Date Completed:** 27/05/2025.

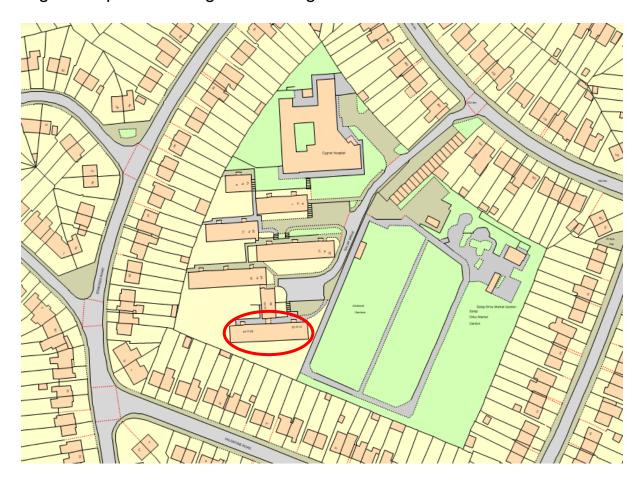
# **Building Plan**

A general plan showing the building location.
