### Fire Risk Assessment

6-8
Warren Drive,
Rowley Regis,
B65 8NS.

### Introduction

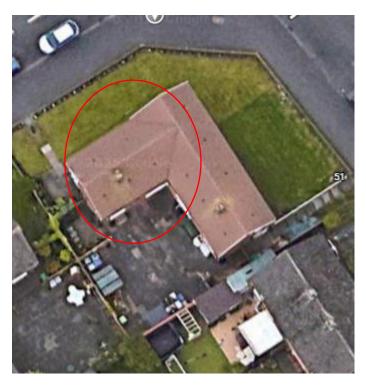
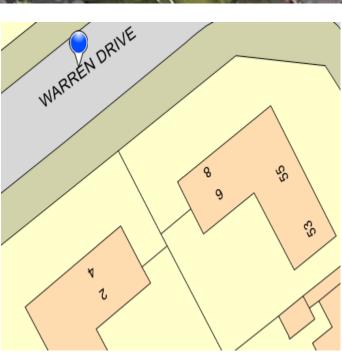
#### 6-8 Warren Drive.

Plan to show the general location/orientation of the building.
